**FINAL  
REMEDIAL INVESTIGATION REPORT**

**FORMER CAMP CROFT  
SPARTANBURG, SOUTH CAROLINA**

MRS 1, MRS 2, MRS 3, AoPI 3, AoPI 5, AoPI 8, AoPI 9E, AoPI 9G,  
AoPI 10A, AoPI 10B, AoPI 11B, AoPI 11C, and AoPI 11D

Zapata Incorporated  
6302 Fairview Road, Suite 600  
Charlotte, North Carolina 28210  
<http://www.zapatainc.com>

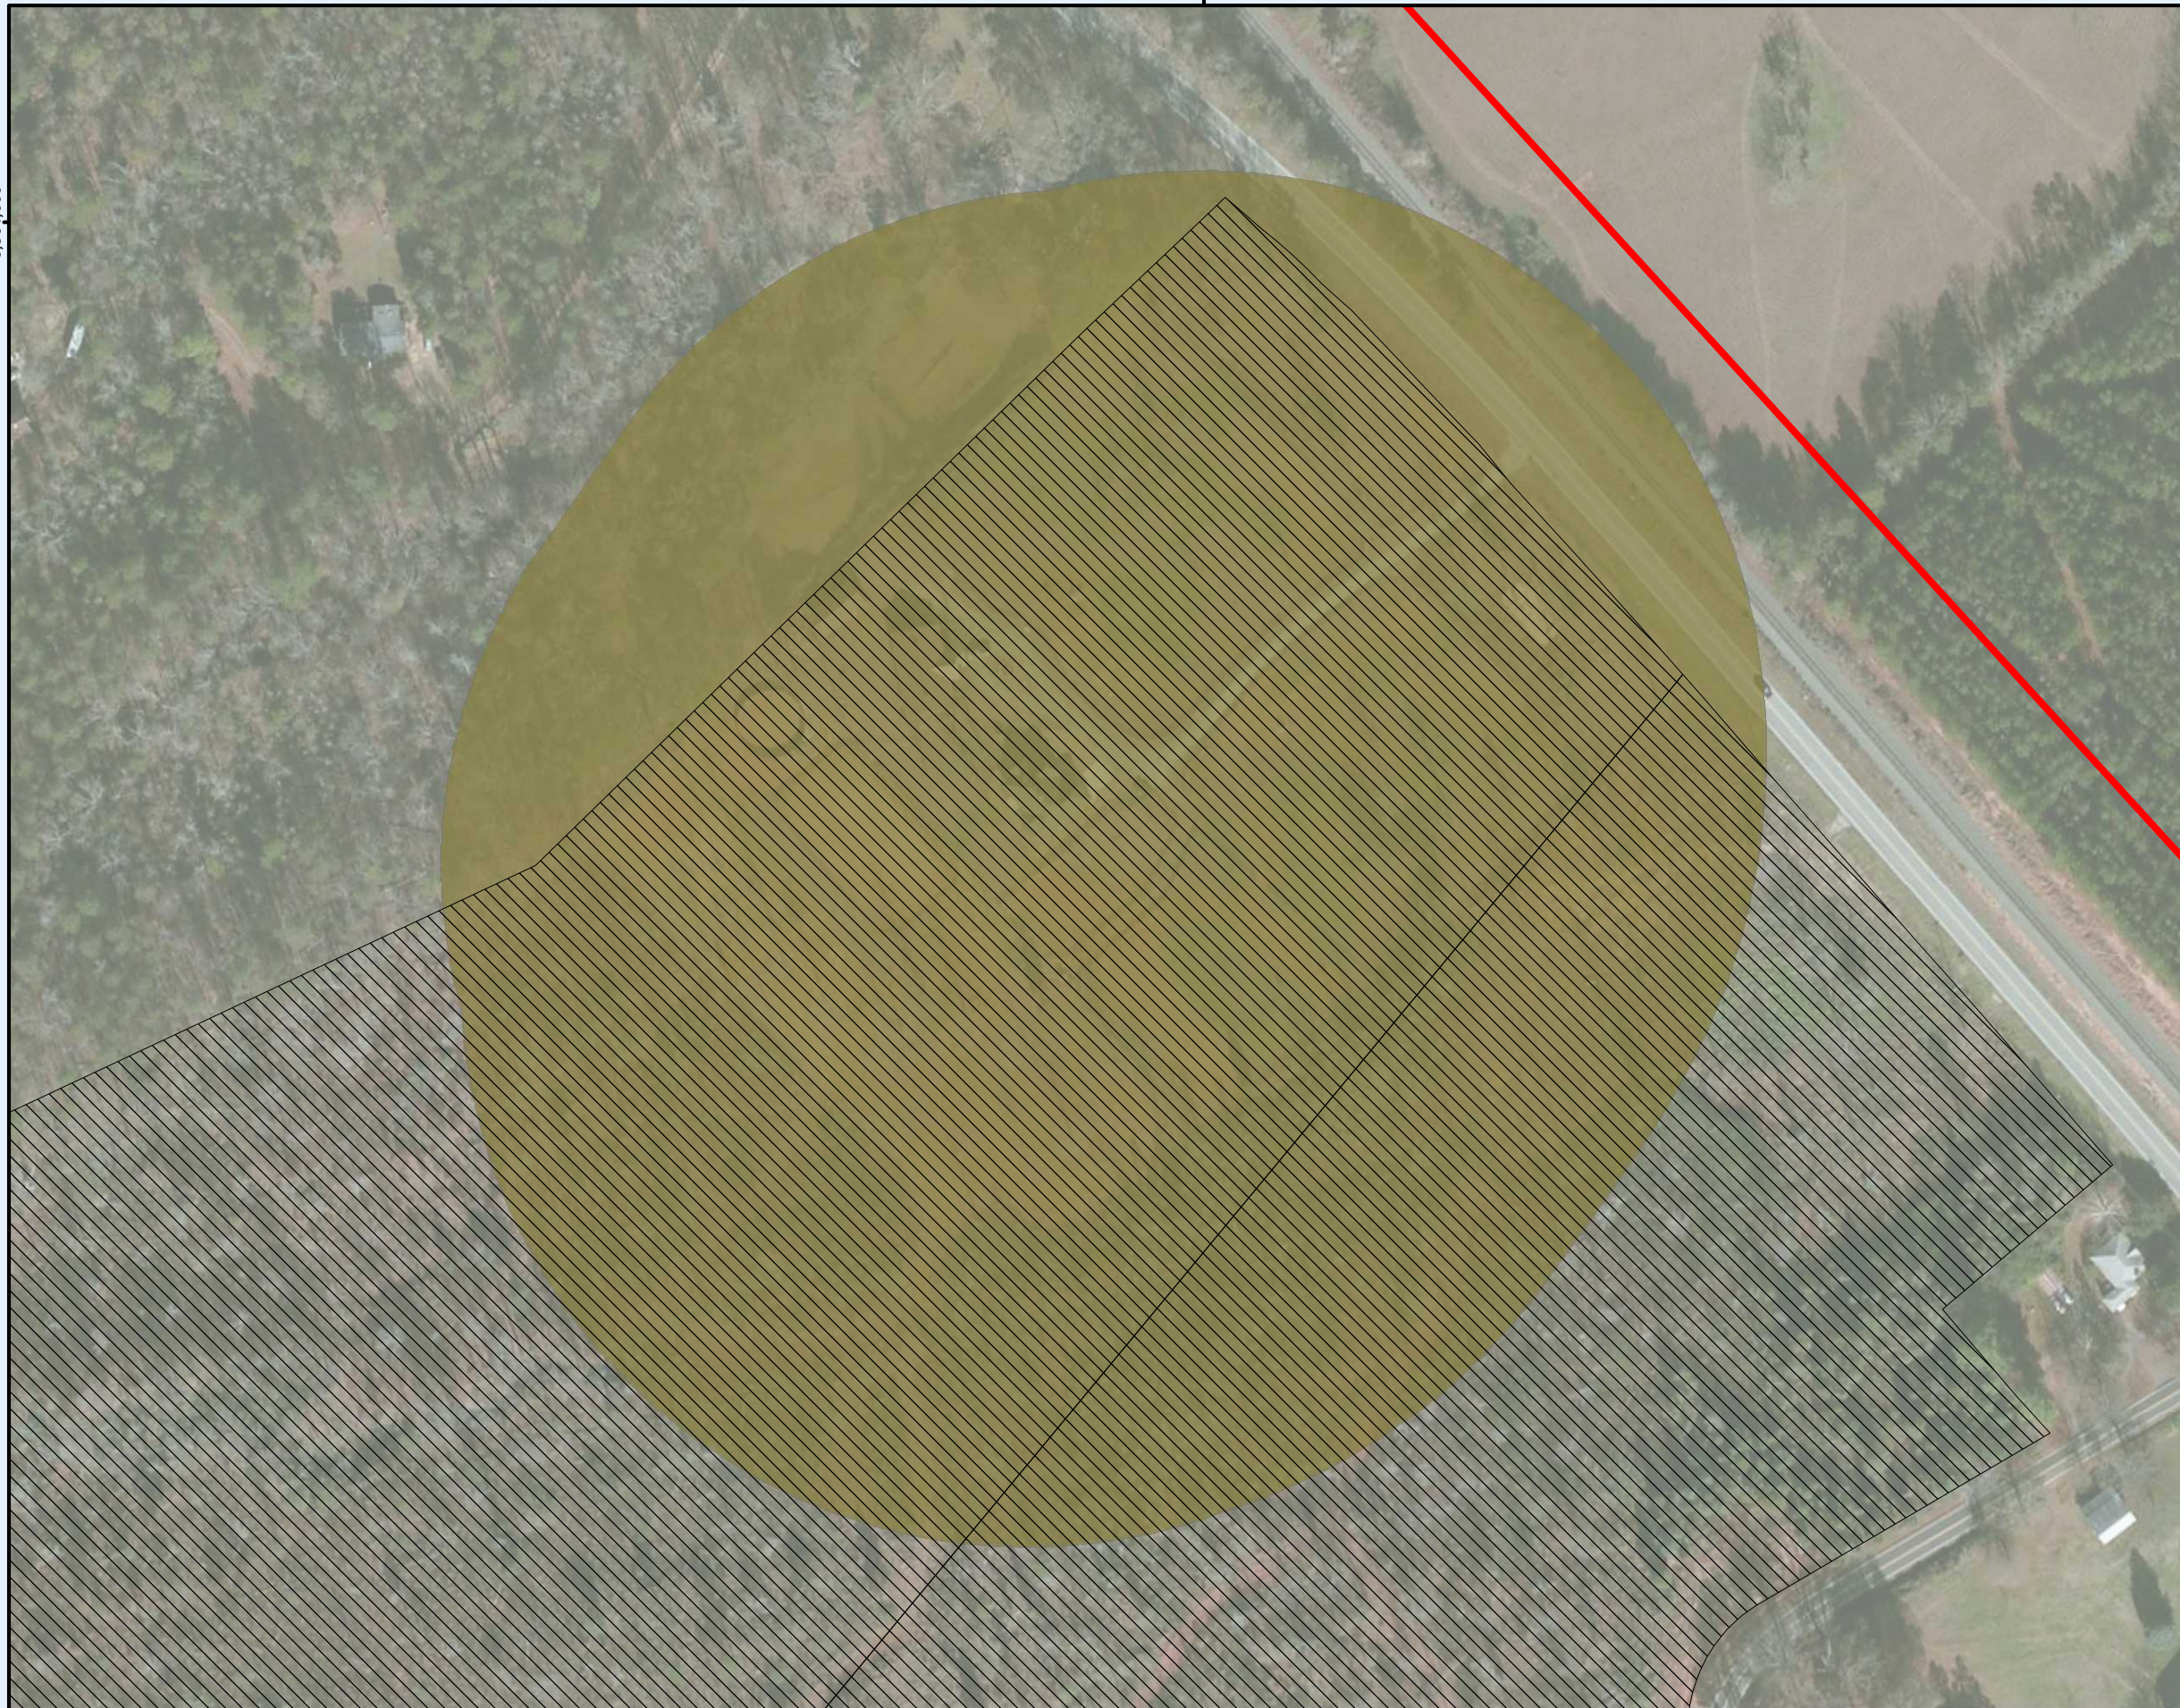
Remedial Investigation Report  
 Proposed Boundary Realignment  
 Former Camp Croft, Spartanburg, SC  
 Proposed MRS 2  
 Revision 2

Note: No boundary change recommended for MRS 2.
