Camp Croft Army Training Facility

GIS-Based Historical Photographic Analysis

FORMER CAMP CROFT ARMY TRAINING FACILITY

OCTOBER 2005 REPORT

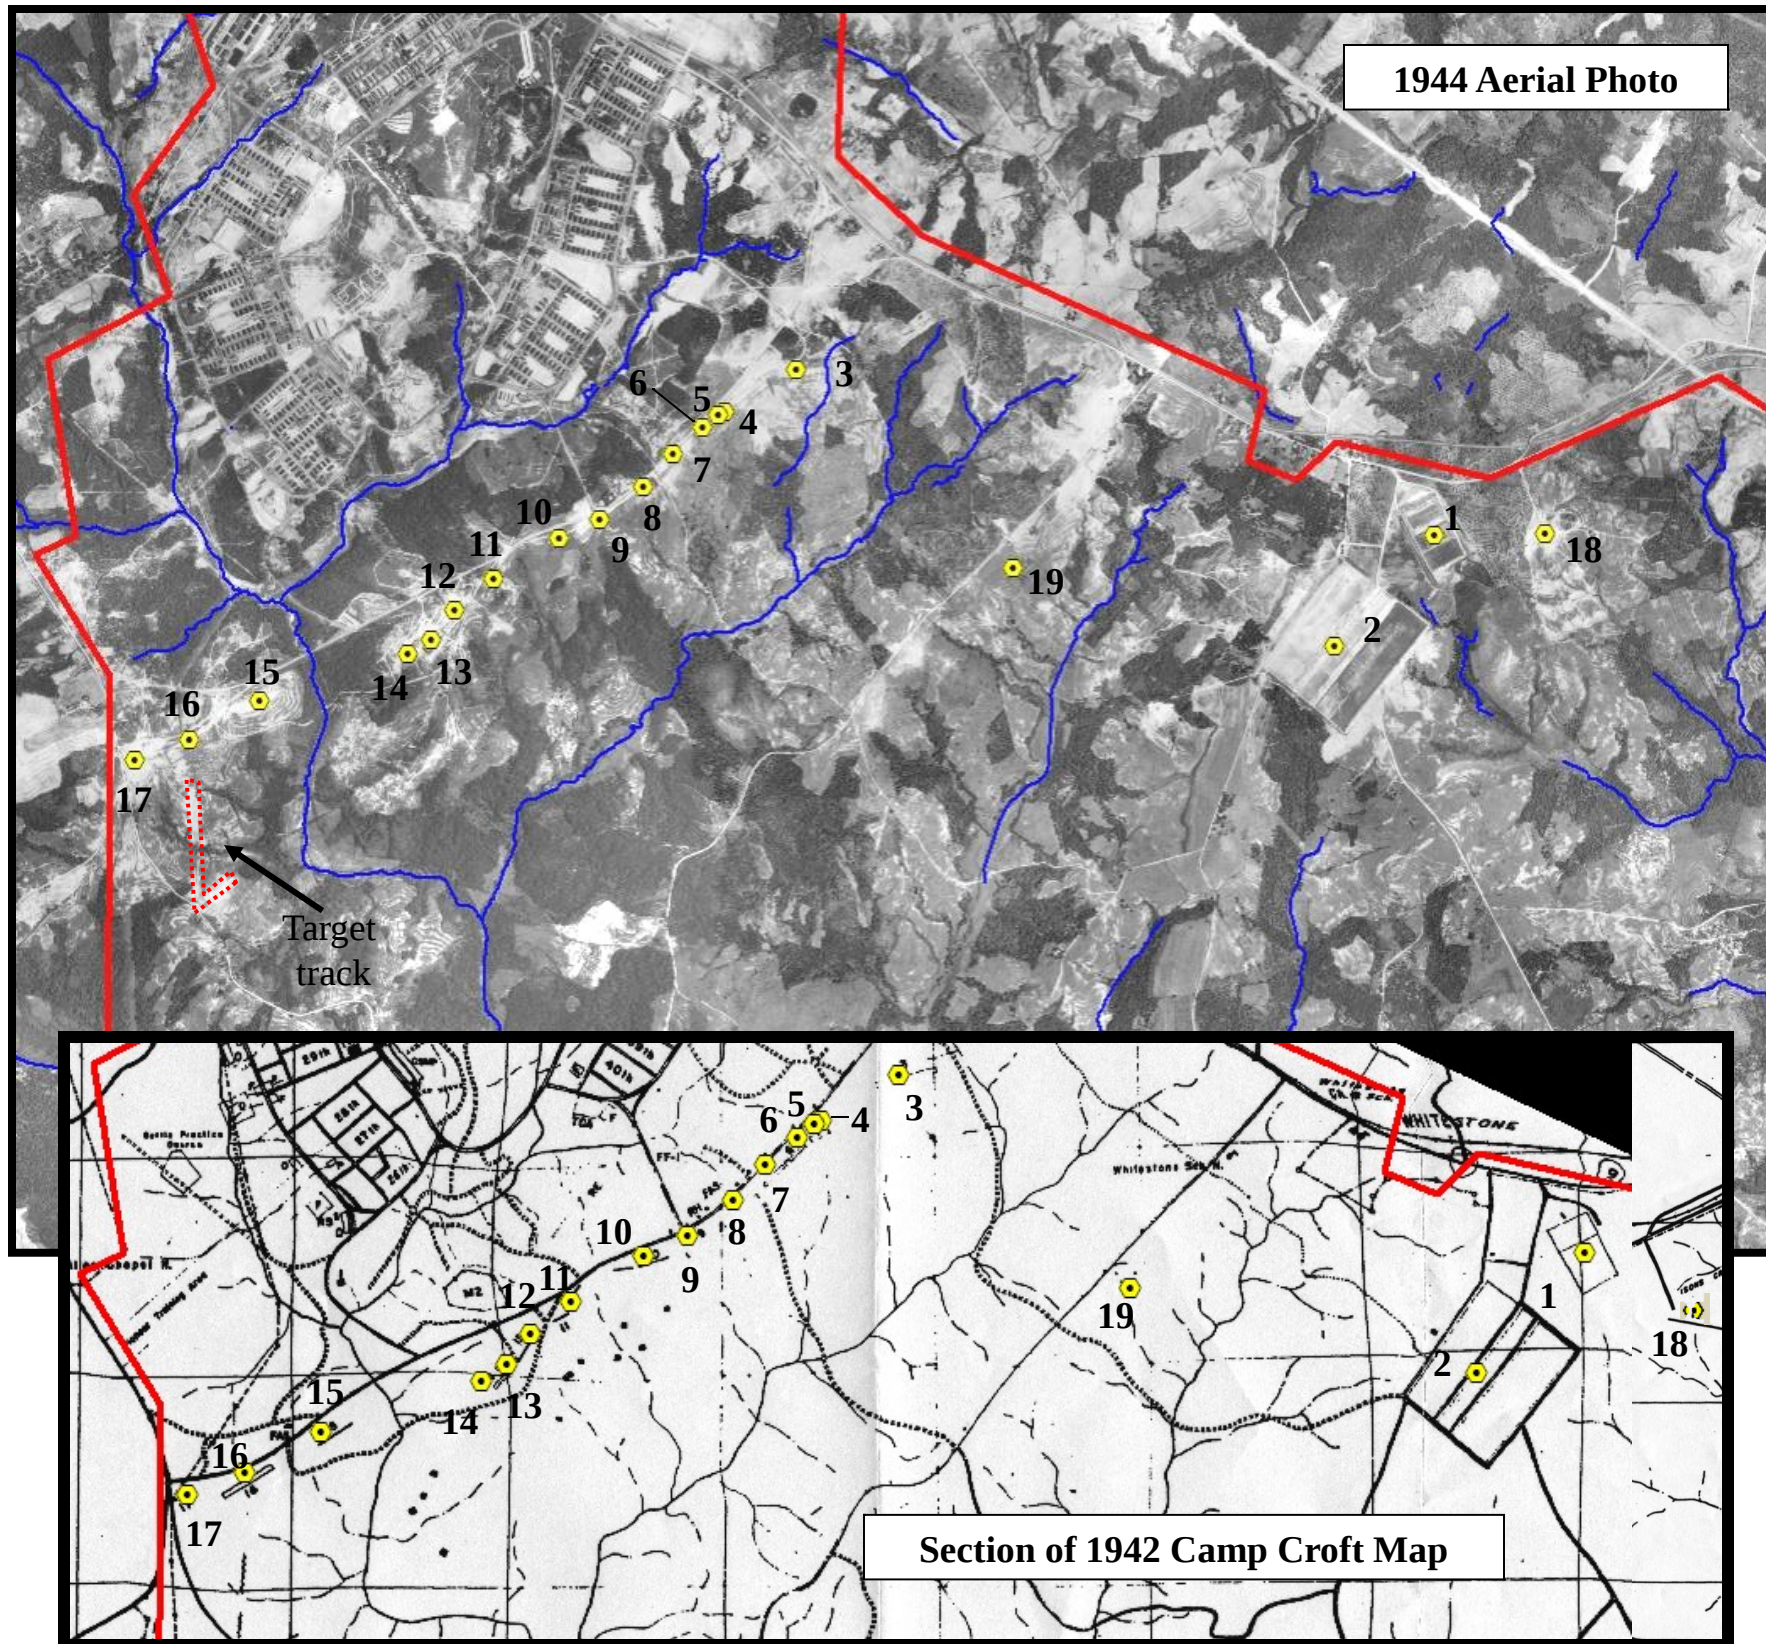
Range Areas - 1942 Map Features Atop 1944 Aerial Photo

Feature #	Range Type
1	Known Distance Range (50 targets)
2	Known Distance Range (200 targets)
3	Landscape Target Range
4	Moving Ground Target Range
5	Moving Ground Target Range
6	Field Target Range
7	Pistol Range
8	500" Cal. 22 Range
9	1000" Range
10	Field Target Range
11	Anti-aircraft Range
12	Field Target Range
13	Anti-aircraft Range
14	Anti-aircraft Range
15	MG Field Target Range
16	1000" Anti-tank Range
17	Anti-tank Field Firing Range
18	Mortar Range (Isons Creek)
19	Mortar Range (Whitstone School)

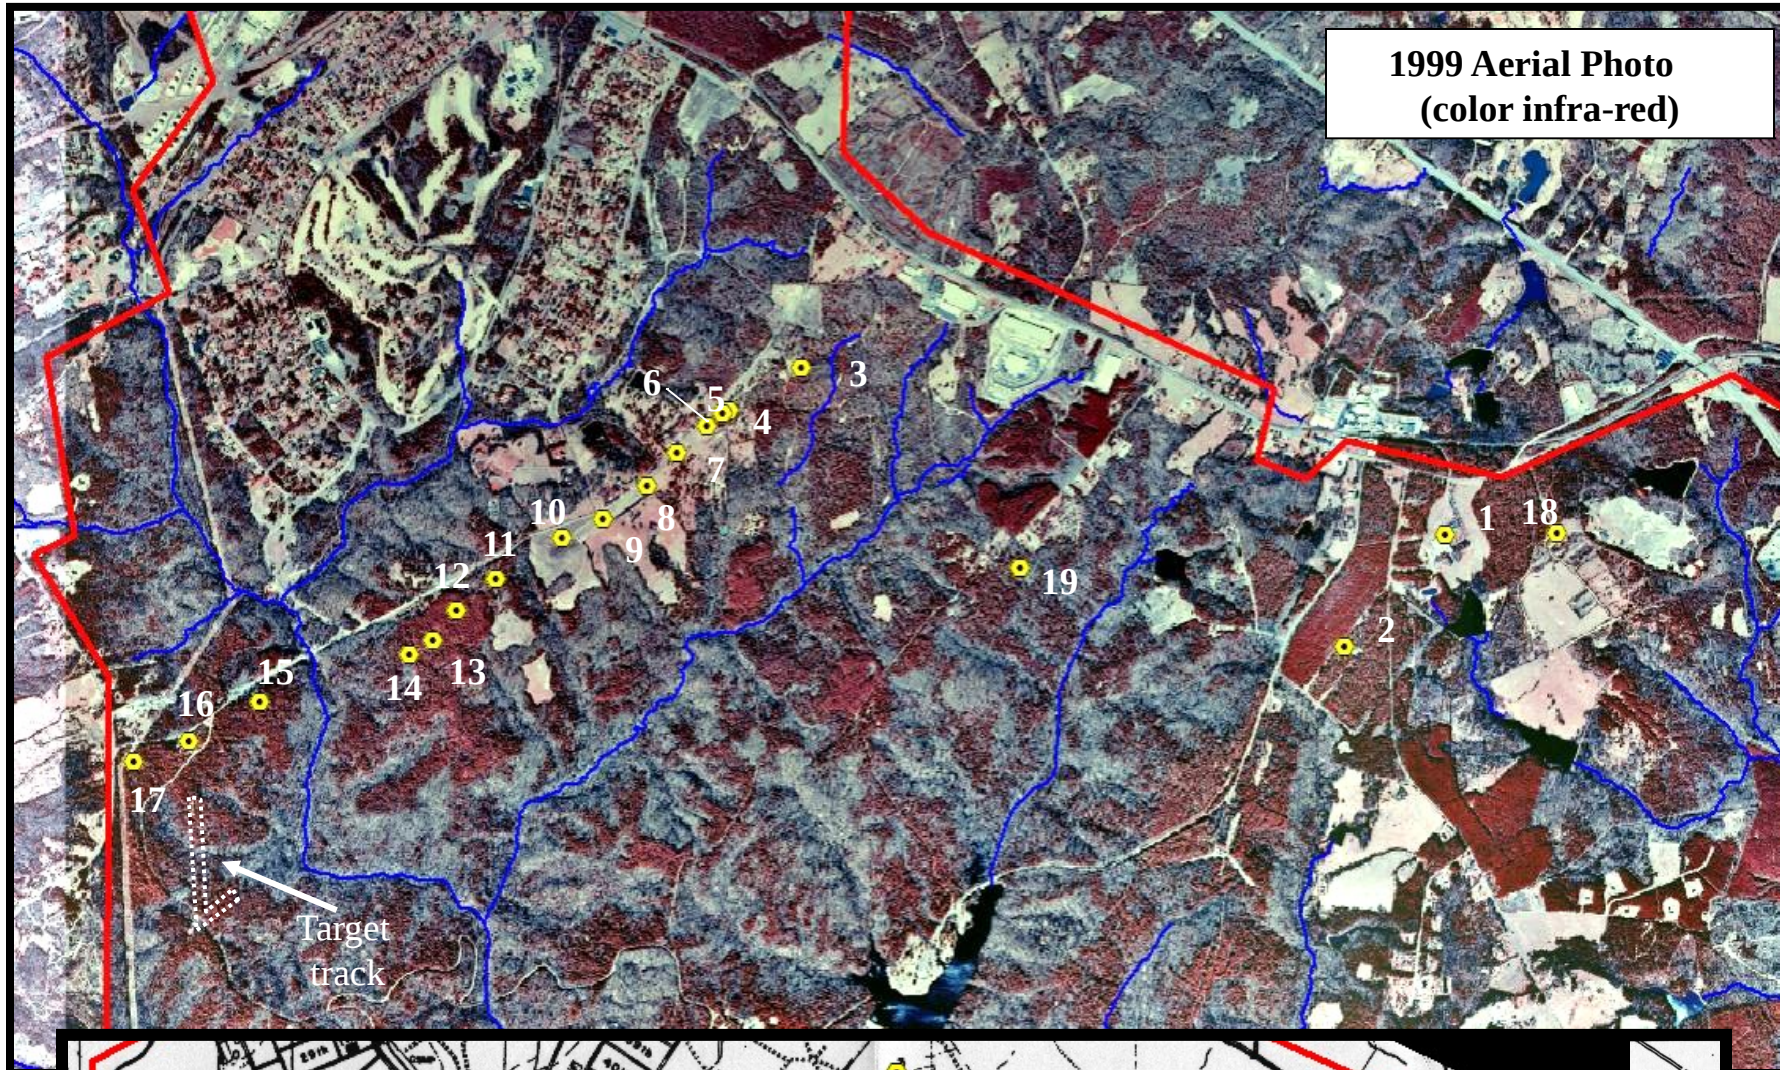
Range Areas - 1942 Map Features Atop 1999 Aerial Photo

Feature #	Range Type
1	Known Distance Range (50 targets)
2	Known Distance Range (200 targets)
3	Landscape Target Range
4	Moving Ground Target Range
5	Moving Ground Target Range
6	Field Target Range
7	Pistol Range
8	500" Cal. 22 Range
9	1000" Range
10	Field Target Range
11	Anti-aircraft Range
12	Field Target Range
13	Anti-aircraft Range
14	Anti-aircraft Range
15	MG Field Target Range
16	1000" Anti-tank Range
17	Anti-tank Field Firing Range
18	Mortar Range (Isons Creek)
19	Mortar Range (Whitestone School)

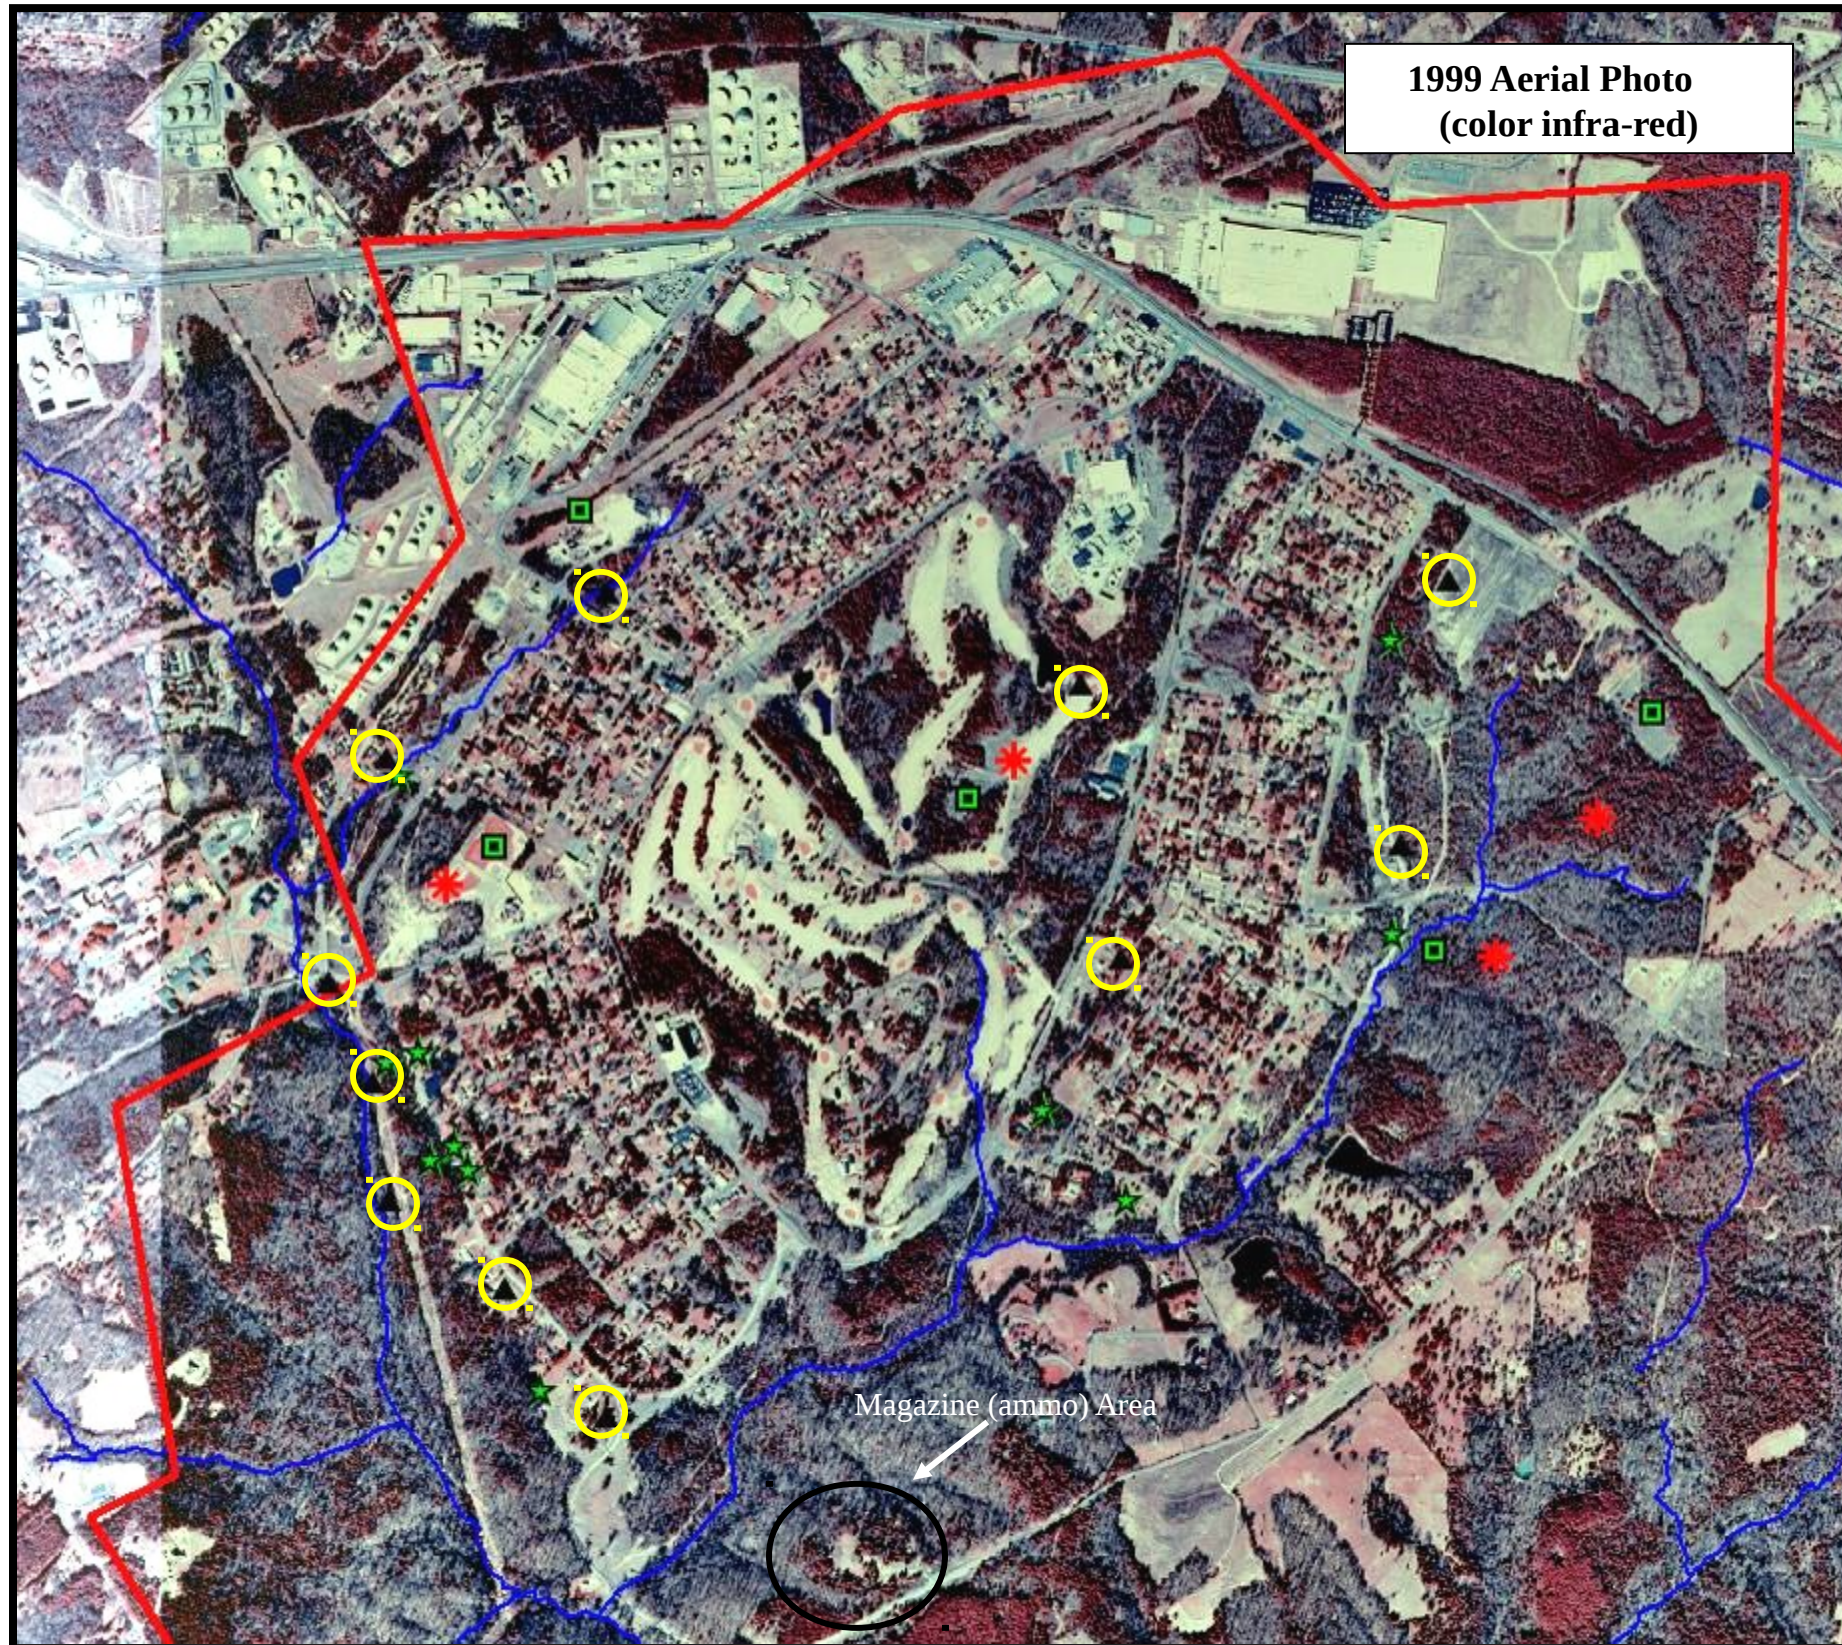
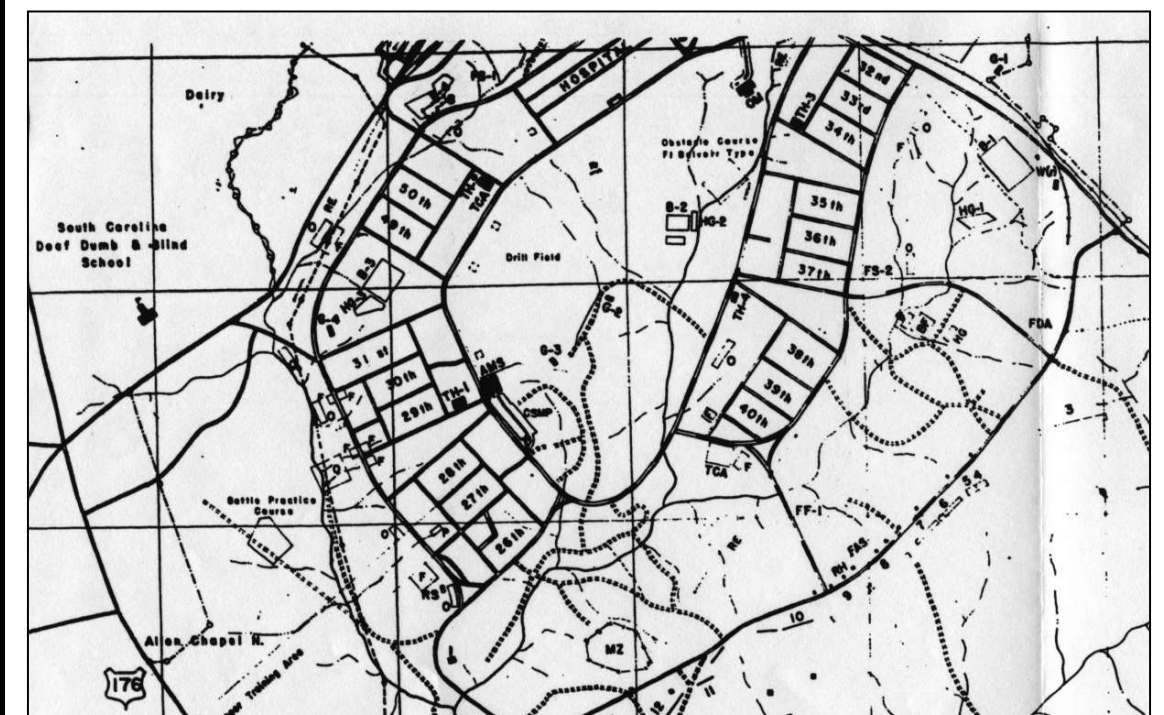
Training Area Sites - 1942 Map Features Atop 1999 Aerial Photo

= Obstacle Course (yellow circle used to highlight feature)
	= Bayonet Court
	= Fit to Fight
	= Grenade Court
	= streams
	= Camp Boundary

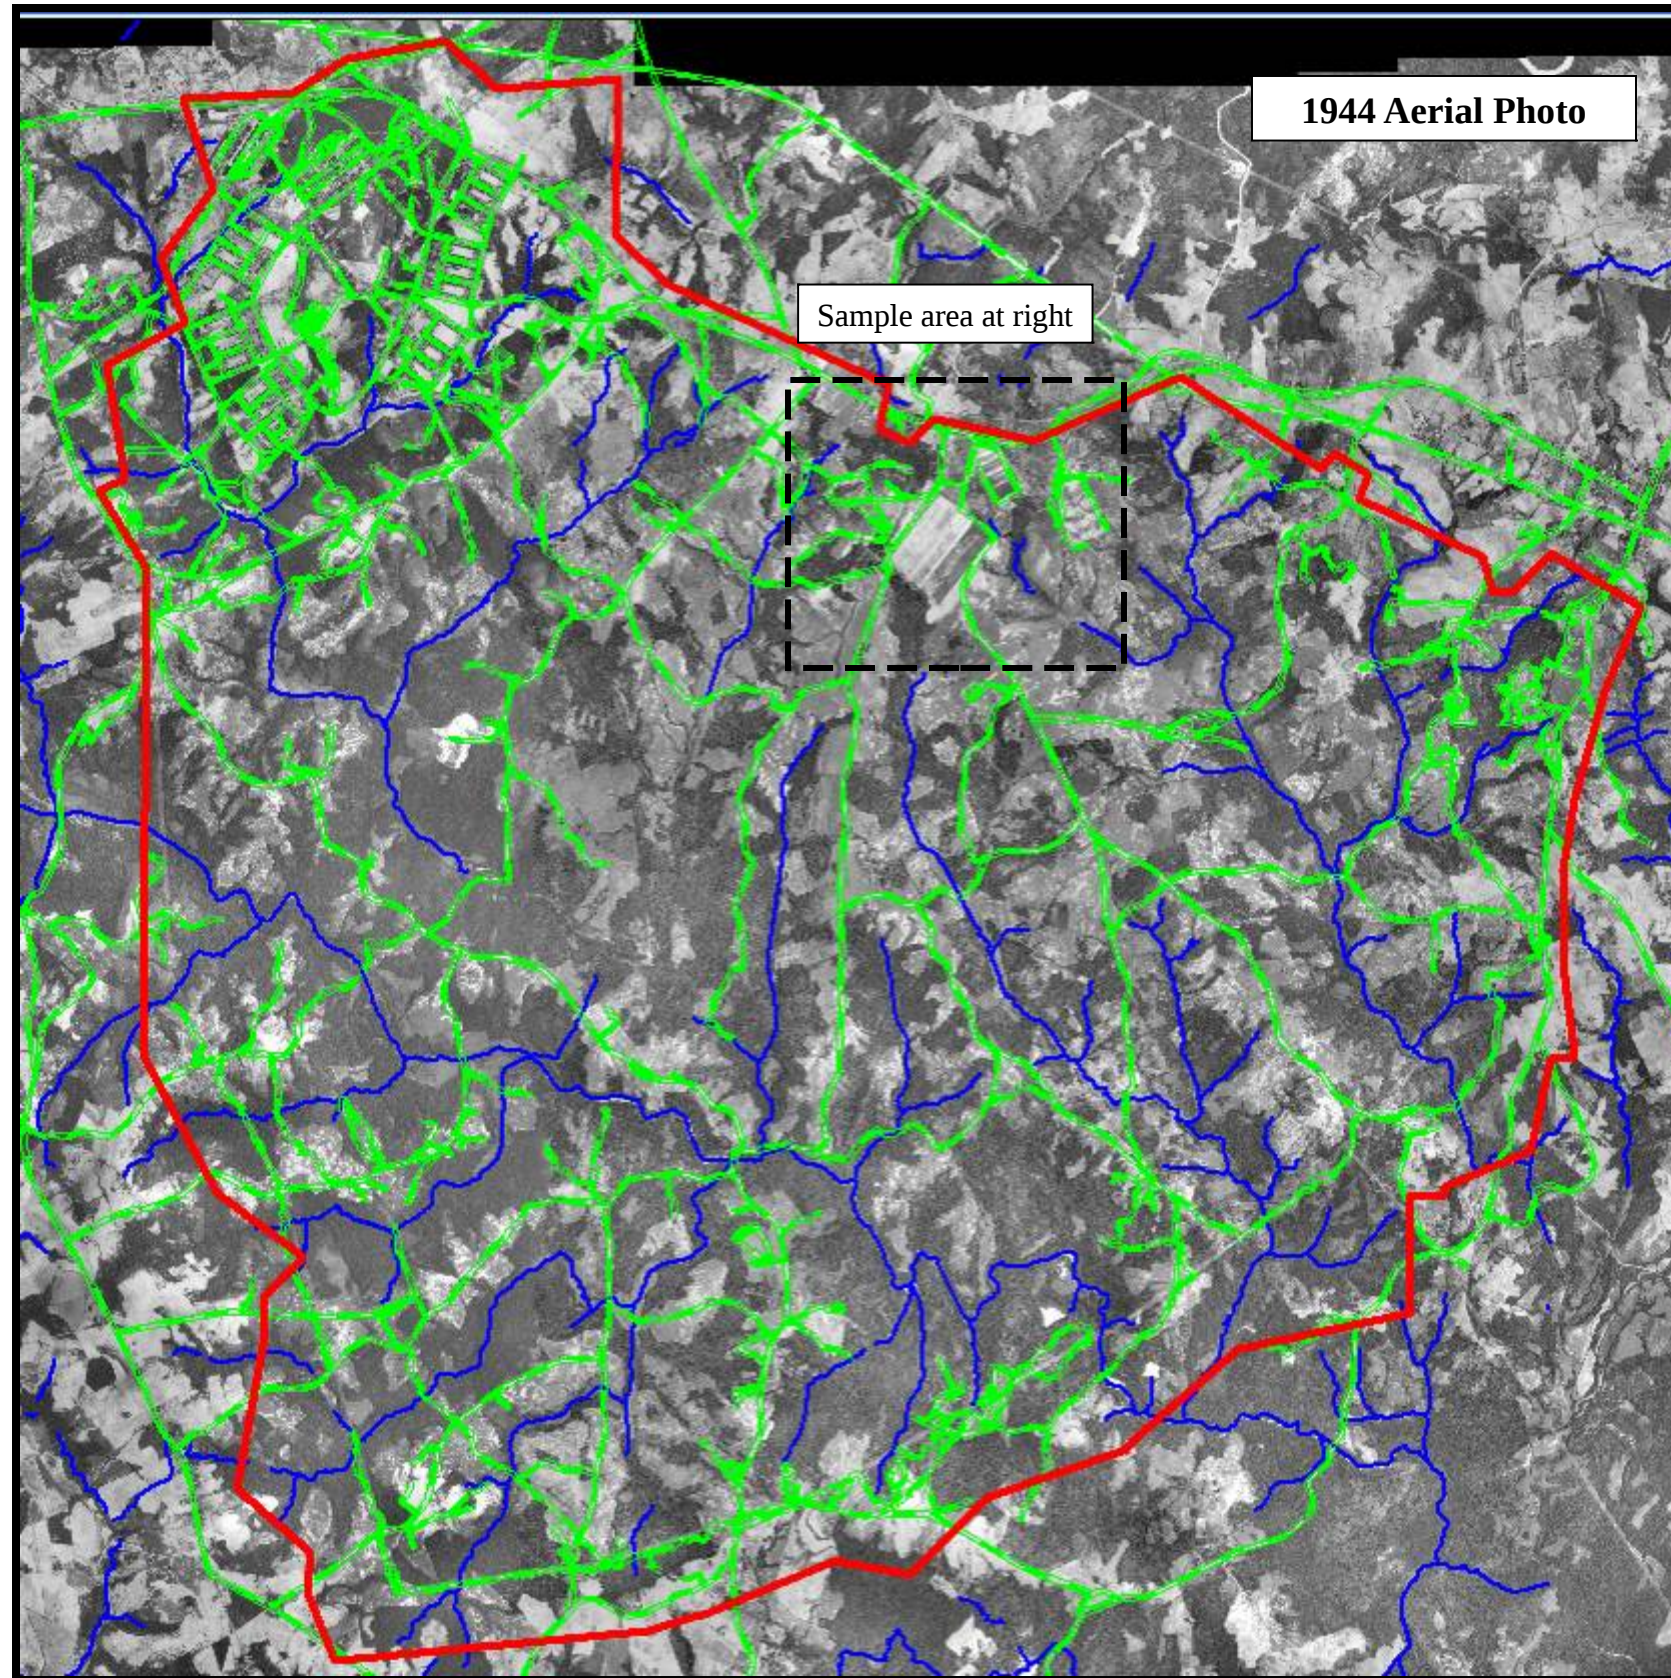
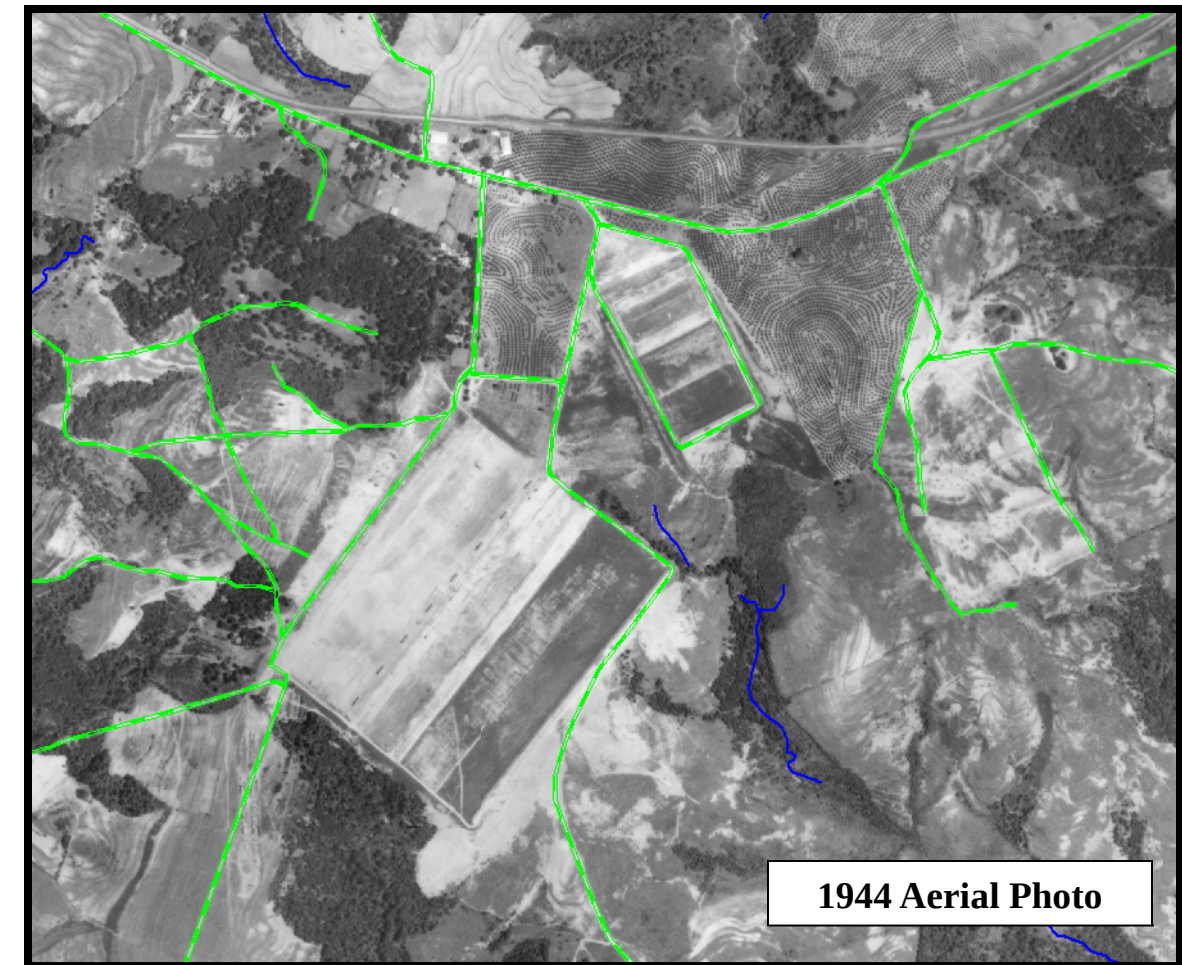
Historical Road Network - 1944 Roads Atop 1944 Aerial Photo

Sample Area –roads and trails.

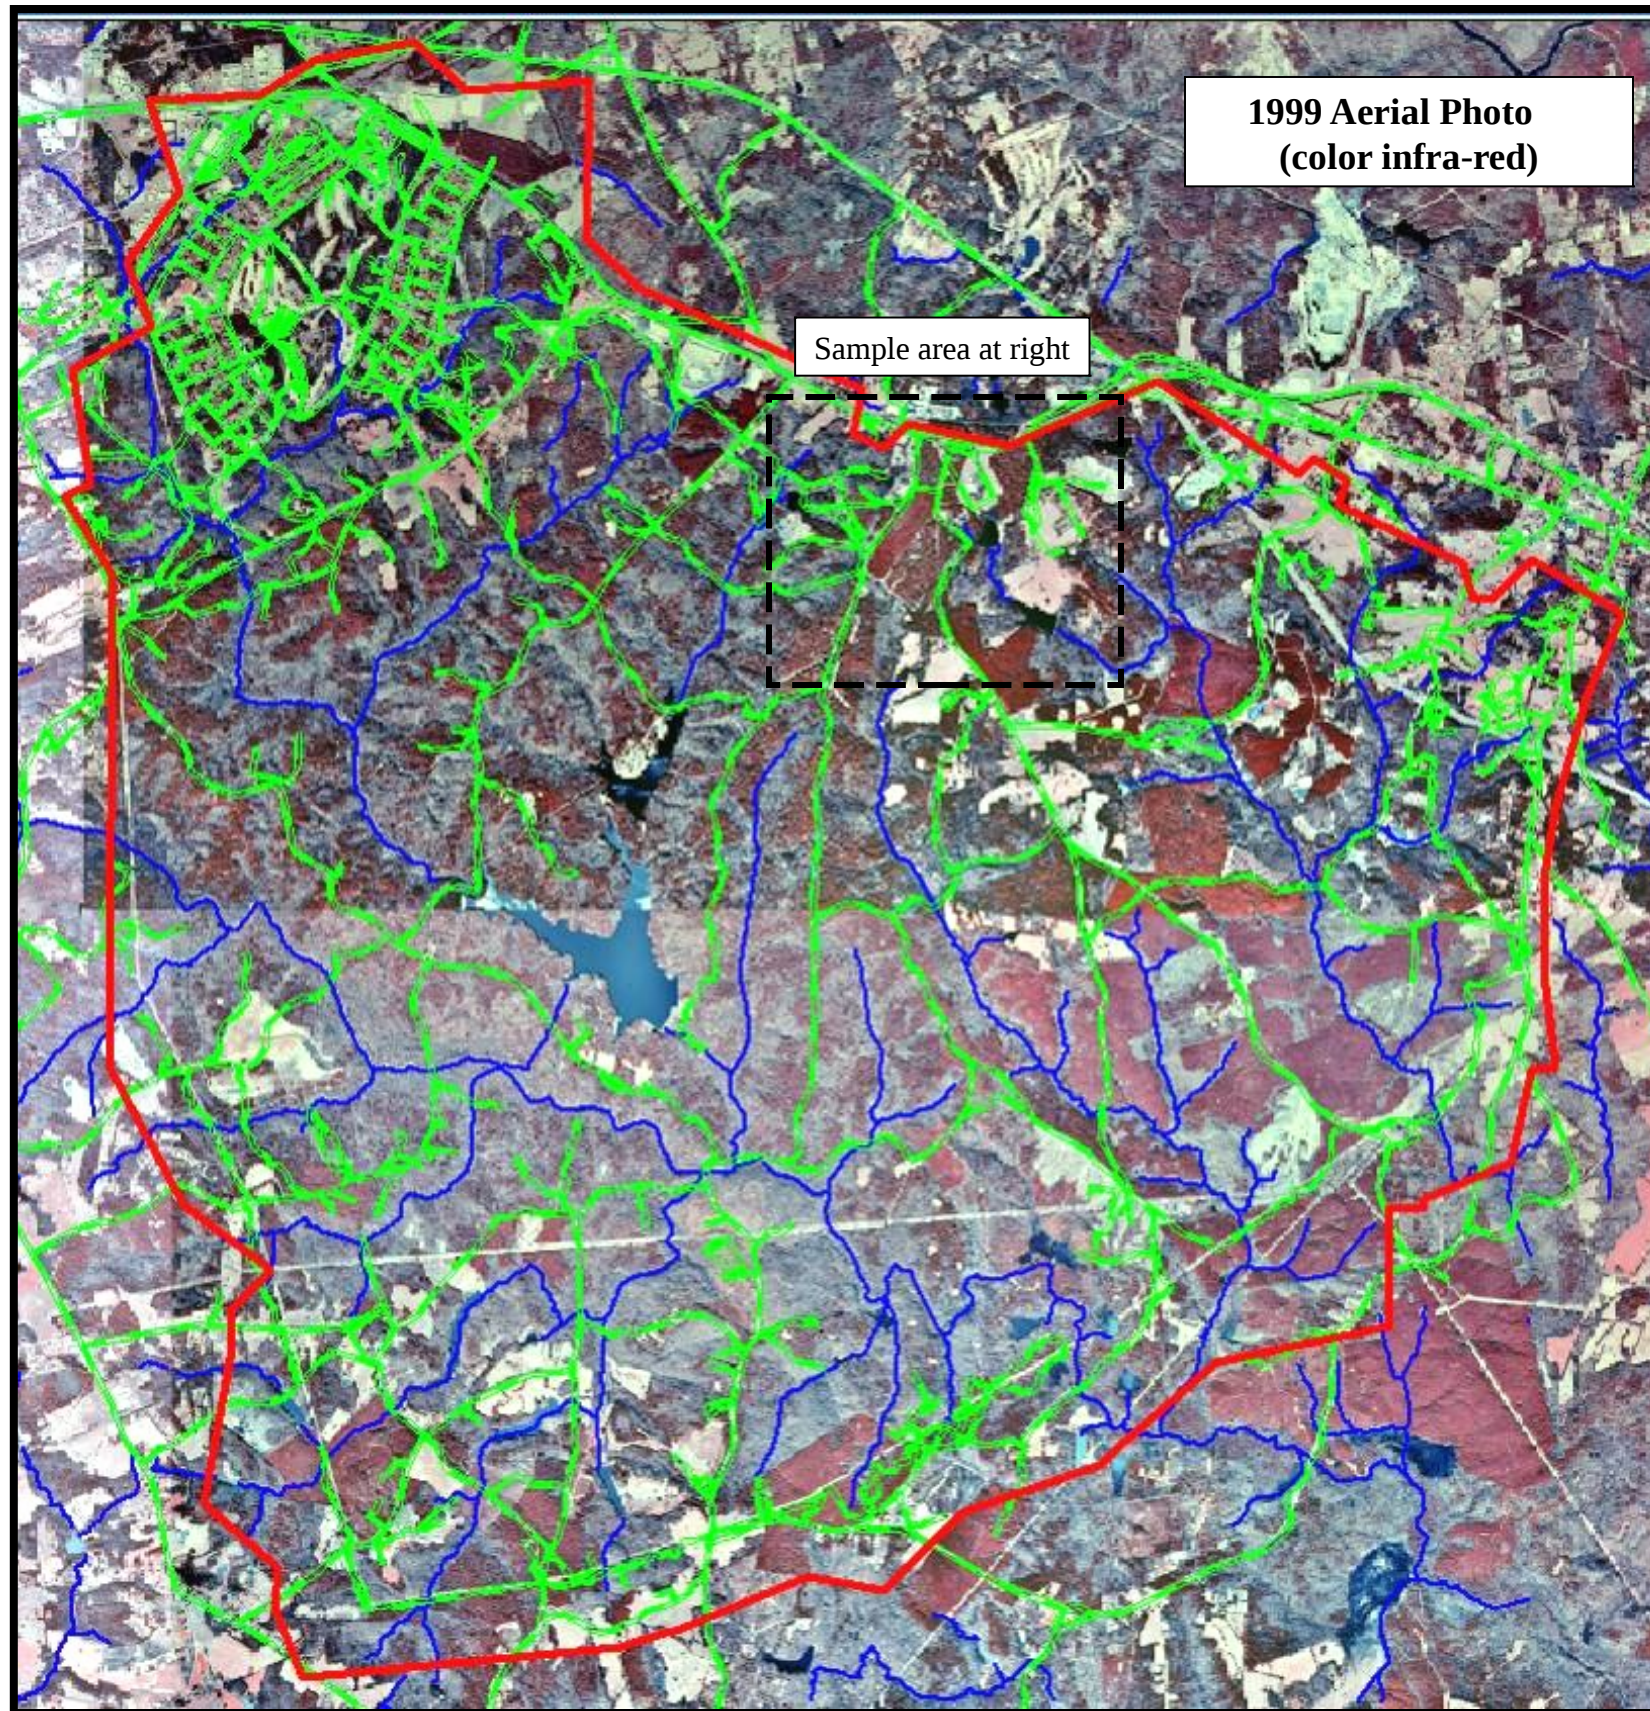
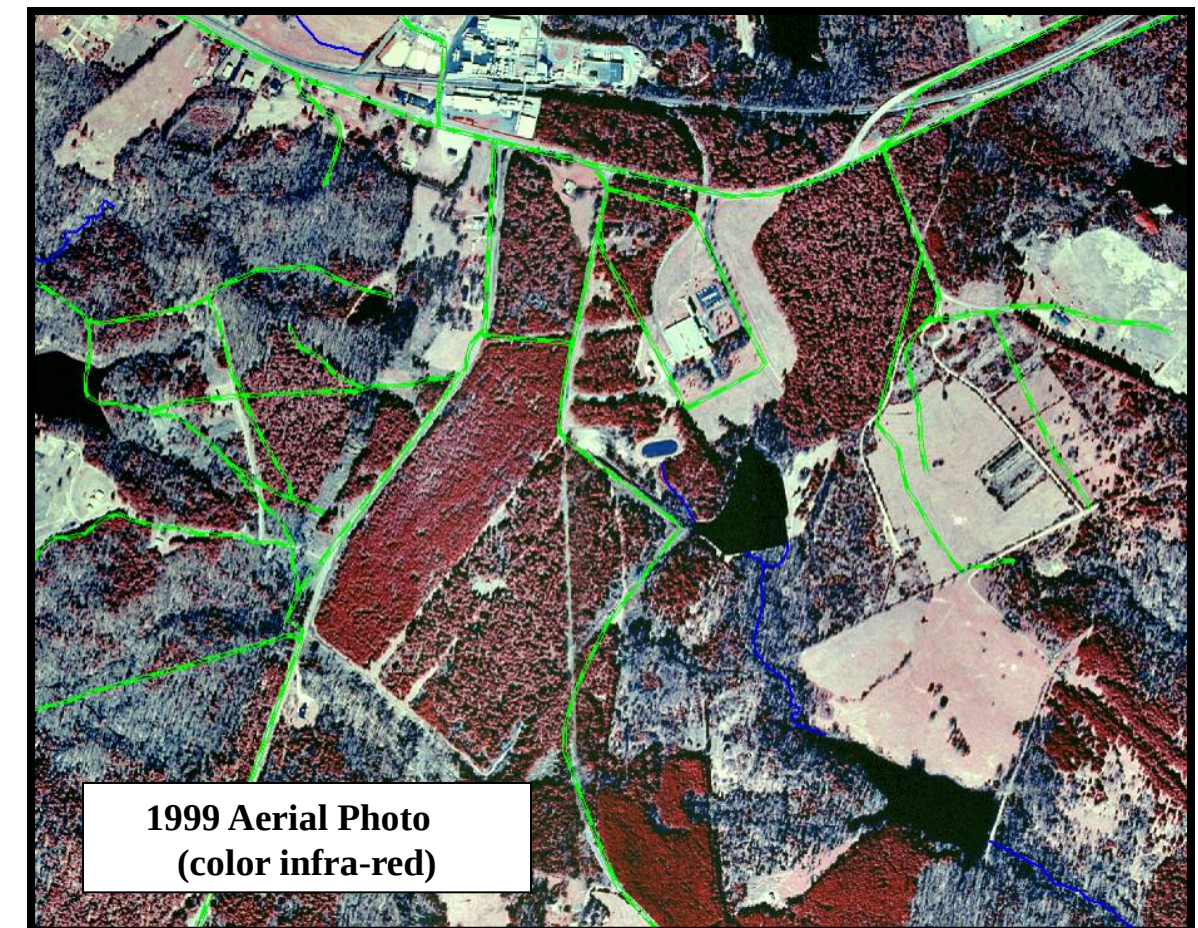
Historical Road Network - 1944 Roads Atop 1999 Aerial Photo

Sample Area –1944 roads and trails.

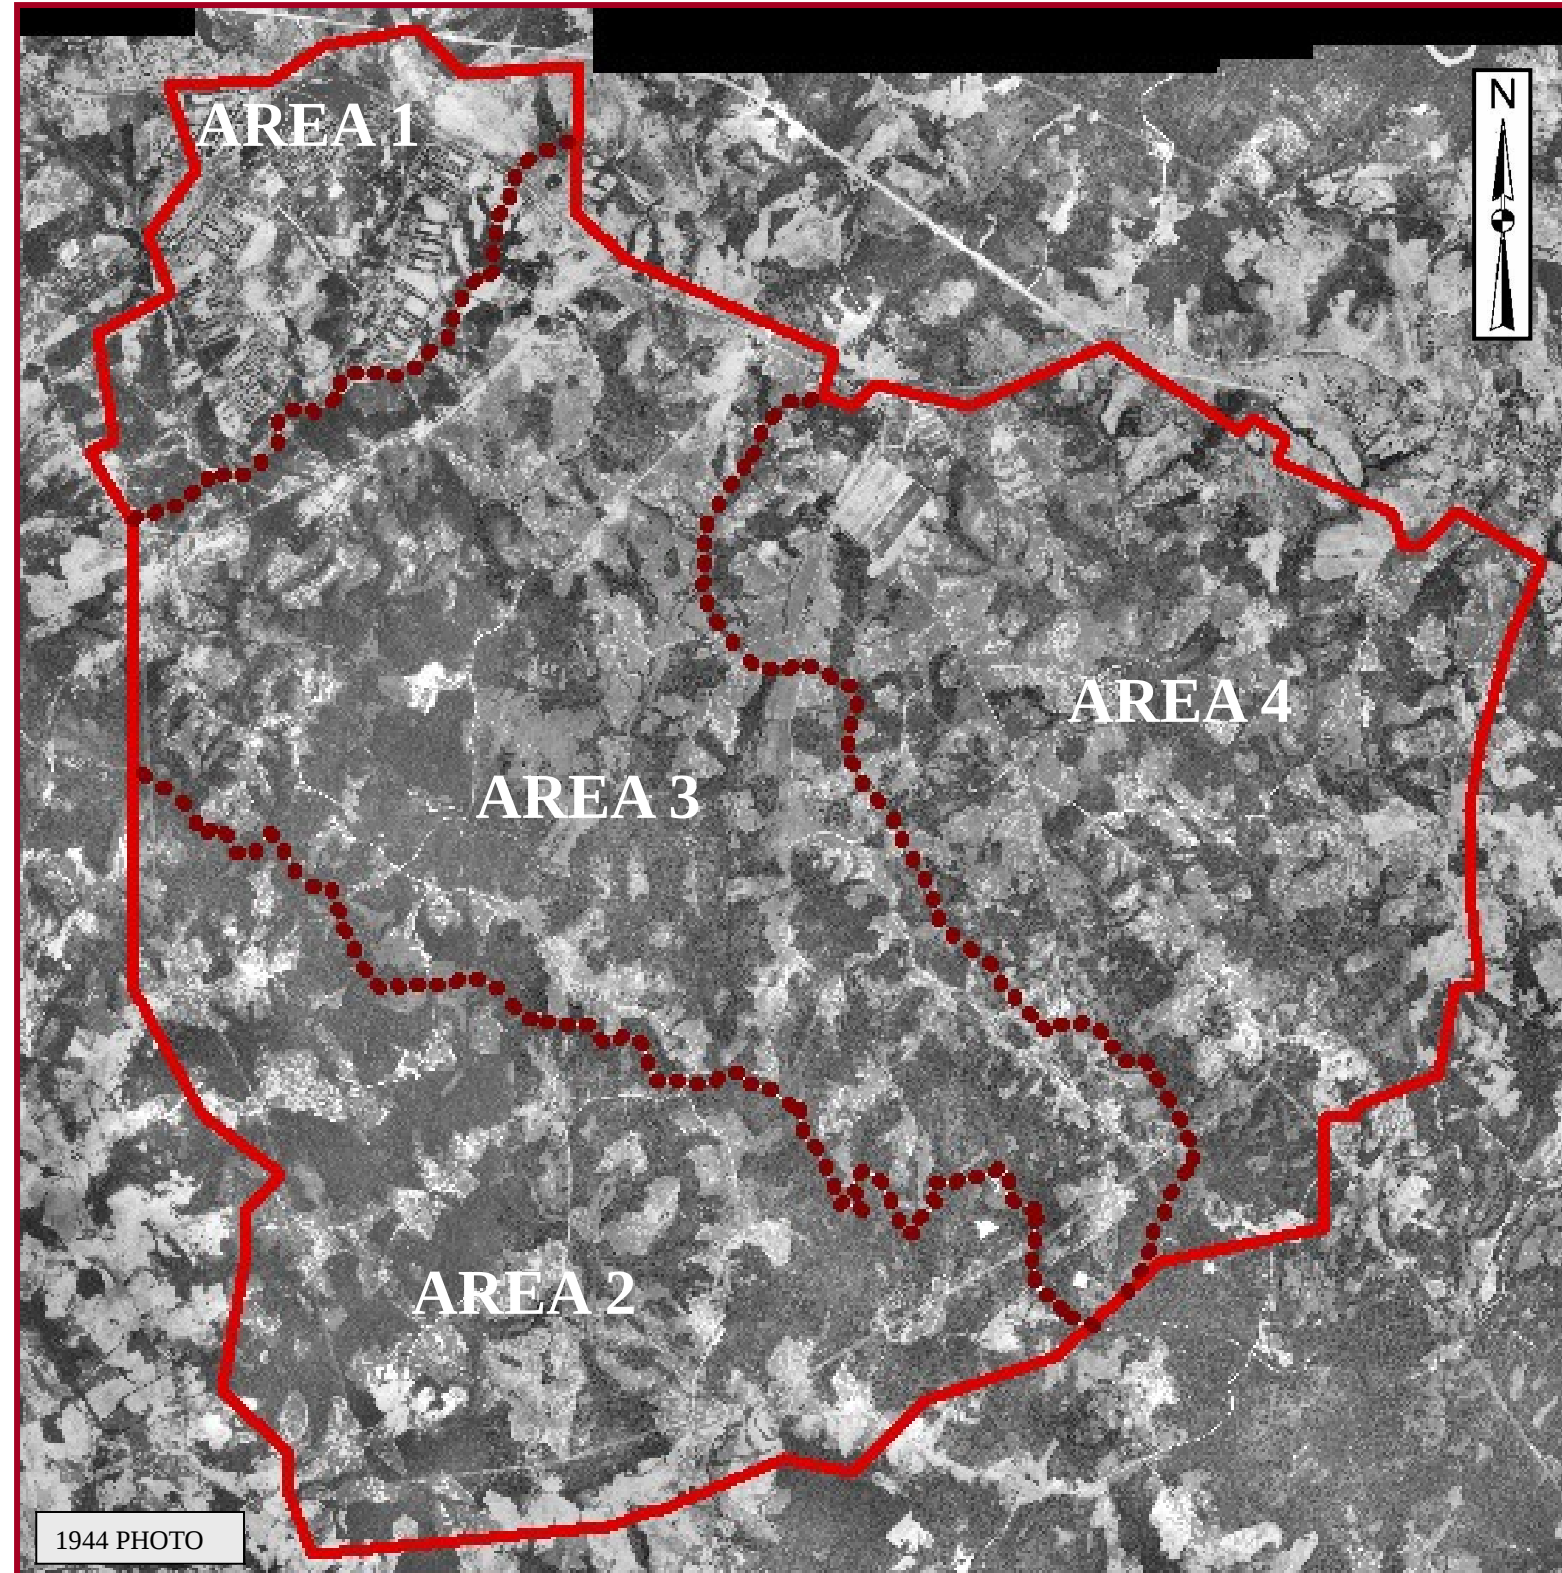
AREA REFERENCE GUIDE

FOR EASE OF USE AND CONTINUITY OF THIS PRESENTATION, THE FORMER CAMP CROFT ARMY TRAINING FACILITY IS BROKEN INTO FOUR AREAS, AS DENOTED ON THIS PAGE. AREAS WERE DIVIDED ALONG STREAMS. THERE ARE SECTIONS WHERE THE DIVIDING LINE DIVERGES AND CROSSES A RIDGE INSTEAD OF FOLLOWING SPECIFIC STREAMS.

EACH SECTION IS PRESENTED SEPARATELY AND CONTAINS WITHIN IT: AN OVERVIEW OF THE SECTION, CLOSE-UPS OF SELECTED FEATURES, AND A TIME-SEQUENCE PRESENTATION OF SELECTED FEATURES.

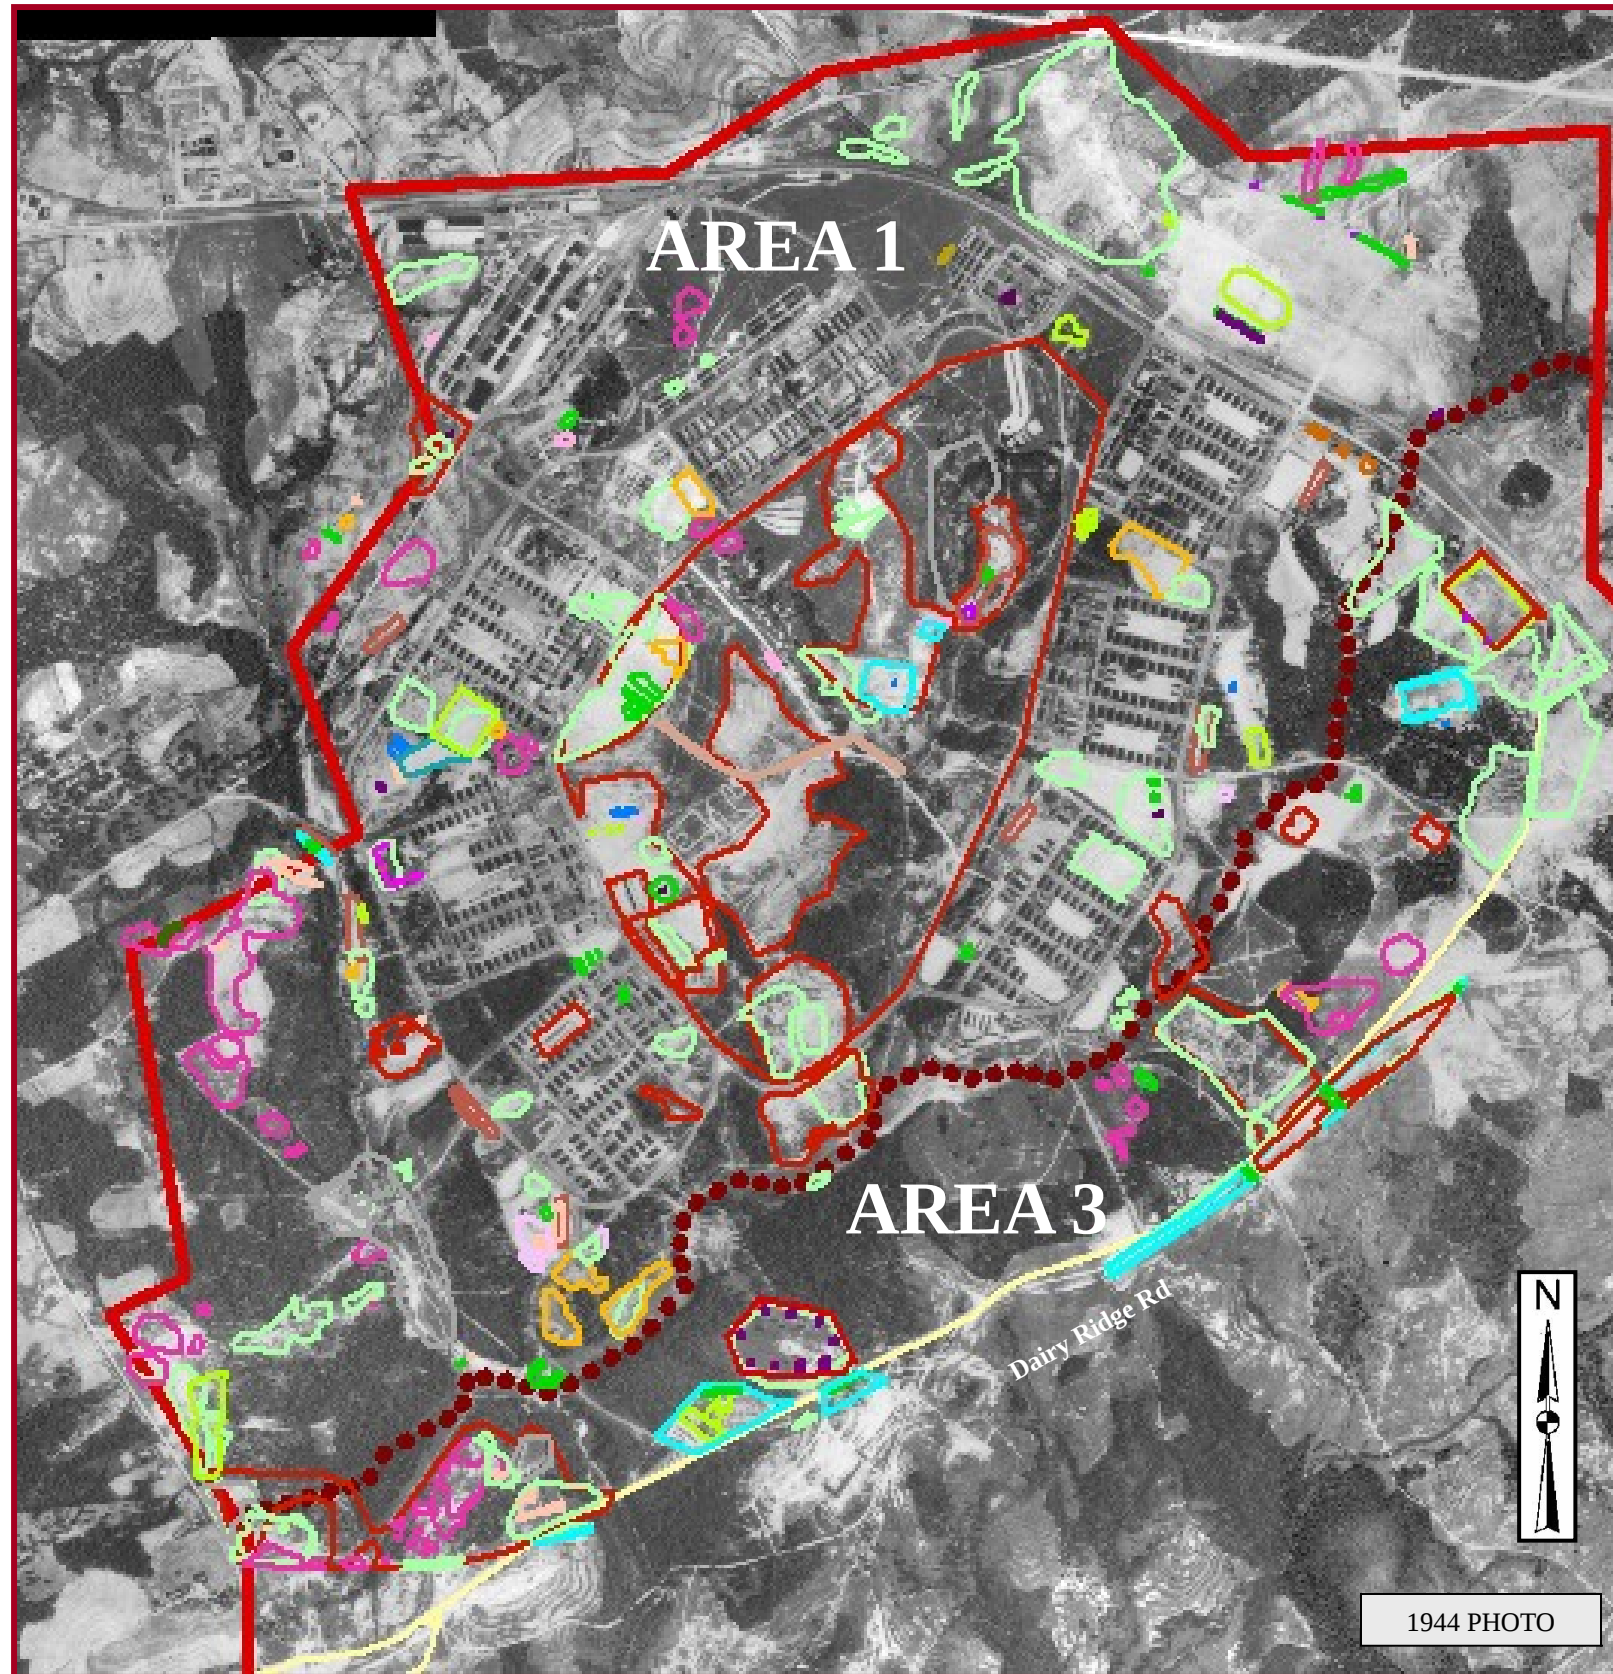
AREA 1 – OVERVIEW OF ALL FEATURES

All of the features found during analysis of the five photo years are displayed on this 1944 photo.
