Camp Croft Army Training Facility

GIS-Based Historical Photographic Analysis

FORMER CAMP CROFT ARMY TRAINING FACILITY

OCTOBER 2005 REPORT

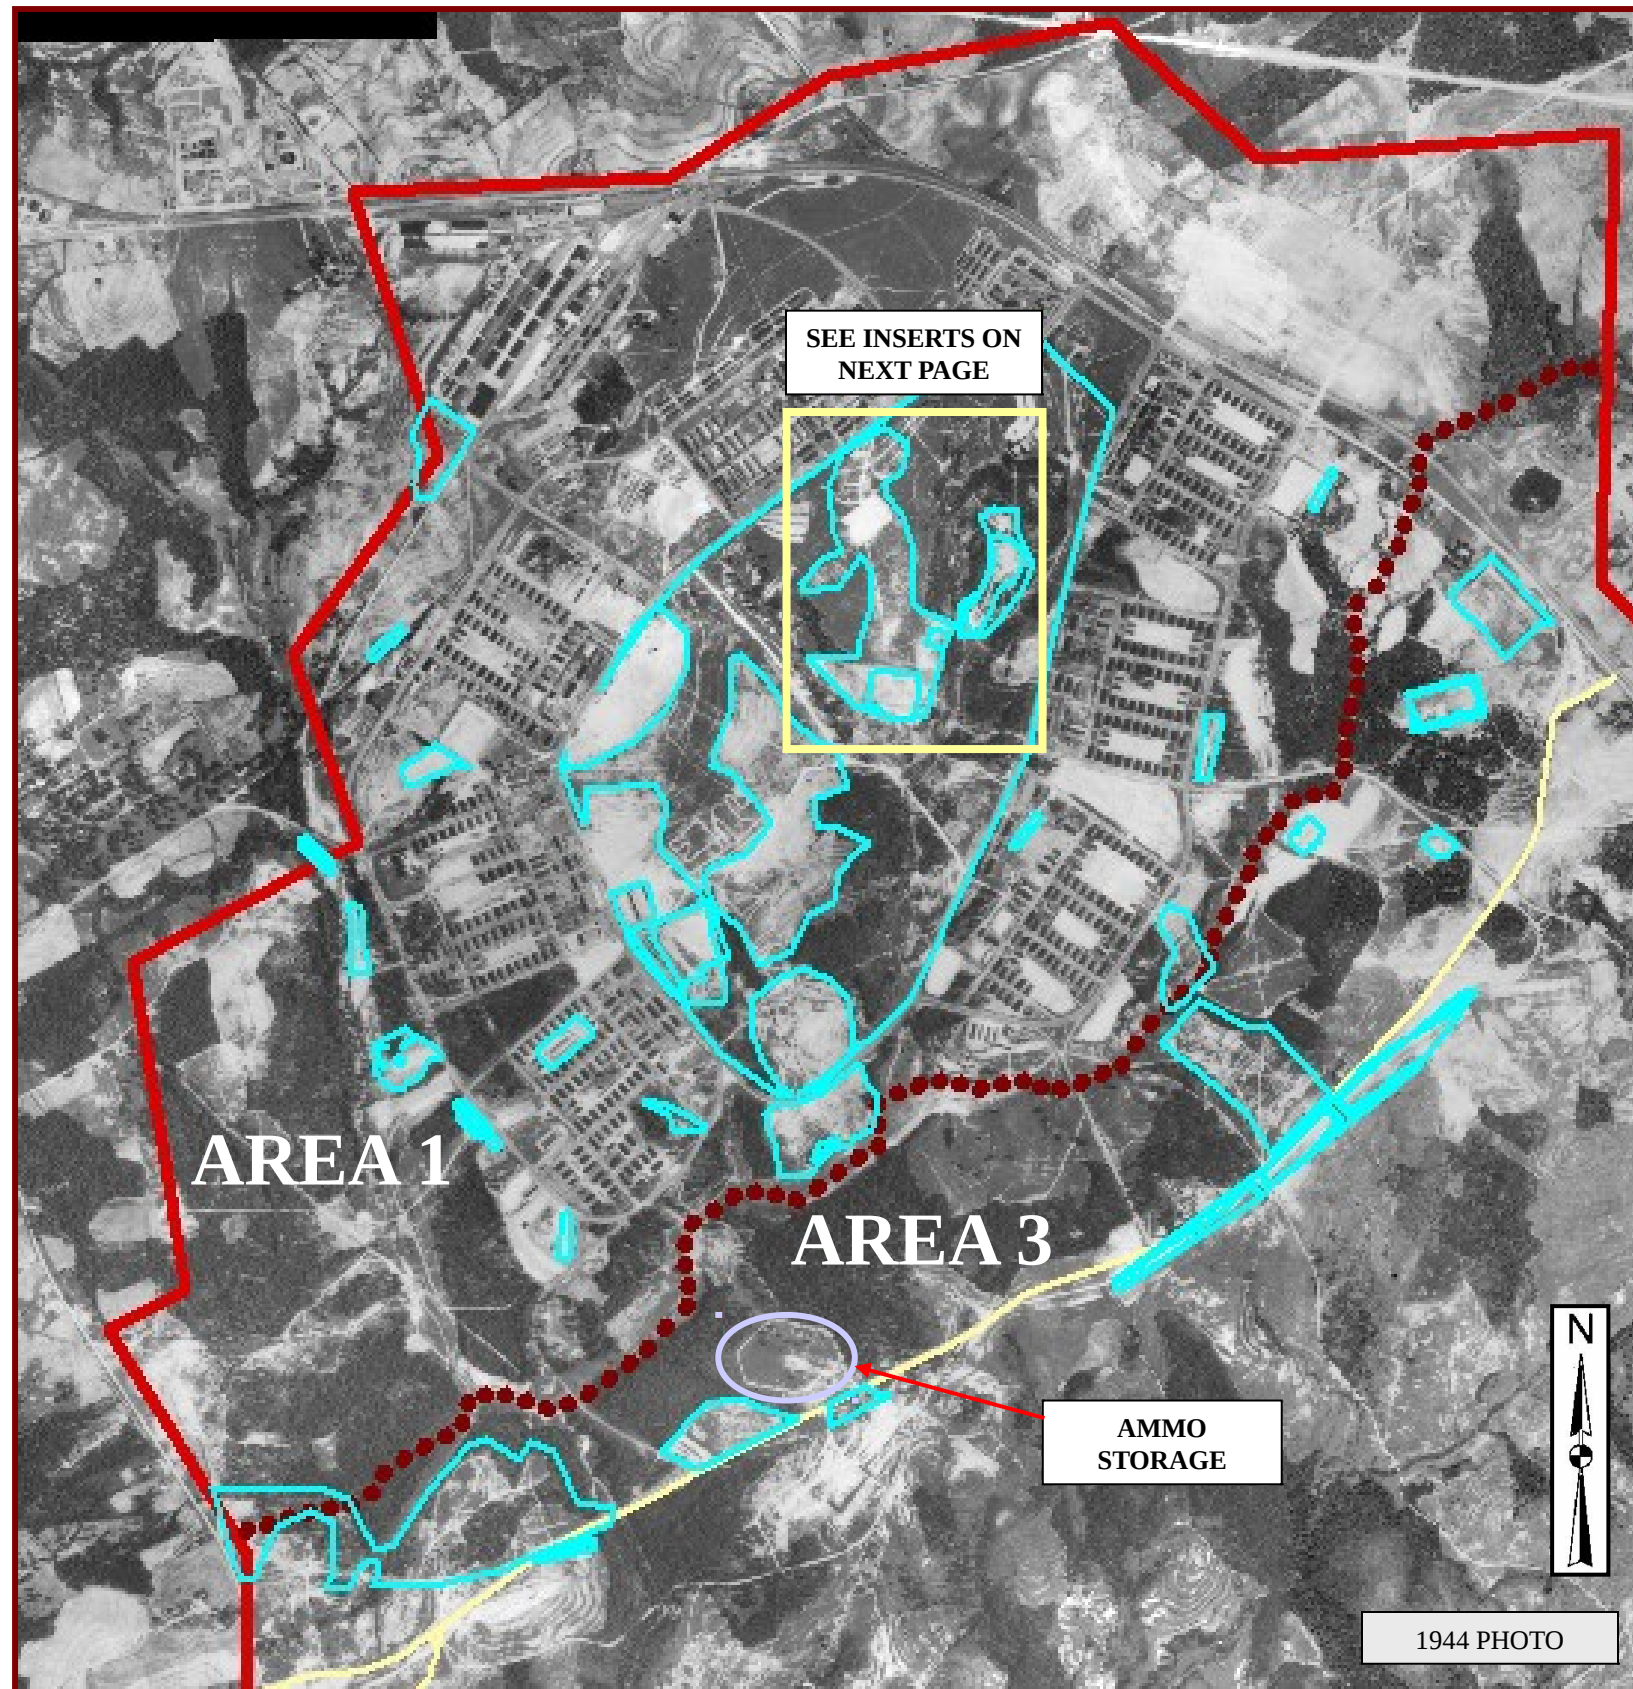
AREA 1 – FIELD TRAINING AREAS

RANGES, TRAINING AREAS, OBSTACLE COURSES, AND TARGETS ARE CONSOLIDATED AND DISPLAYED AS ONE GROUP CALLED “FIELD TRAINING AREAS”. THE LOCATION OF MANY OF THESE FEATURES IS SUPPORTED BY ANCILLARY DATA.

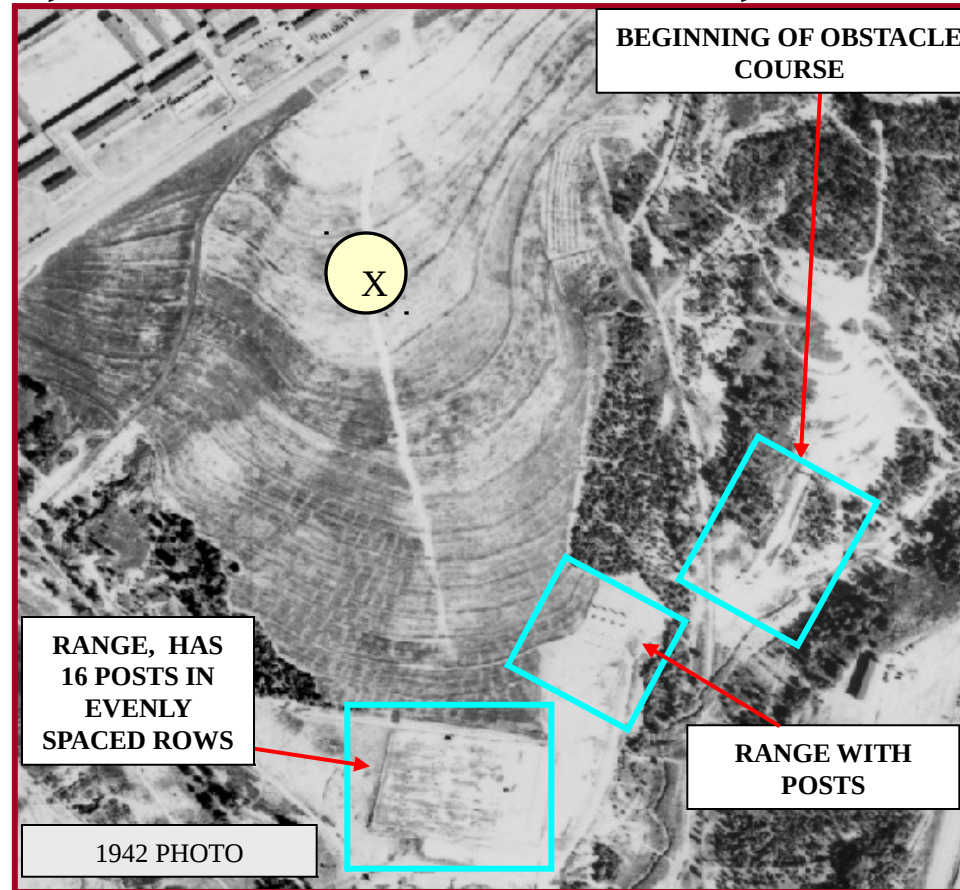
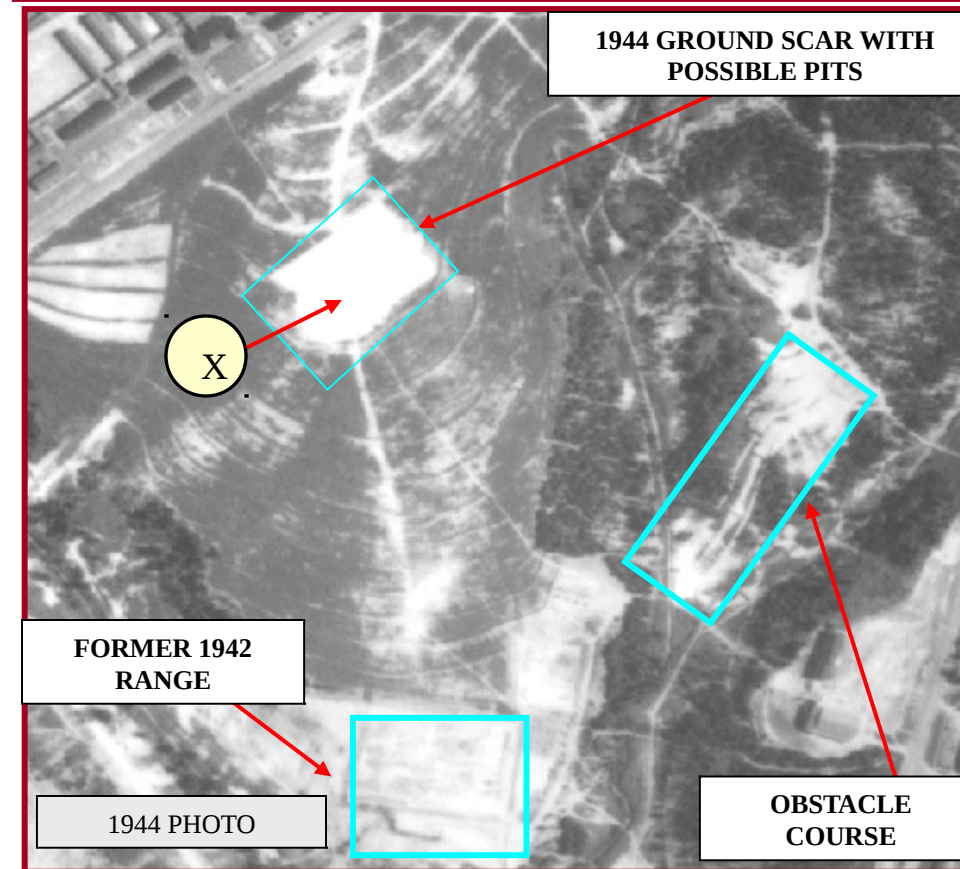
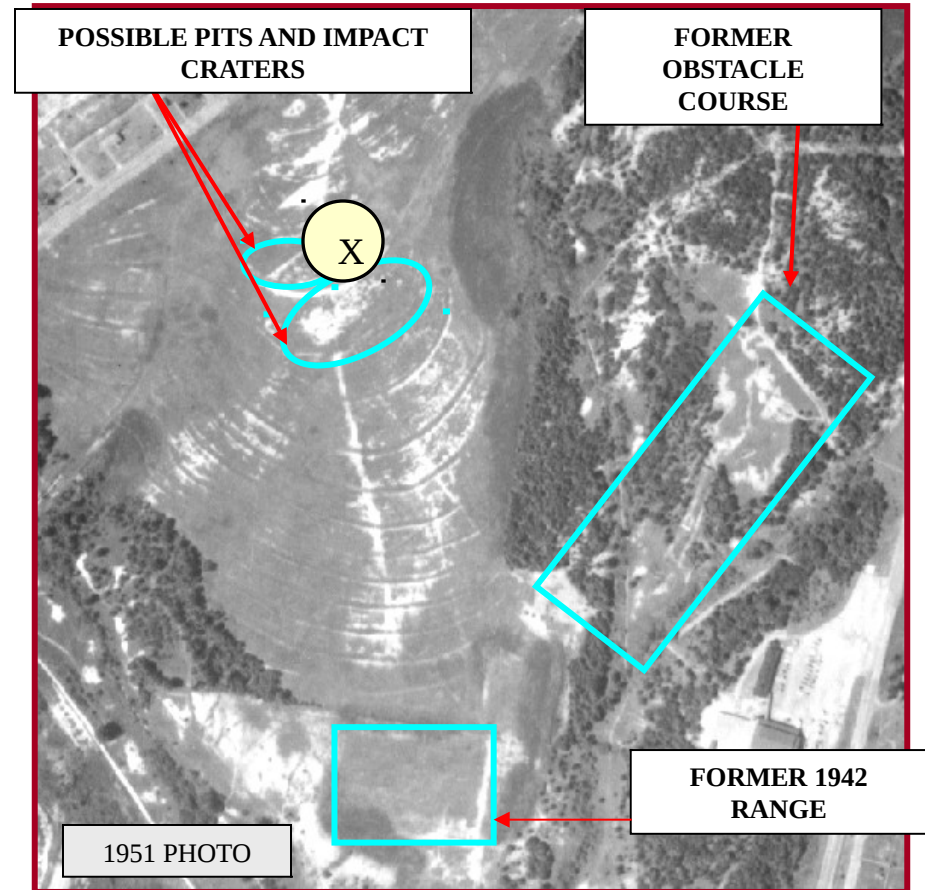
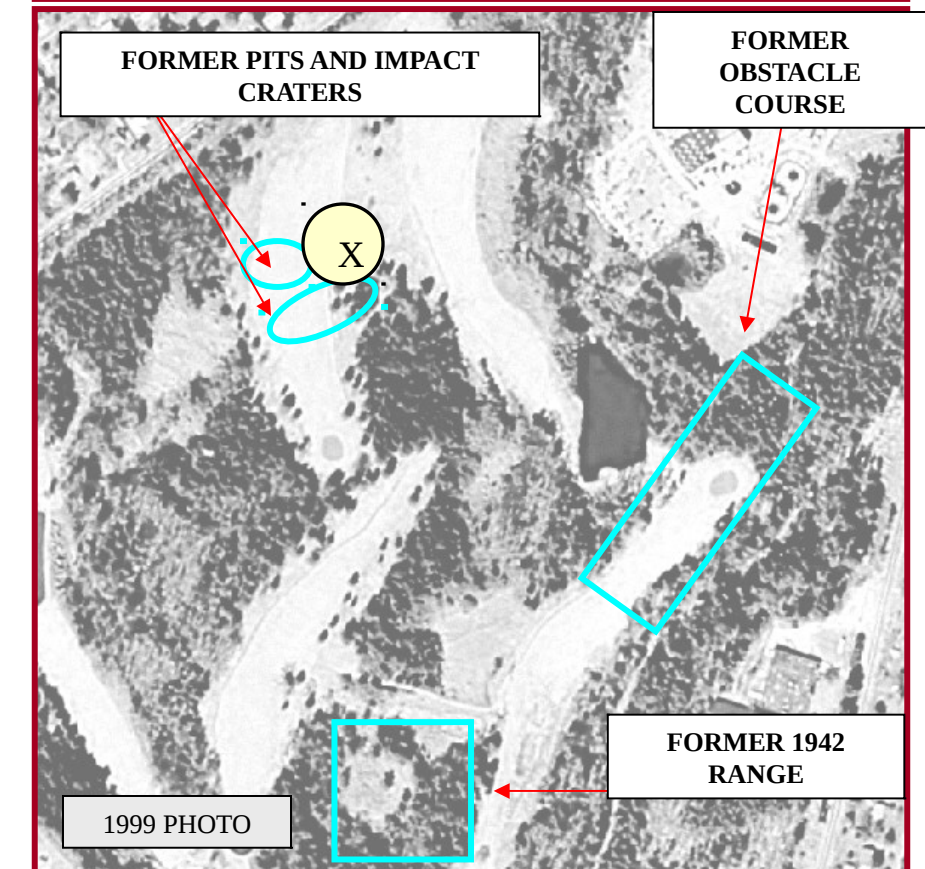
AREA 1 – FIELD TRAINING AREAS – SELECTED FEATURES

INSERTS SHOW THE CHANGES SEEN IN FOUR SEPARATE YEARS OF AERIAL PHOTOS. AREA HAD SEVERAL USES FROM 1942 TO 1951.

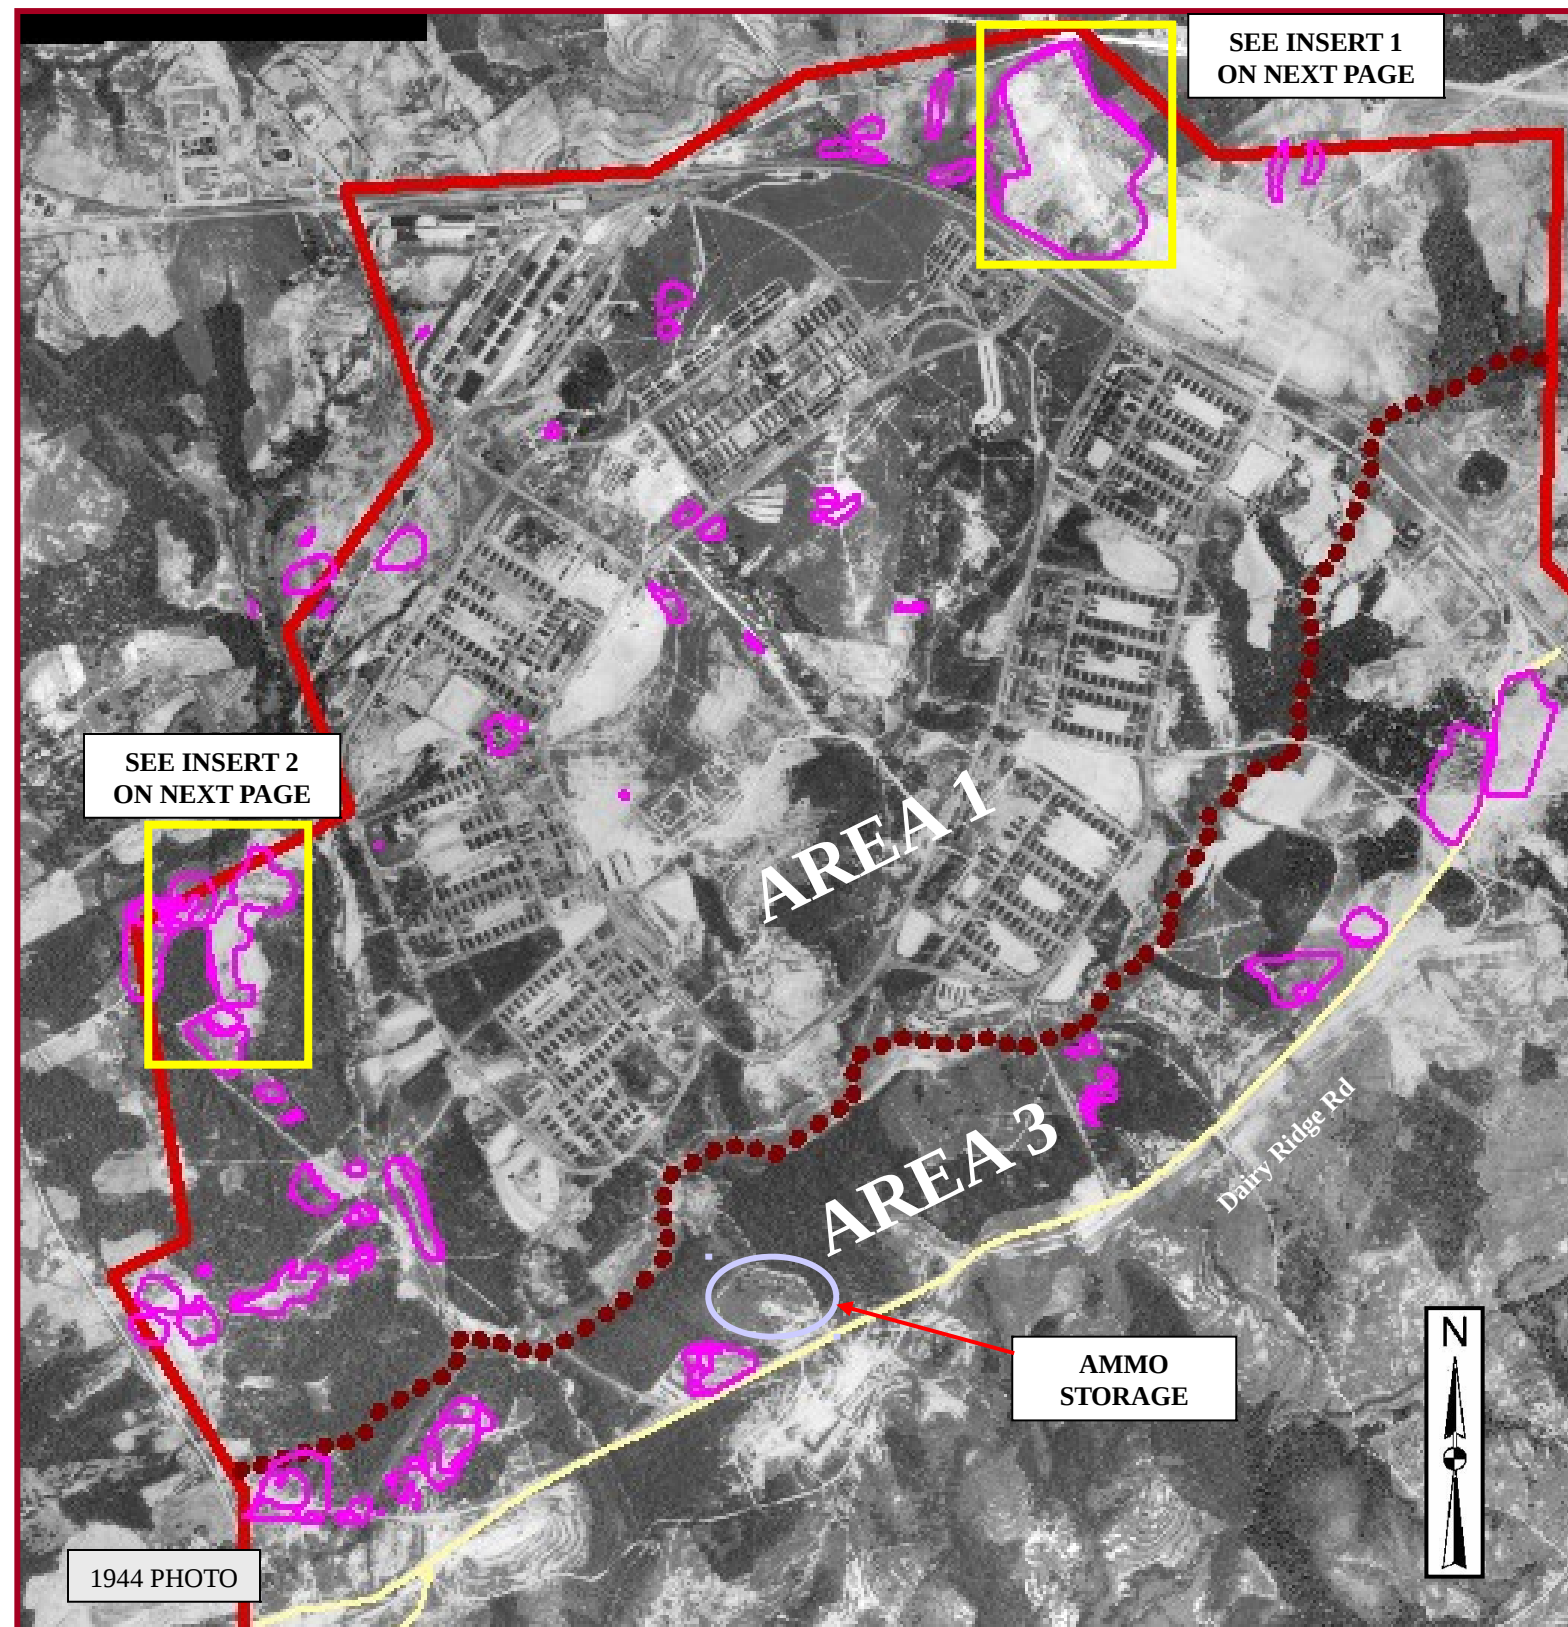
AREA 1 – CIRCULAR SHAPED FEATURES

POSSIBLE IMPACT CRATERS, PITS AND CIRCLE FEATURES HAVE BEEN CONSOLIDATED AND DISPLAYED AS ONE GROUP CALLED “CIRCULAR SHAPED FEATURES”. THESE FEATURES EXHIBIT SIMILAR PHOTO SIGNATURES BUT THE ORIGIN OR CAUSE FOR THE SIGNATURE MAY VARY. IMPACTS OF EXPLOSIVES CAN RESULT IN SIGNATURES THAT ARE ANALYZED AS PITS OR CIRCLE FEATURES.

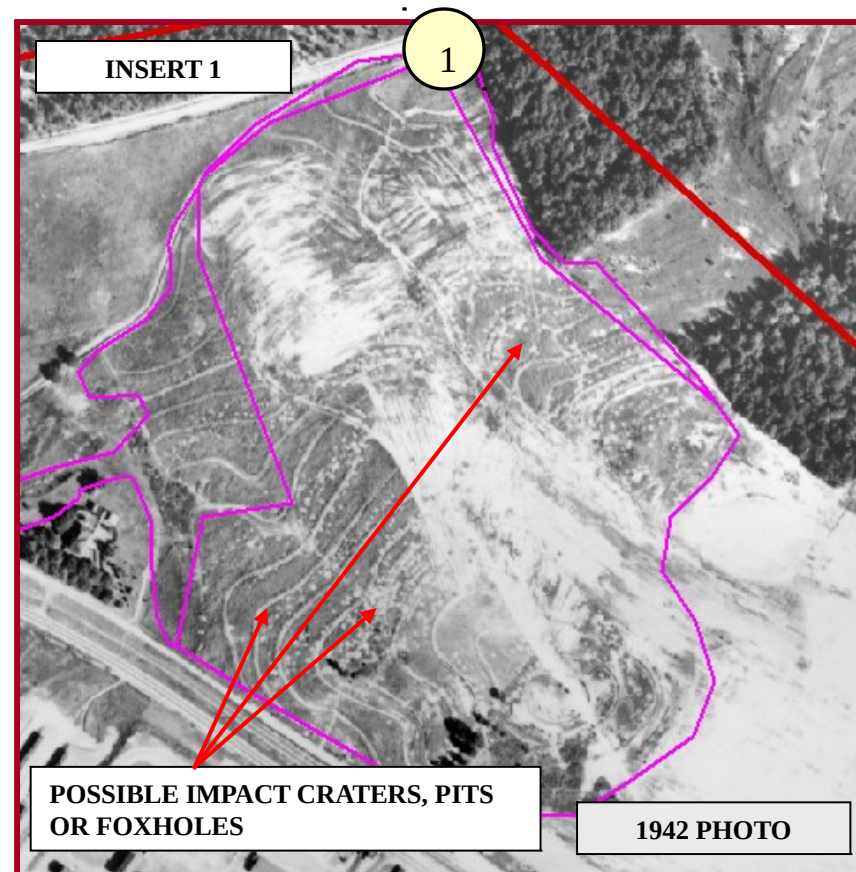
POSSIBLE IMPACT CRATERS, PITS OR FOXHOLES

Inserts 1 and 2 are samples of how pits and impact craters look in historic photos (1942).
 These areas also are shown outlined over top 1999 photos.
 A 1942 Map indicates a "Battle Practice Course" in the vicinity of Insert 2.

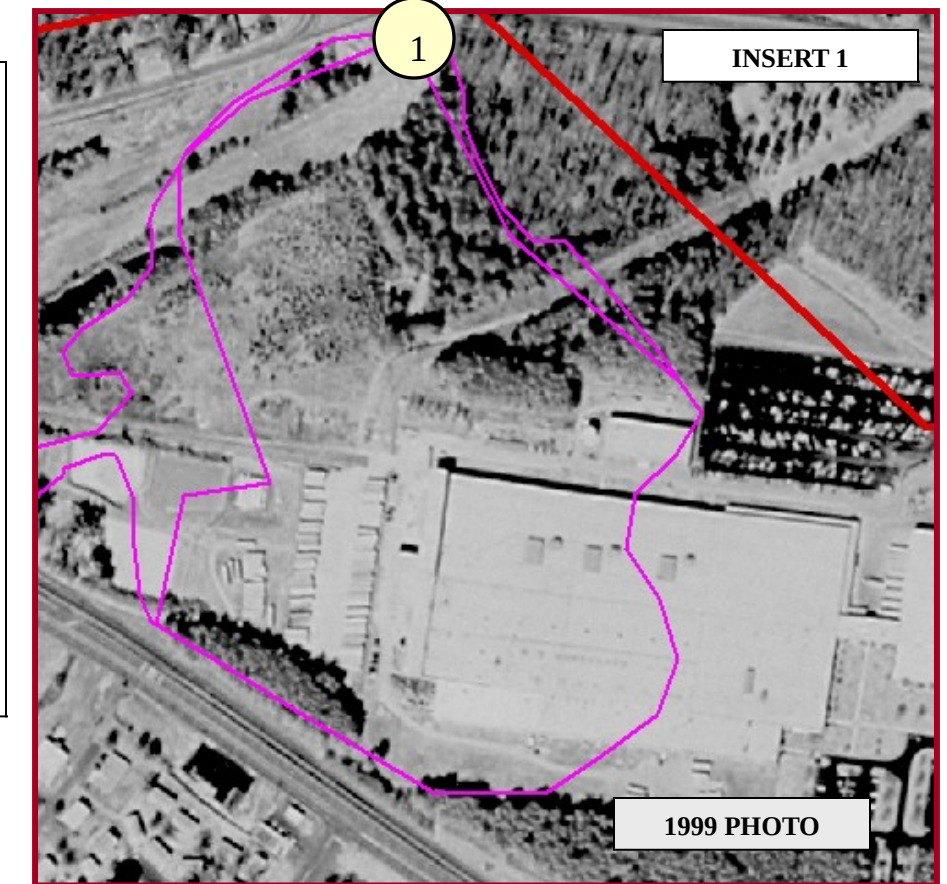
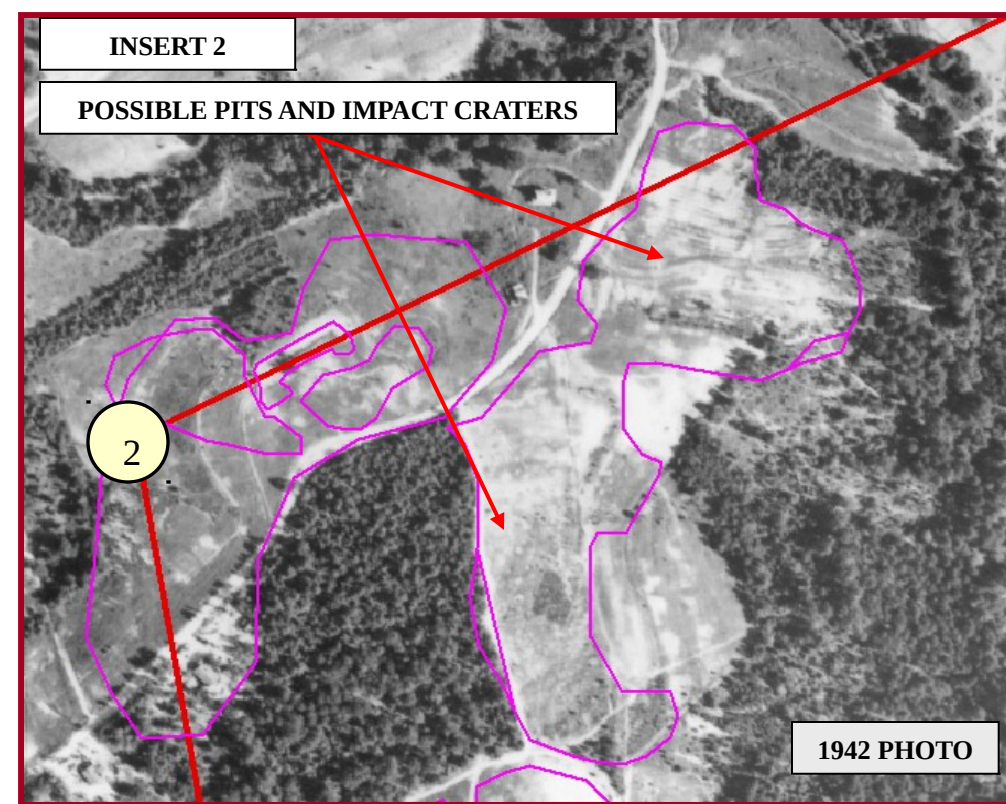
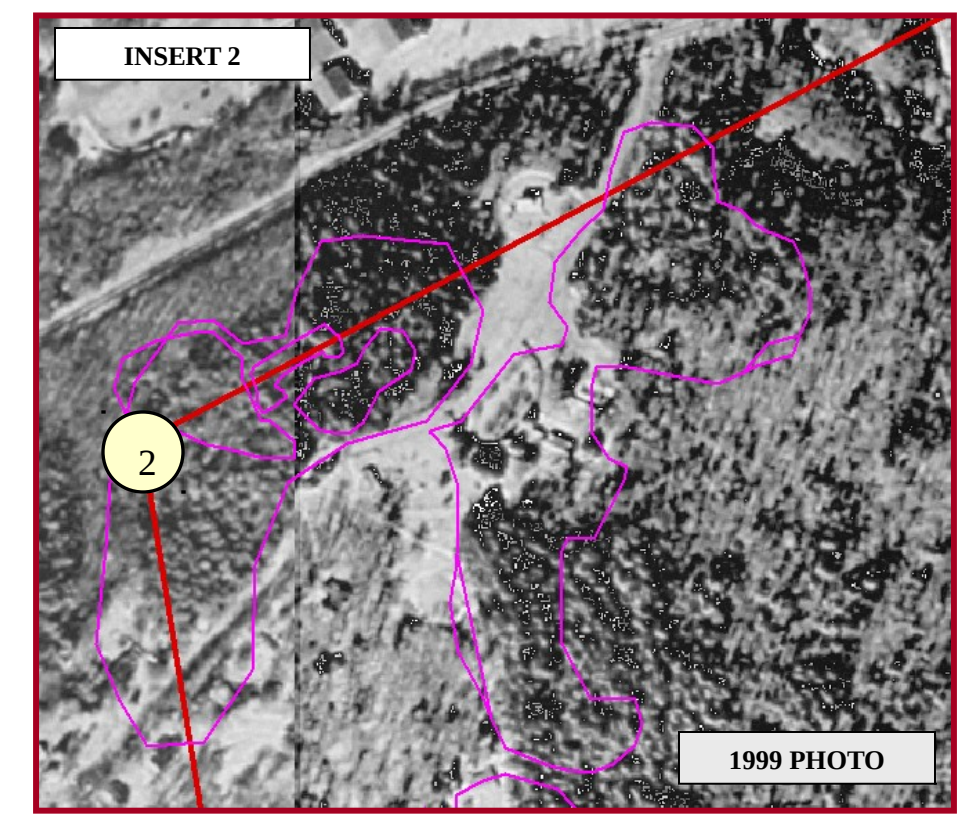
AREA 1 – CIRCULAR SHAPED FEATURES – SELECTED FEATURES

POSSIBLE PITS AND IMPACT CRATERS

As such, it is possible that areas of potential ordnance contamination exist in areas that are identified as pits, craters, disturbed ground, circle features and ground scars. Further field investigation will be required to determine if the areas are potentially hazardous sites (some may not be hazardous).

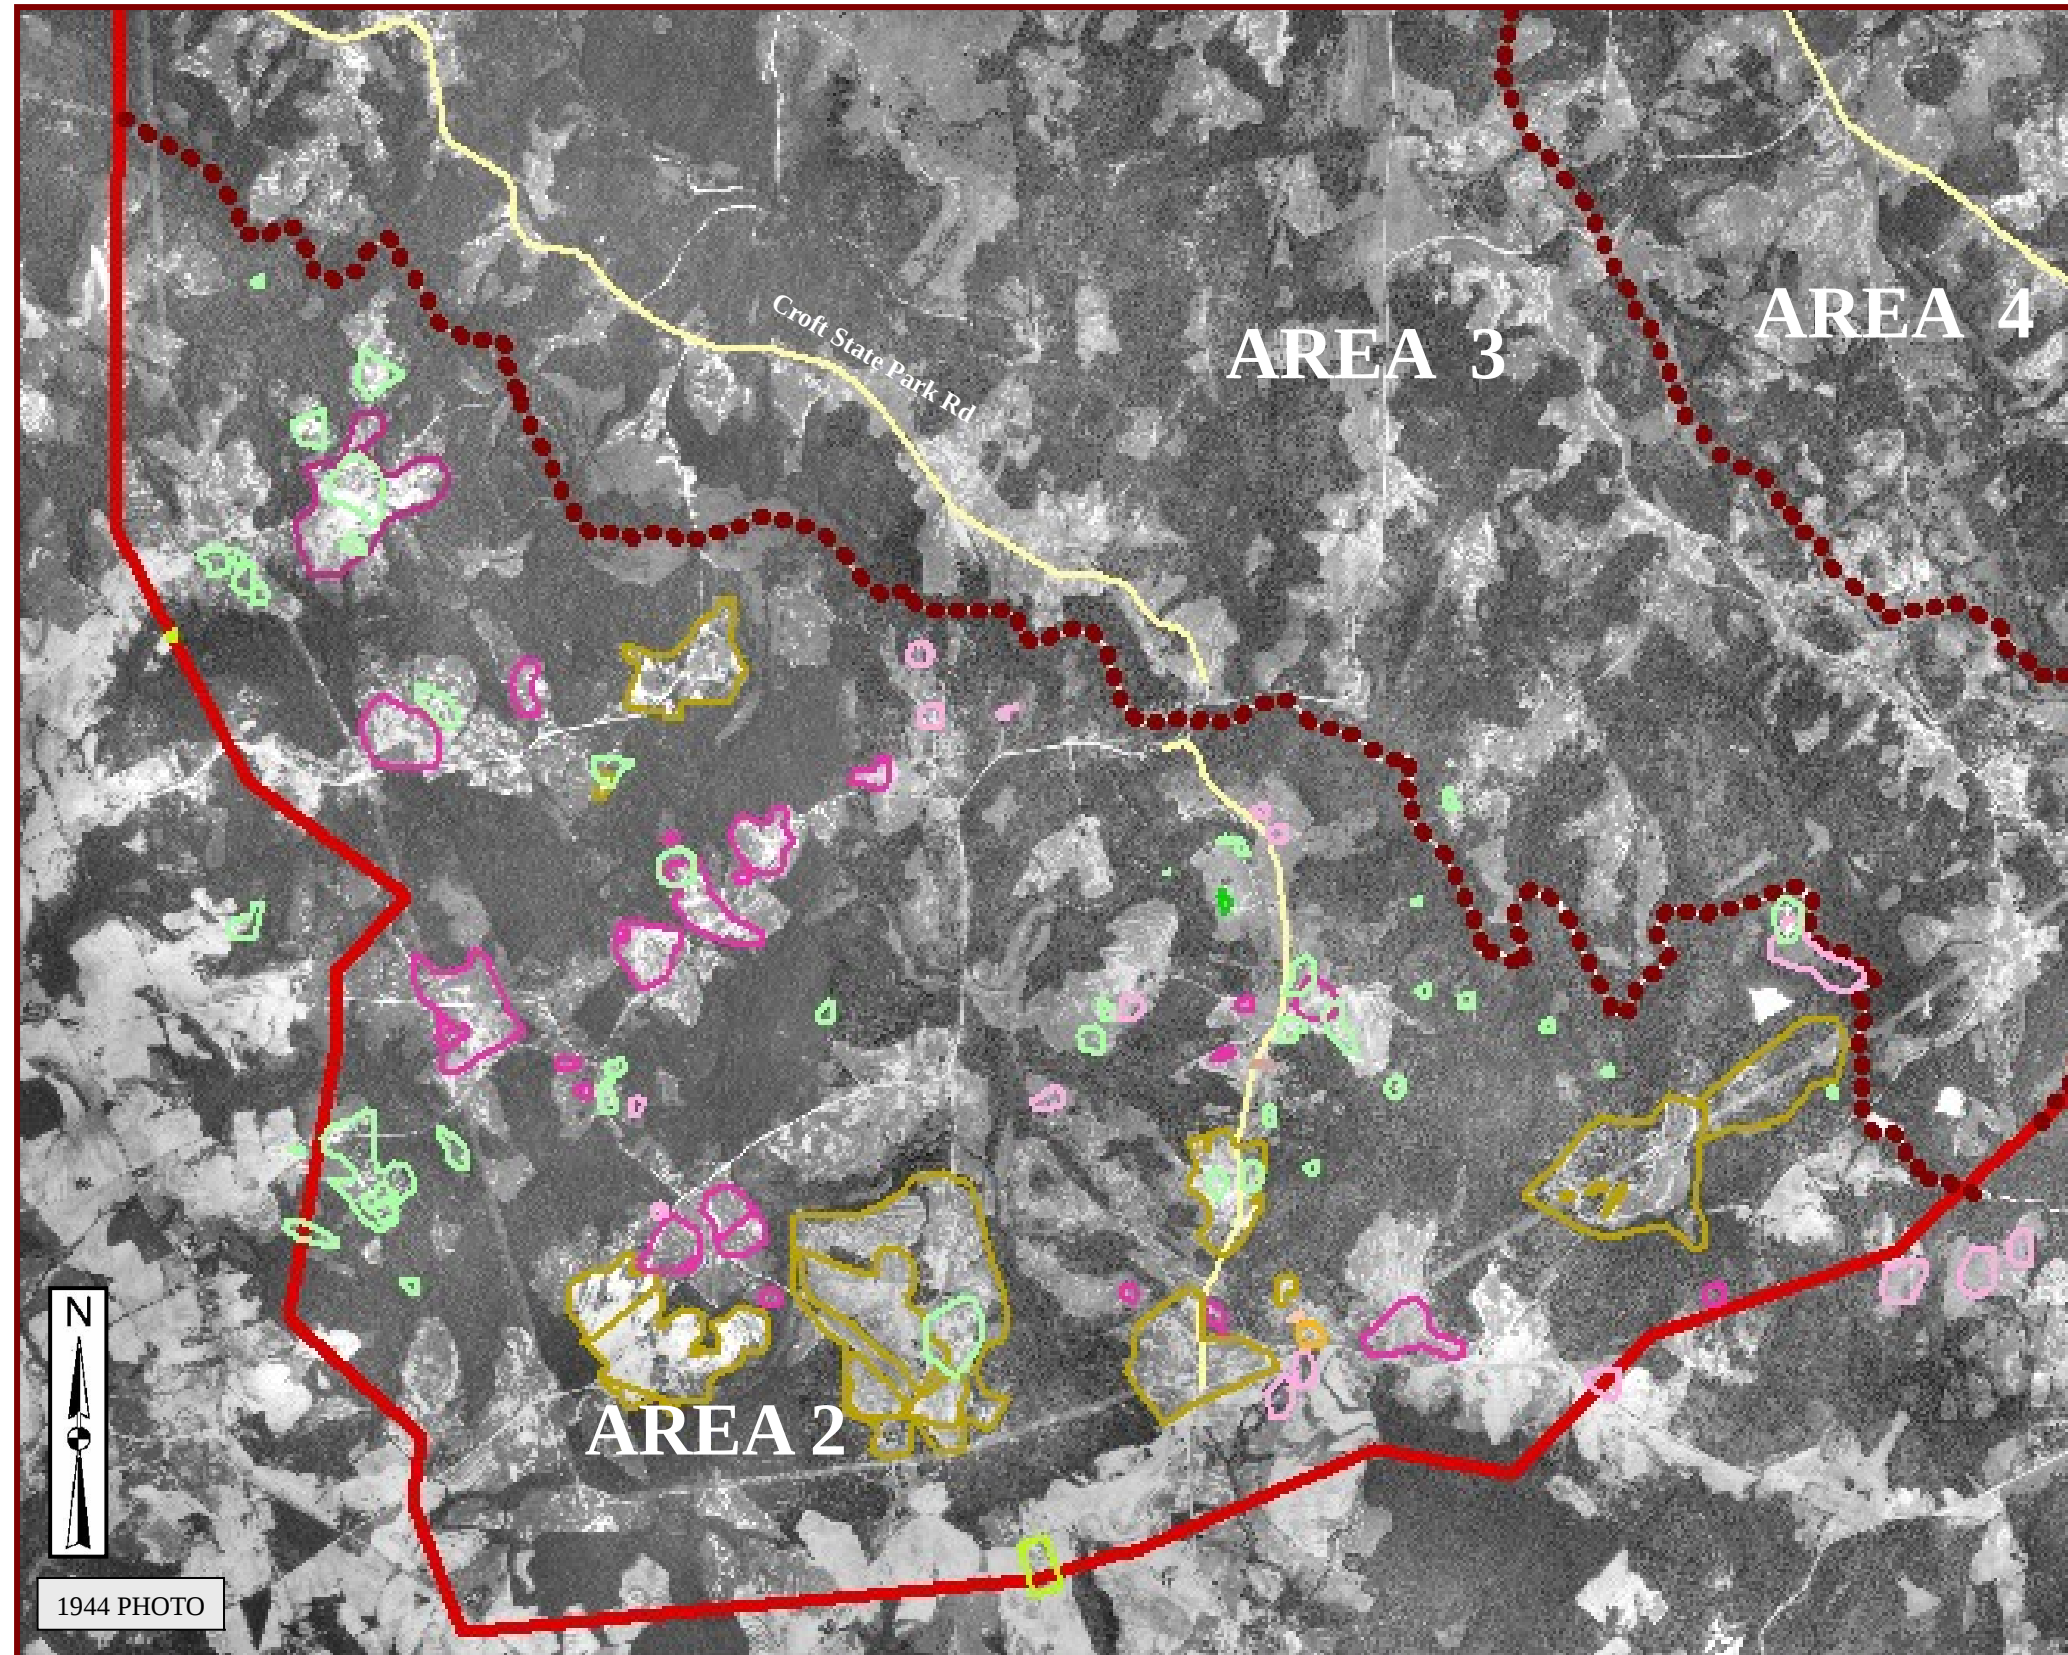
AREA 2 – OVERVIEW OF ALL FEATURES

All of the features found during analysis of the five photo years are displayed on this 1944 photo.

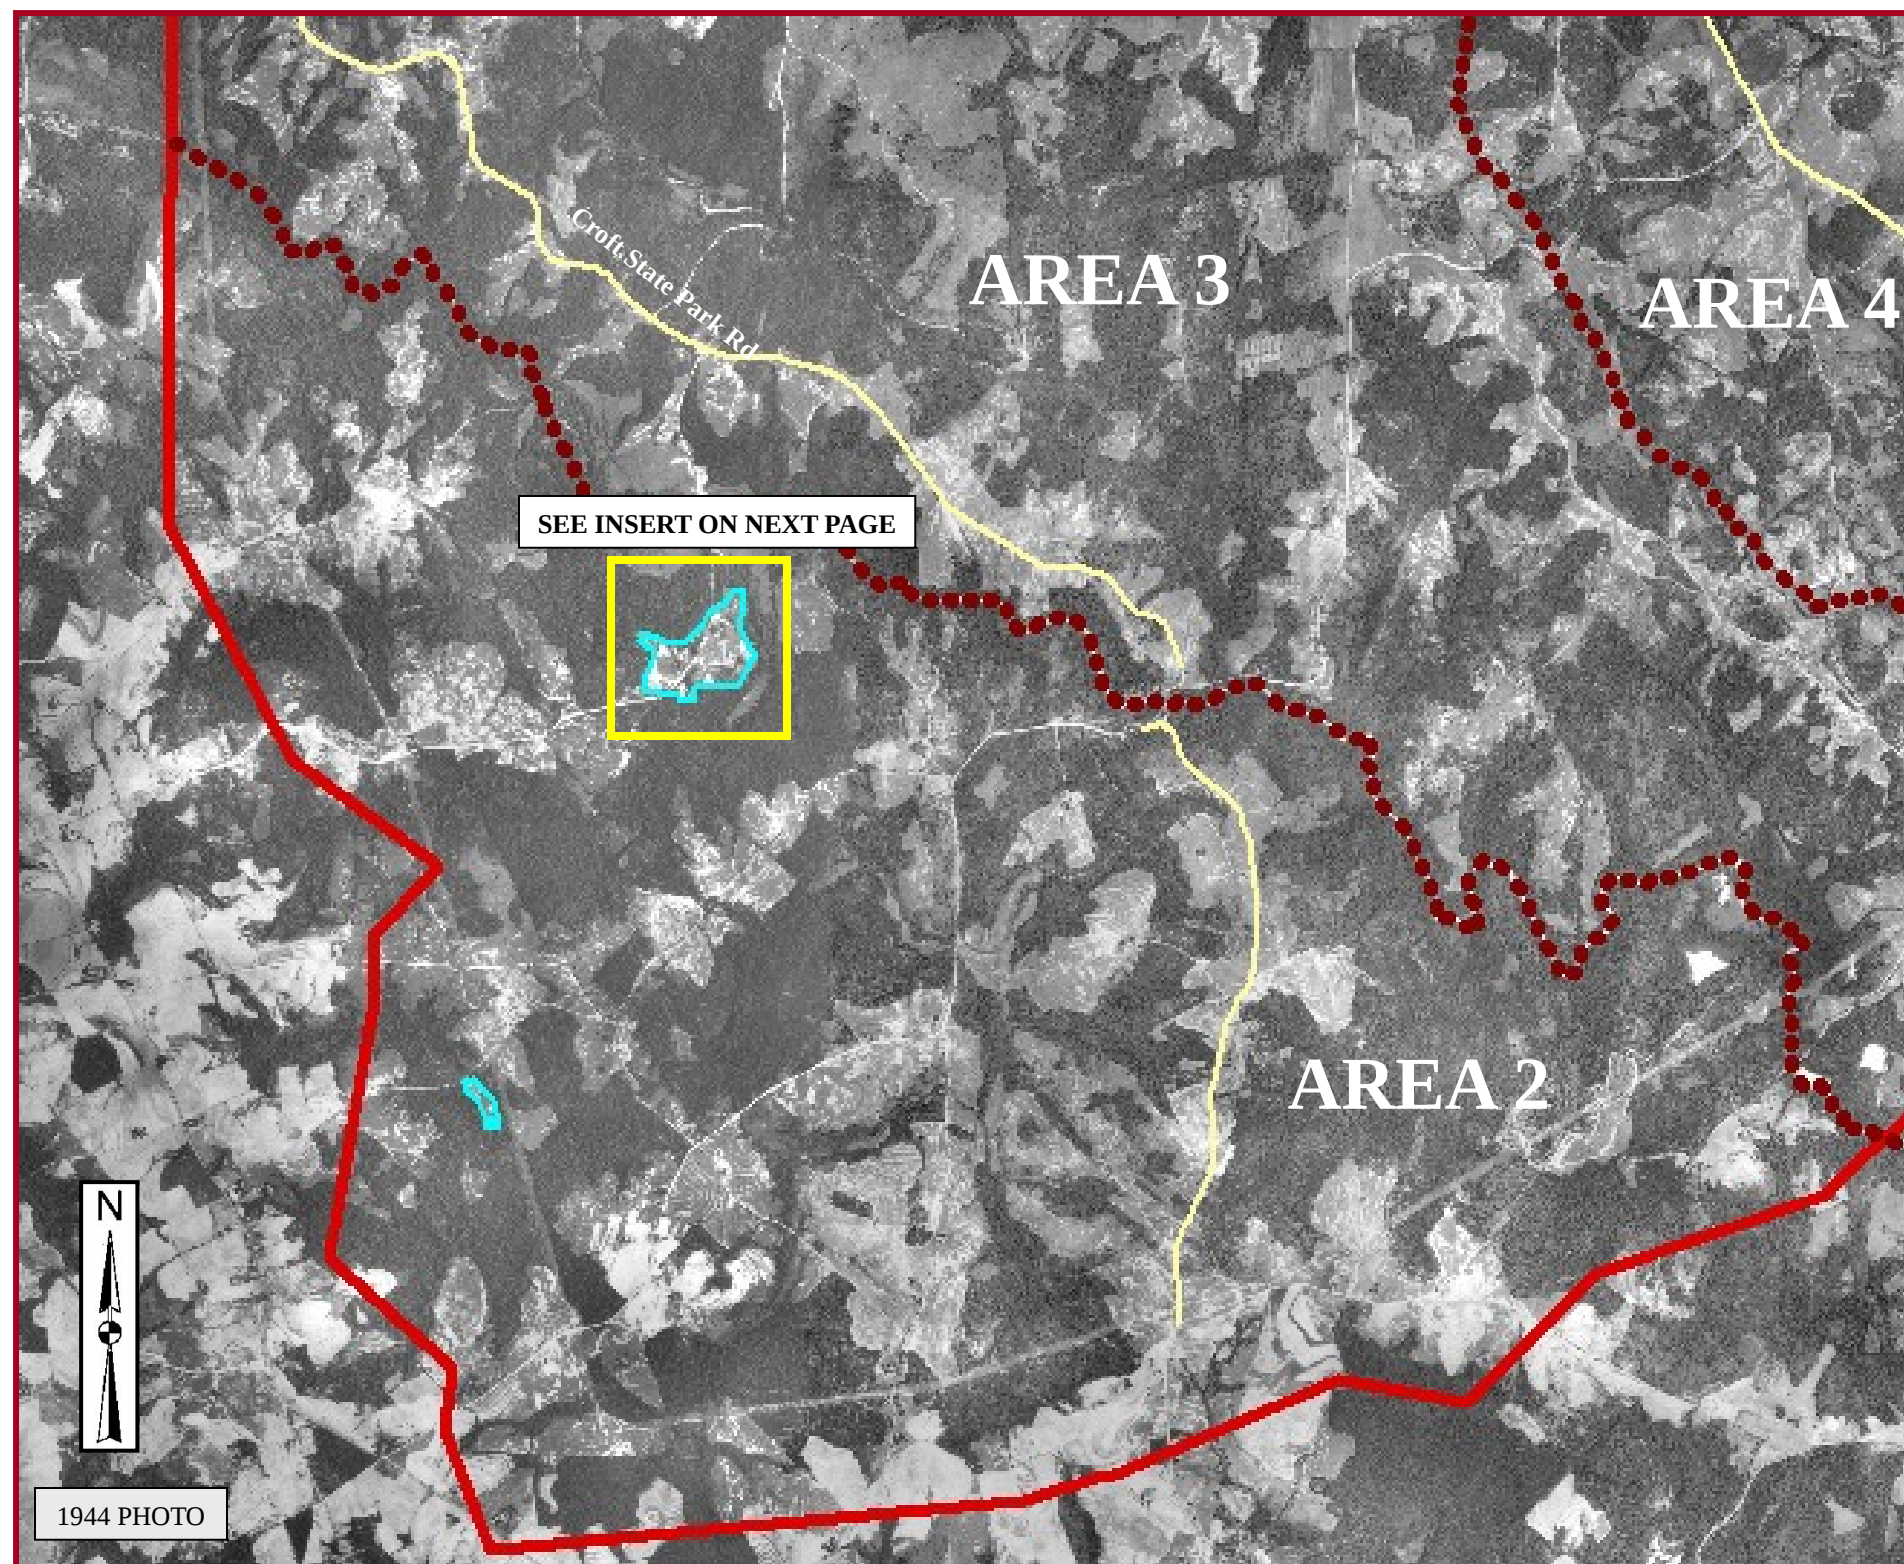
AREA 2 – FIELD TRAINING AREAS

RANGES, TRAINING AREAS, OBSTACLE COURSES, AND TARGETS ARE CONSOLIDATED AND DISPLAYED AS ONE GROUP CALLED "FIELD TRAINING AREAS". THE LOCATION OF MANY OF THESE FEATURES IS SUPPORTED BY ANCILLARY DATA.

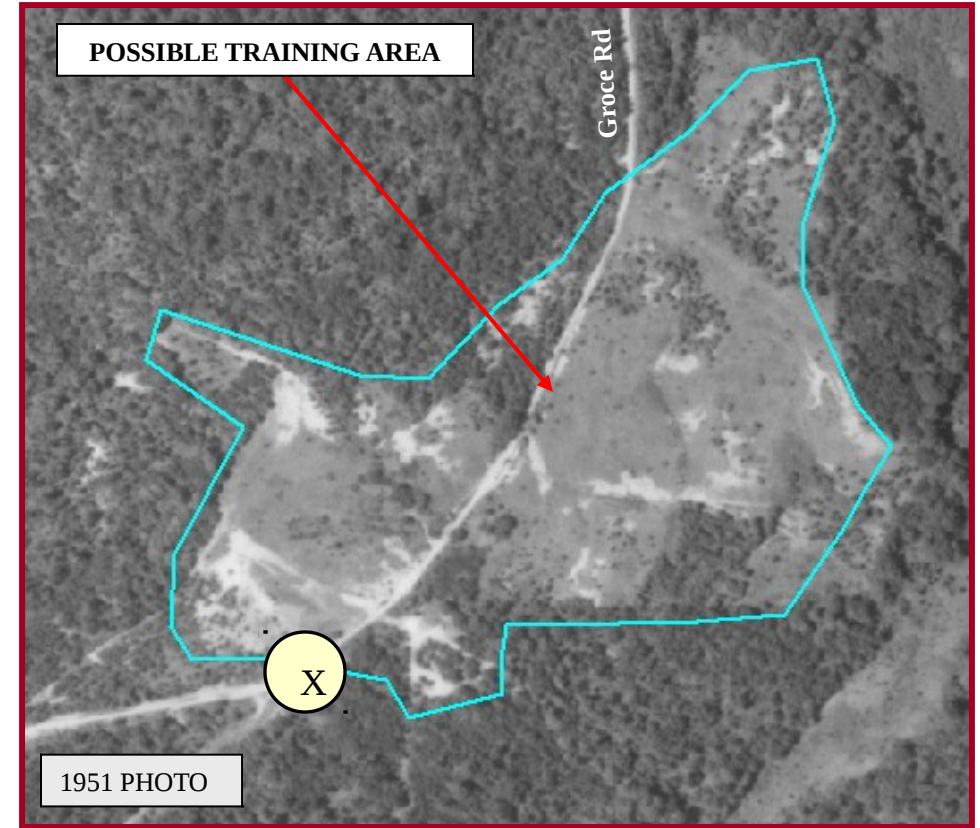
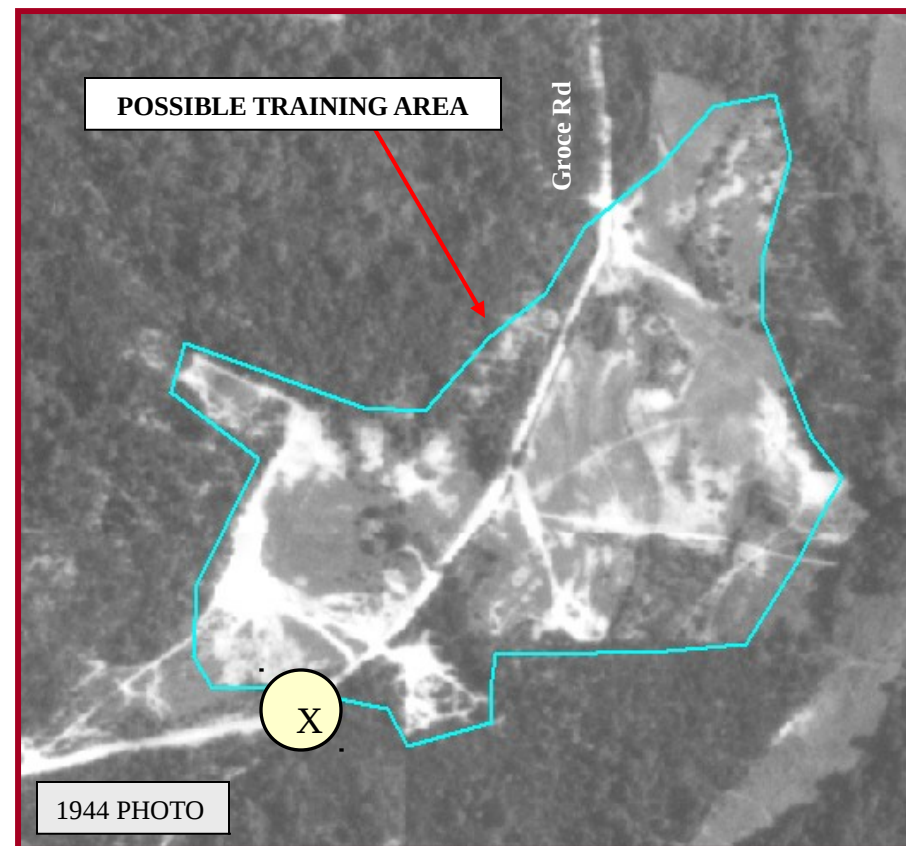
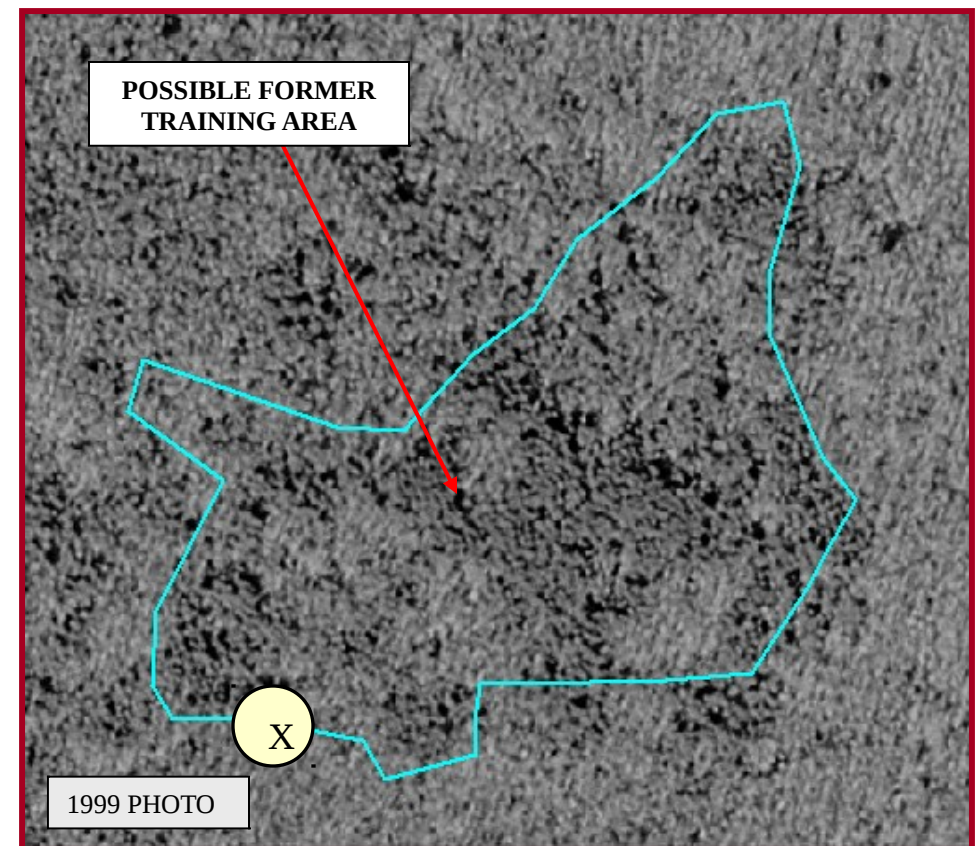
AREA 2 – FIELD TRAINING AREAS – SELECTED FEATURES

INSERTS SHOW THE CHANGES SEEN IN FOUR SEPARATE YEARS OF AERIAL PHOTOS.
