Camp Croft Army Training Facility

GIS-Based Historical Photographic Analysis

FORMER CAMP CROFT ARMY TRAINING FACILITY

OCTOBER 2005 REPORT

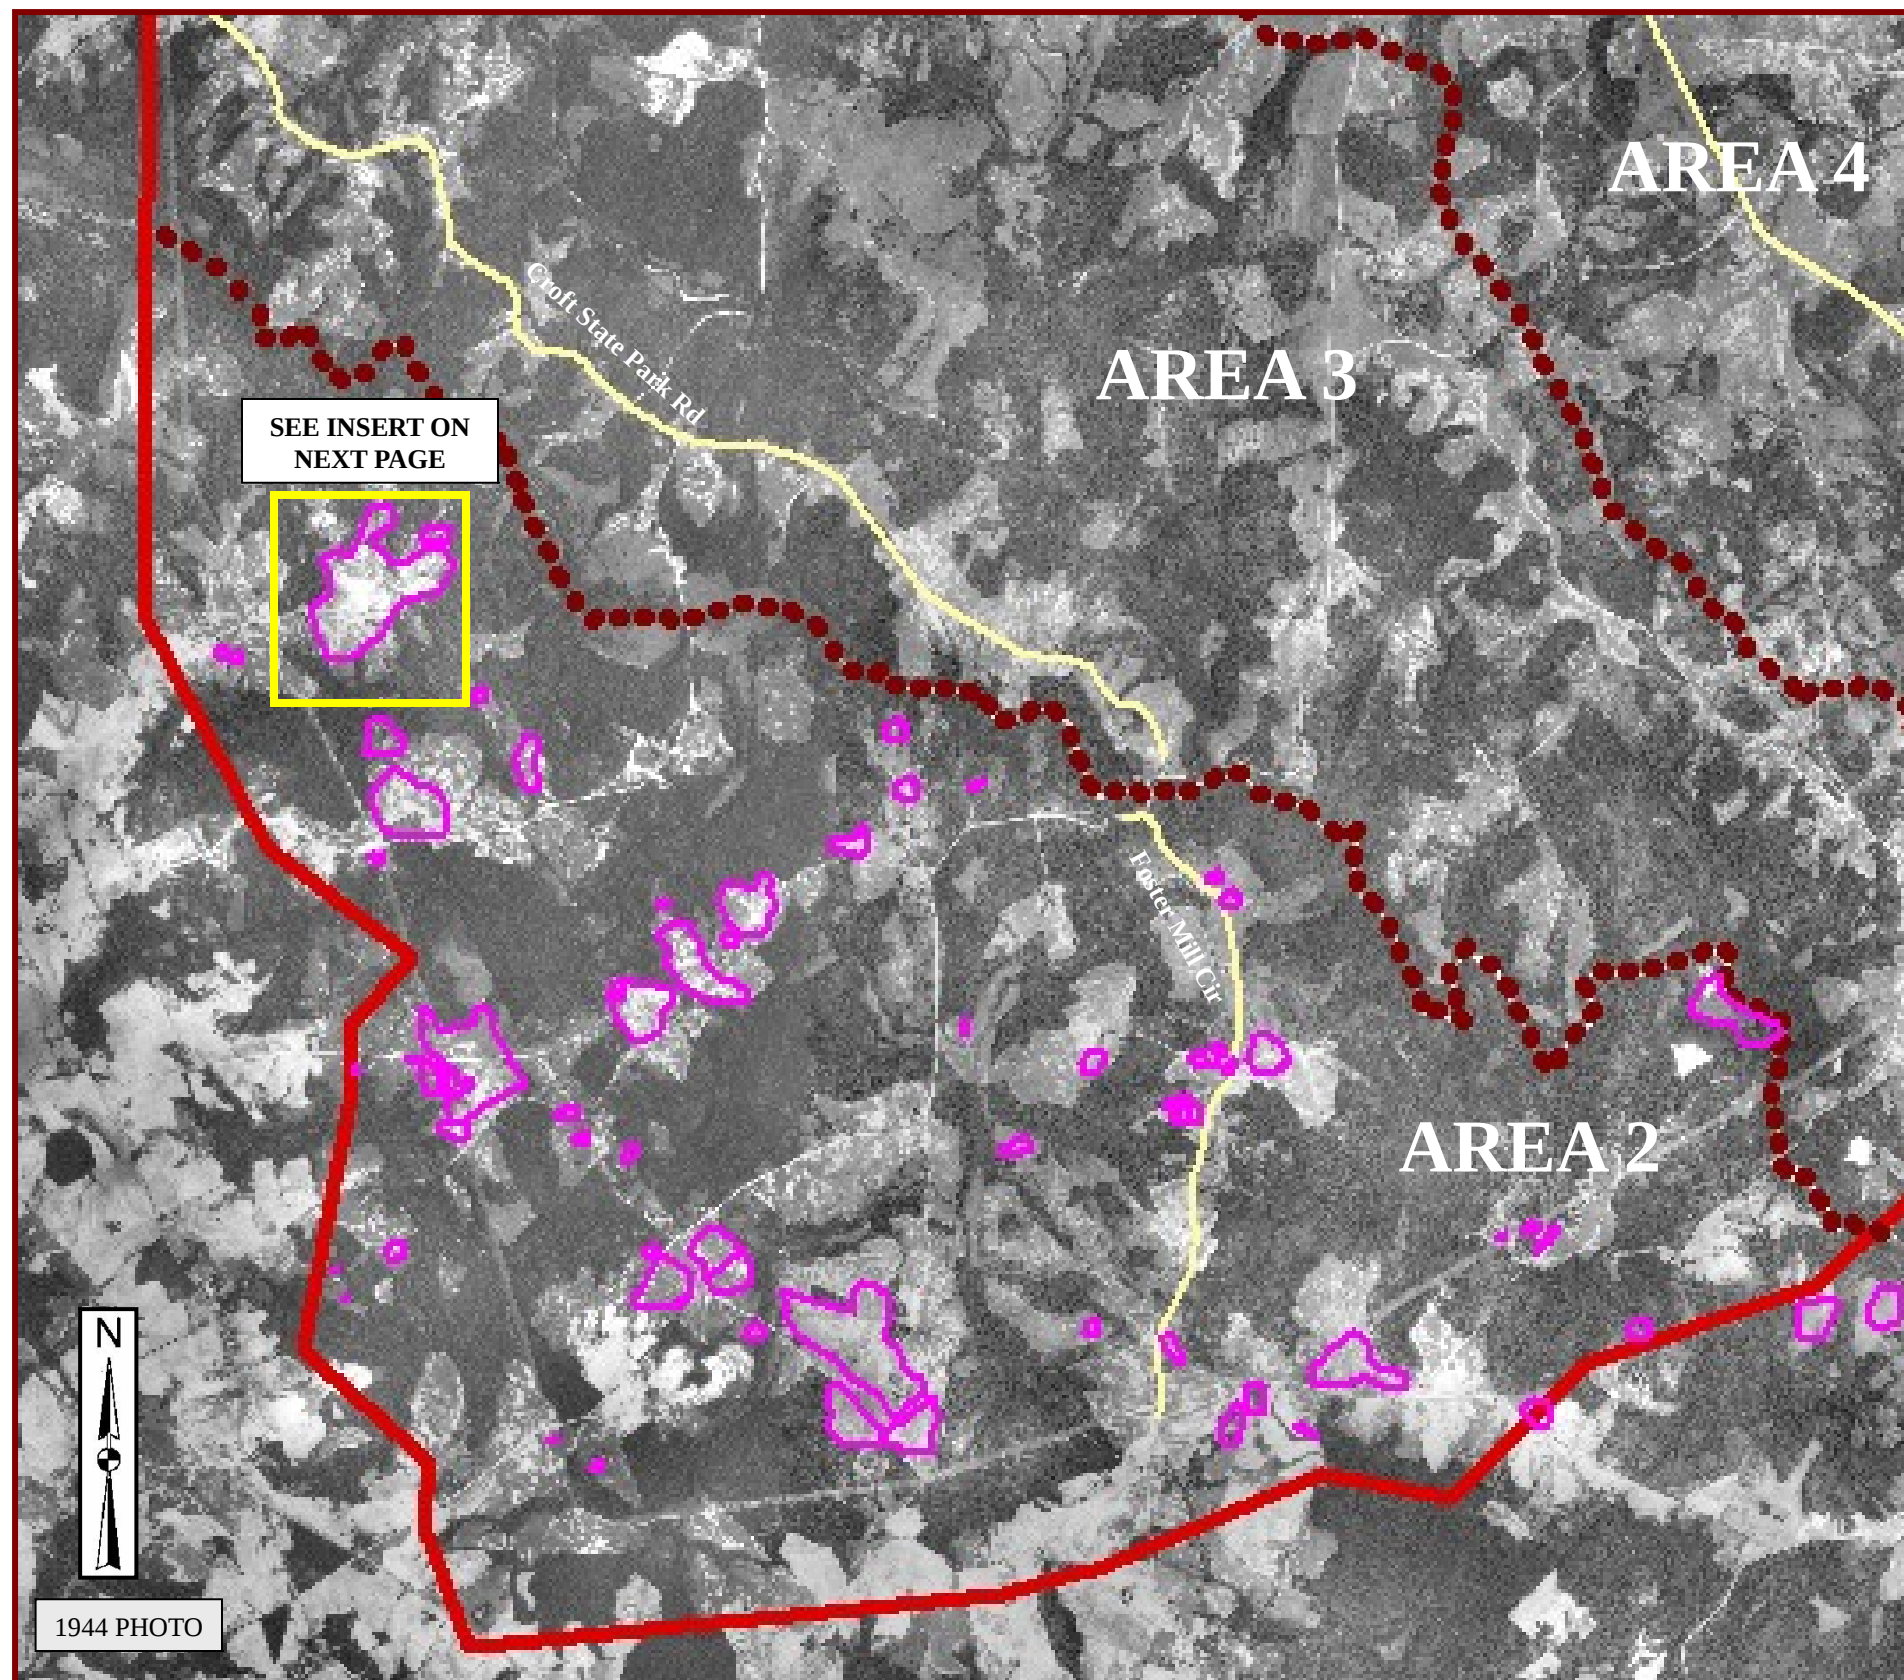
AREA 2 – CIRCULAR SHAPED FEATURES

POSSIBLE IMPACT CRATERS, PITS AND CIRCLE FEATURES HAVE BEEN CONSOLIDATED AND DISPLAYED AS ONE GROUP CALLED "CIRCULAR SHAPED FEATURES". THESE FEATURES EXHIBIT SIMILAR PHOTO SIGNATURES BUT THE ORIGIN OR CAUSE FOR THE SIGNATURE MAY VARY. IMPACTS OF EXPLOSIVES CAN RESULT IN SIGNATURES THAT ARE ANALYZED AS PITS OR CIRCLE FEATURES.

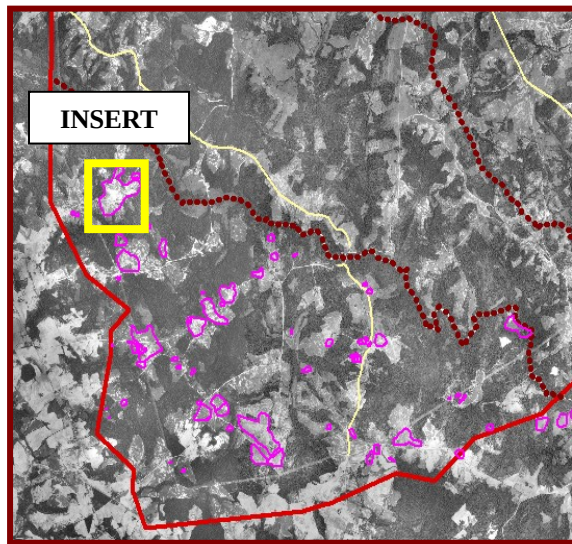
AREA 2 – CIRCULAR SHAPED FEATURES – SELECTED FEATURES

Inserts are samples of how ground features change from one photo year to next. Impact Craters are first observed in 1944 photos. They are seen as ground scars in 1951 photos.

The area is outlined over top 1999 photos.

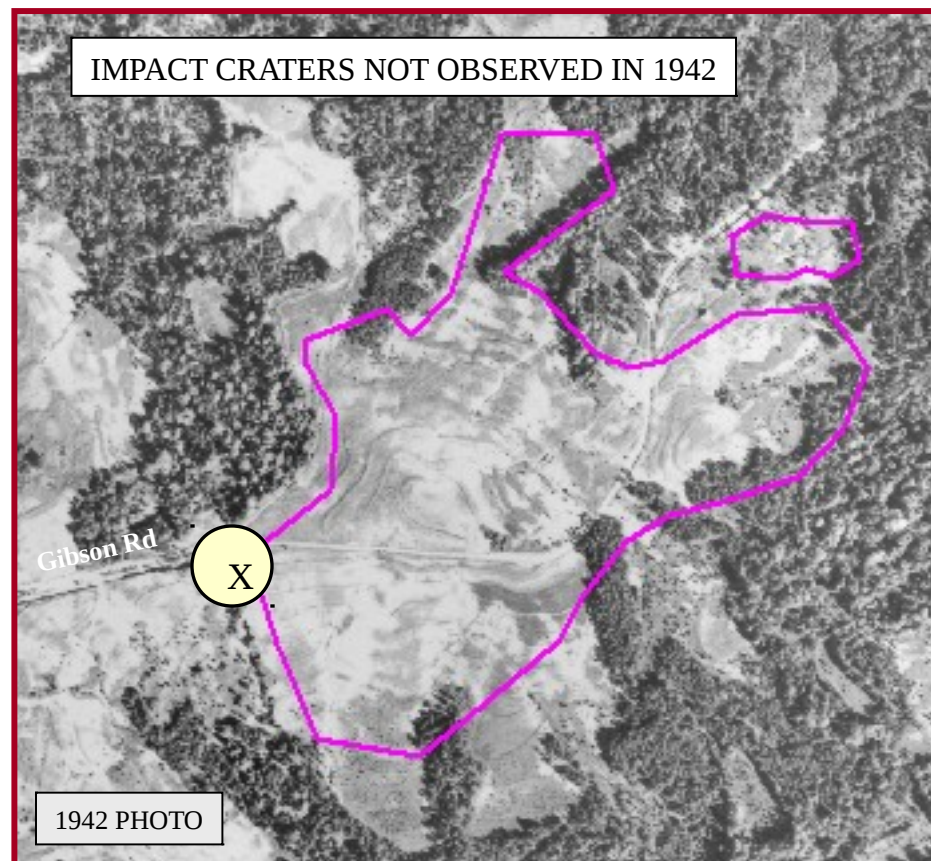
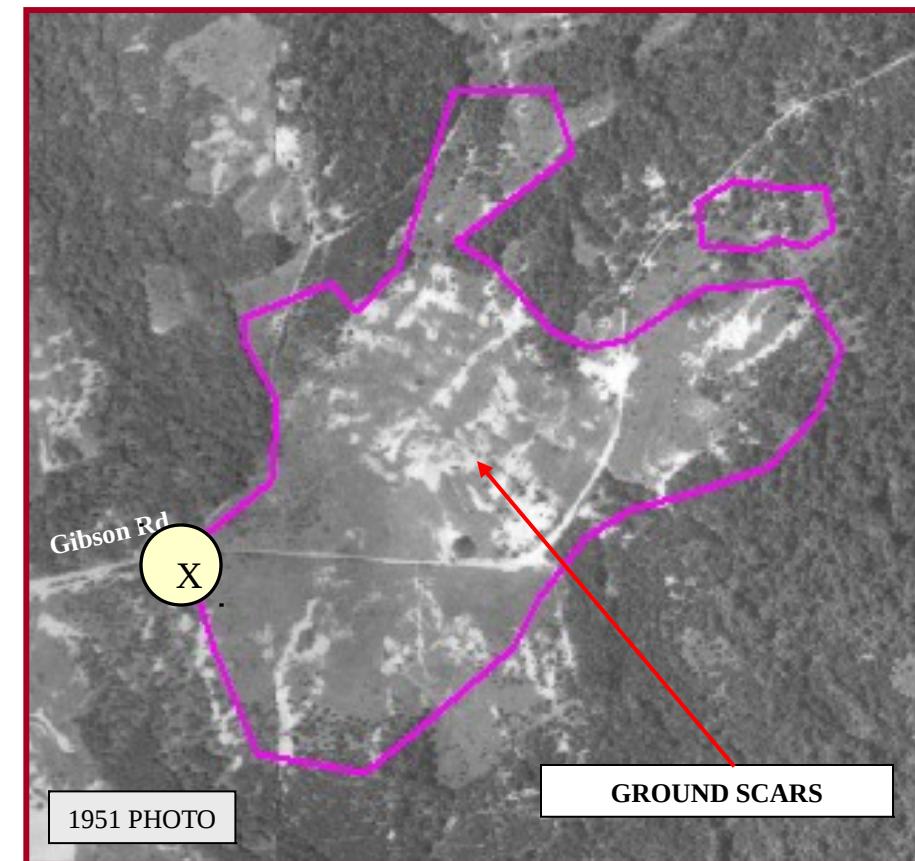
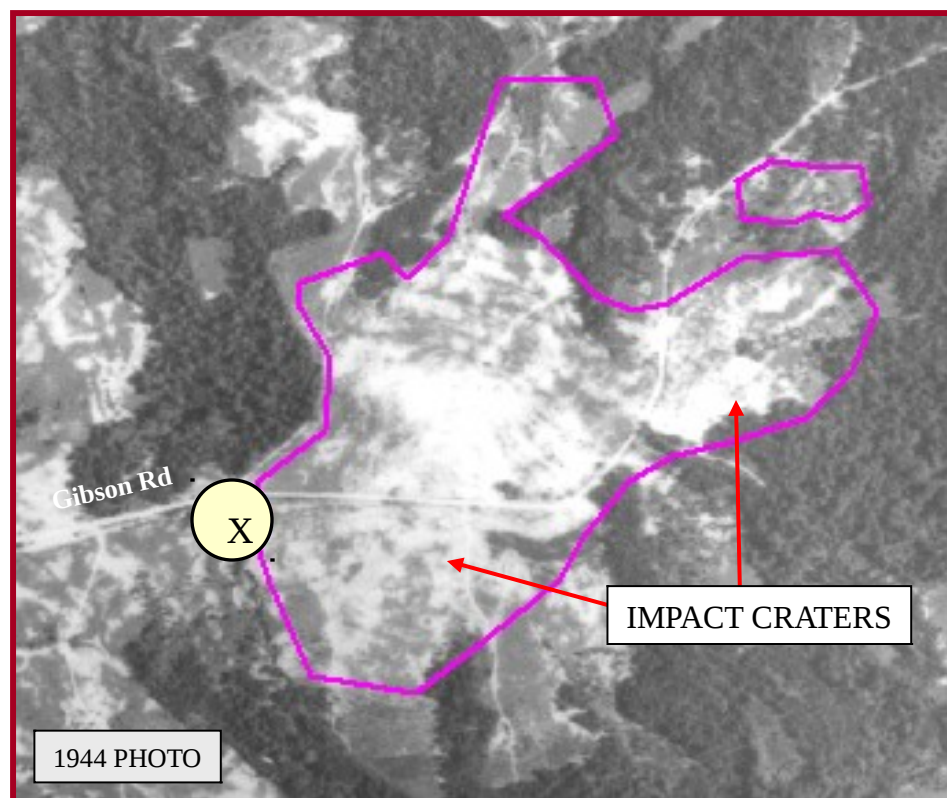
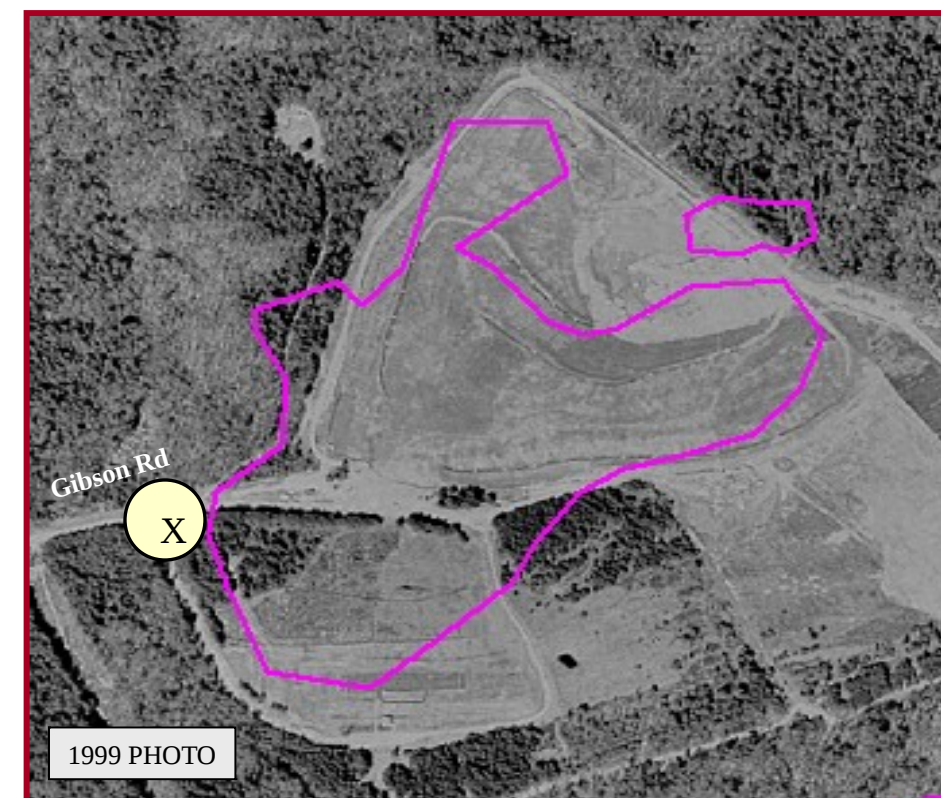
GROUND SCARS

IMPACT CRATERS

As such, it is possible that areas of potential ordnance contamination exist in areas that are identified as pits, craters, disturbed ground, circle features and ground scars. Further field investigation will be required to determine if the areas are potentially hazardous sites (some may not be hazardous).

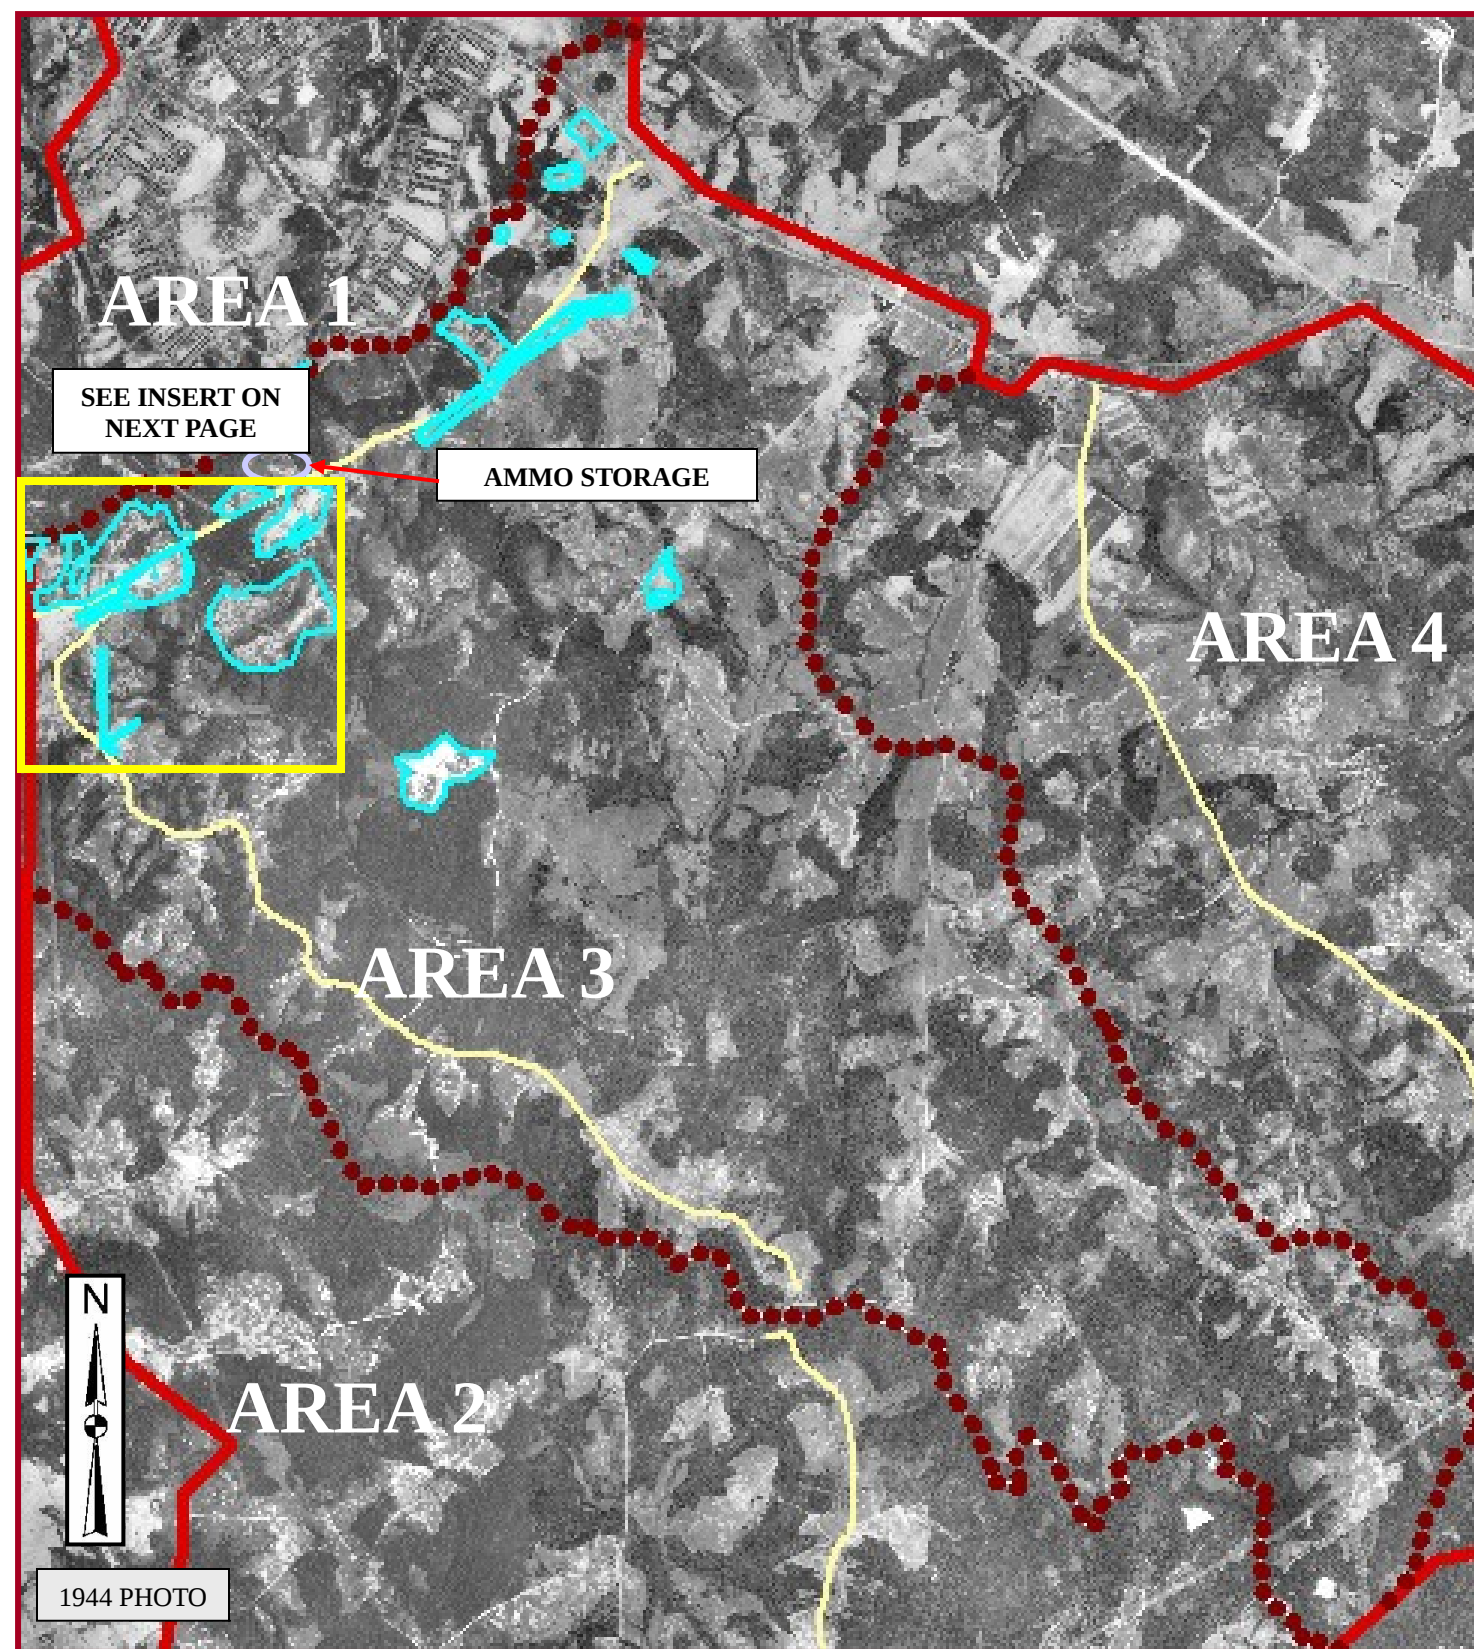
AREA 3 – FIELD TRAINING AREAS

RANGES, TRAINING AREAS, OBSTACLE COURSES, AND TARGETS ARE CONSOLIDATED AND DISPLAYED AS ONE GROUP CALLED "FIELD TRAINING AREAS". THE LOCATION OF MANY OF THESE FEATURES IS SUPPORTED BY ANCILLARY DATA.

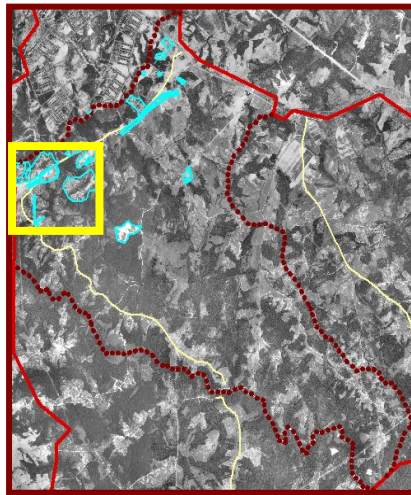
AREA 3 – FIELD TRAINING AREAS – SELECTED FEATURES

INSERTS SHOW THE CHANGES SEEN IN FOUR SEPARATE YEARS OF AERIAL PHOTOS.

1942 PHOTOS INDICATE THAT NOT ALL OF THE RANGES NAMED ON THE 1942 "PLANS & TRAINING MAP SECTIONS" WERE INSTALLED IN SEPTEMBER OF THAT YEAR. THEY ARE FOUND ON THE 1944 PHOTOS.

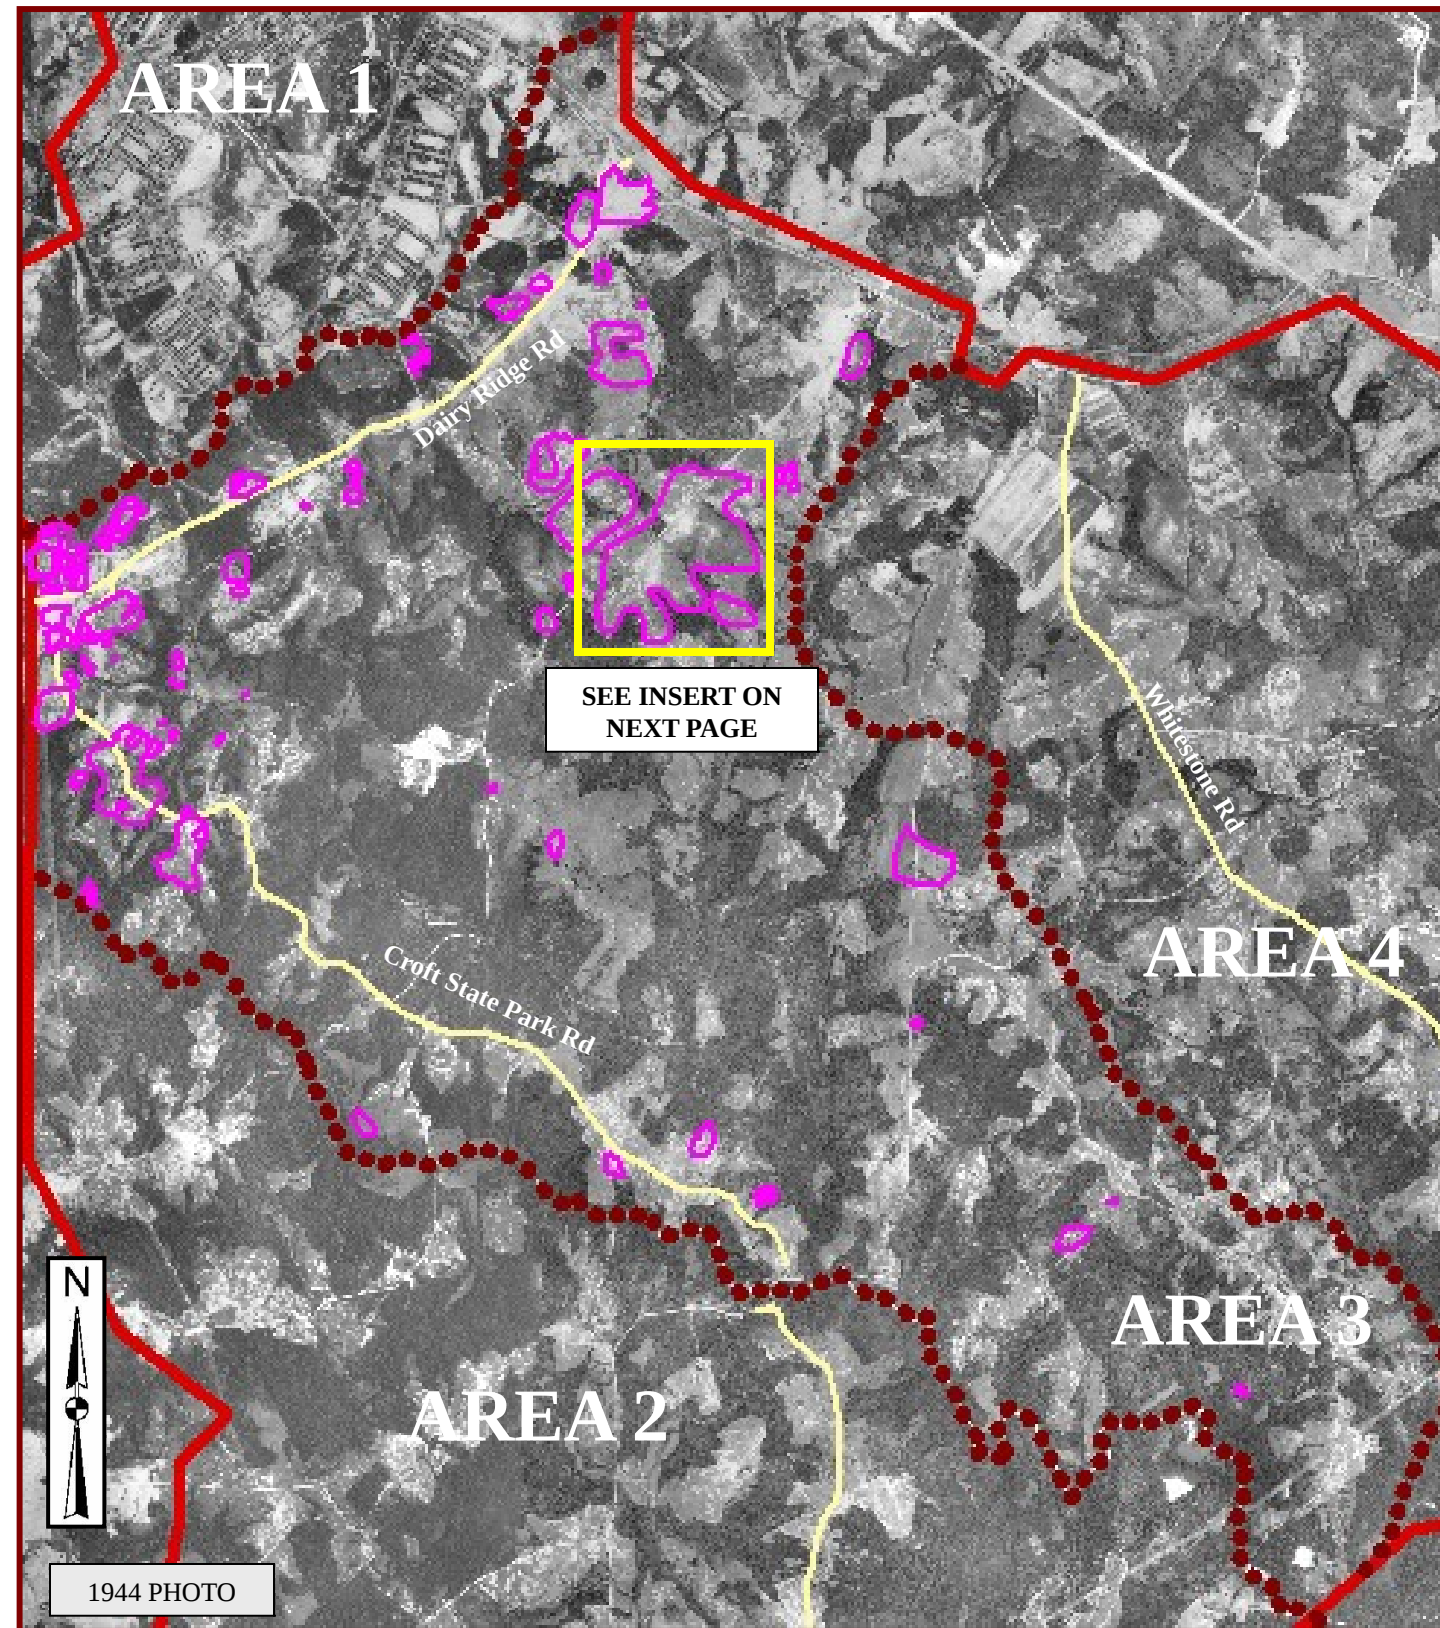
AREA 3 – CIRCULAR SHAPED FEATURES

POSSIBLE IMPACT CRATERS, PITS AND CIRCLE FEATURES HAVE BEEN CONSOLIDATED AND DISPLAYED AS ONE GROUP CALLED “CIRCULAR SHAPED FEATURES”. THESE FEATURES EXHIBIT SIMILAR PHOTO SIGNATURES BUT THE ORIGIN OR CAUSE FOR THE SIGNATURE MAY VARY. IMPACTS OF EXPLOSIVES CAN RESULT IN SIGNATURES THAT ARE ANALYZED AS PITS OR CIRCLE FEATURES.

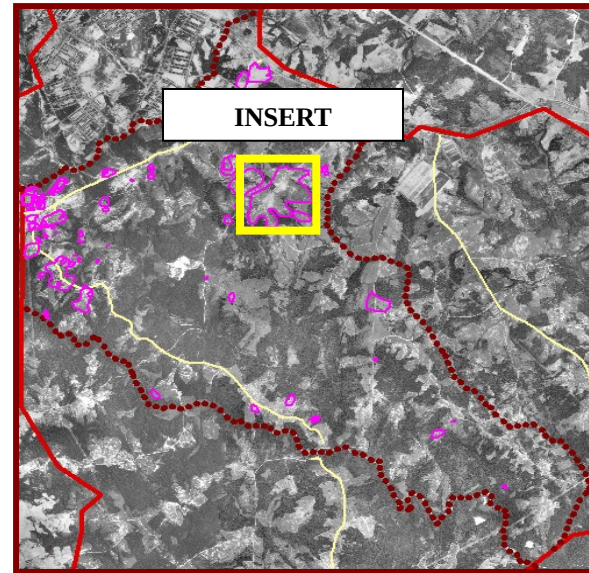
AREA 3 – CIRCULAR SHAPED FEATURES – SELECTED FEATURES

ACTIVITY INCREASED FROM VERY LITTLE IN THE AREA IN 1942 TO LARGE AREAS OF DISTURBANCE (POSSIBLY IMPACT CRATERS AND PITS) IN 1944.

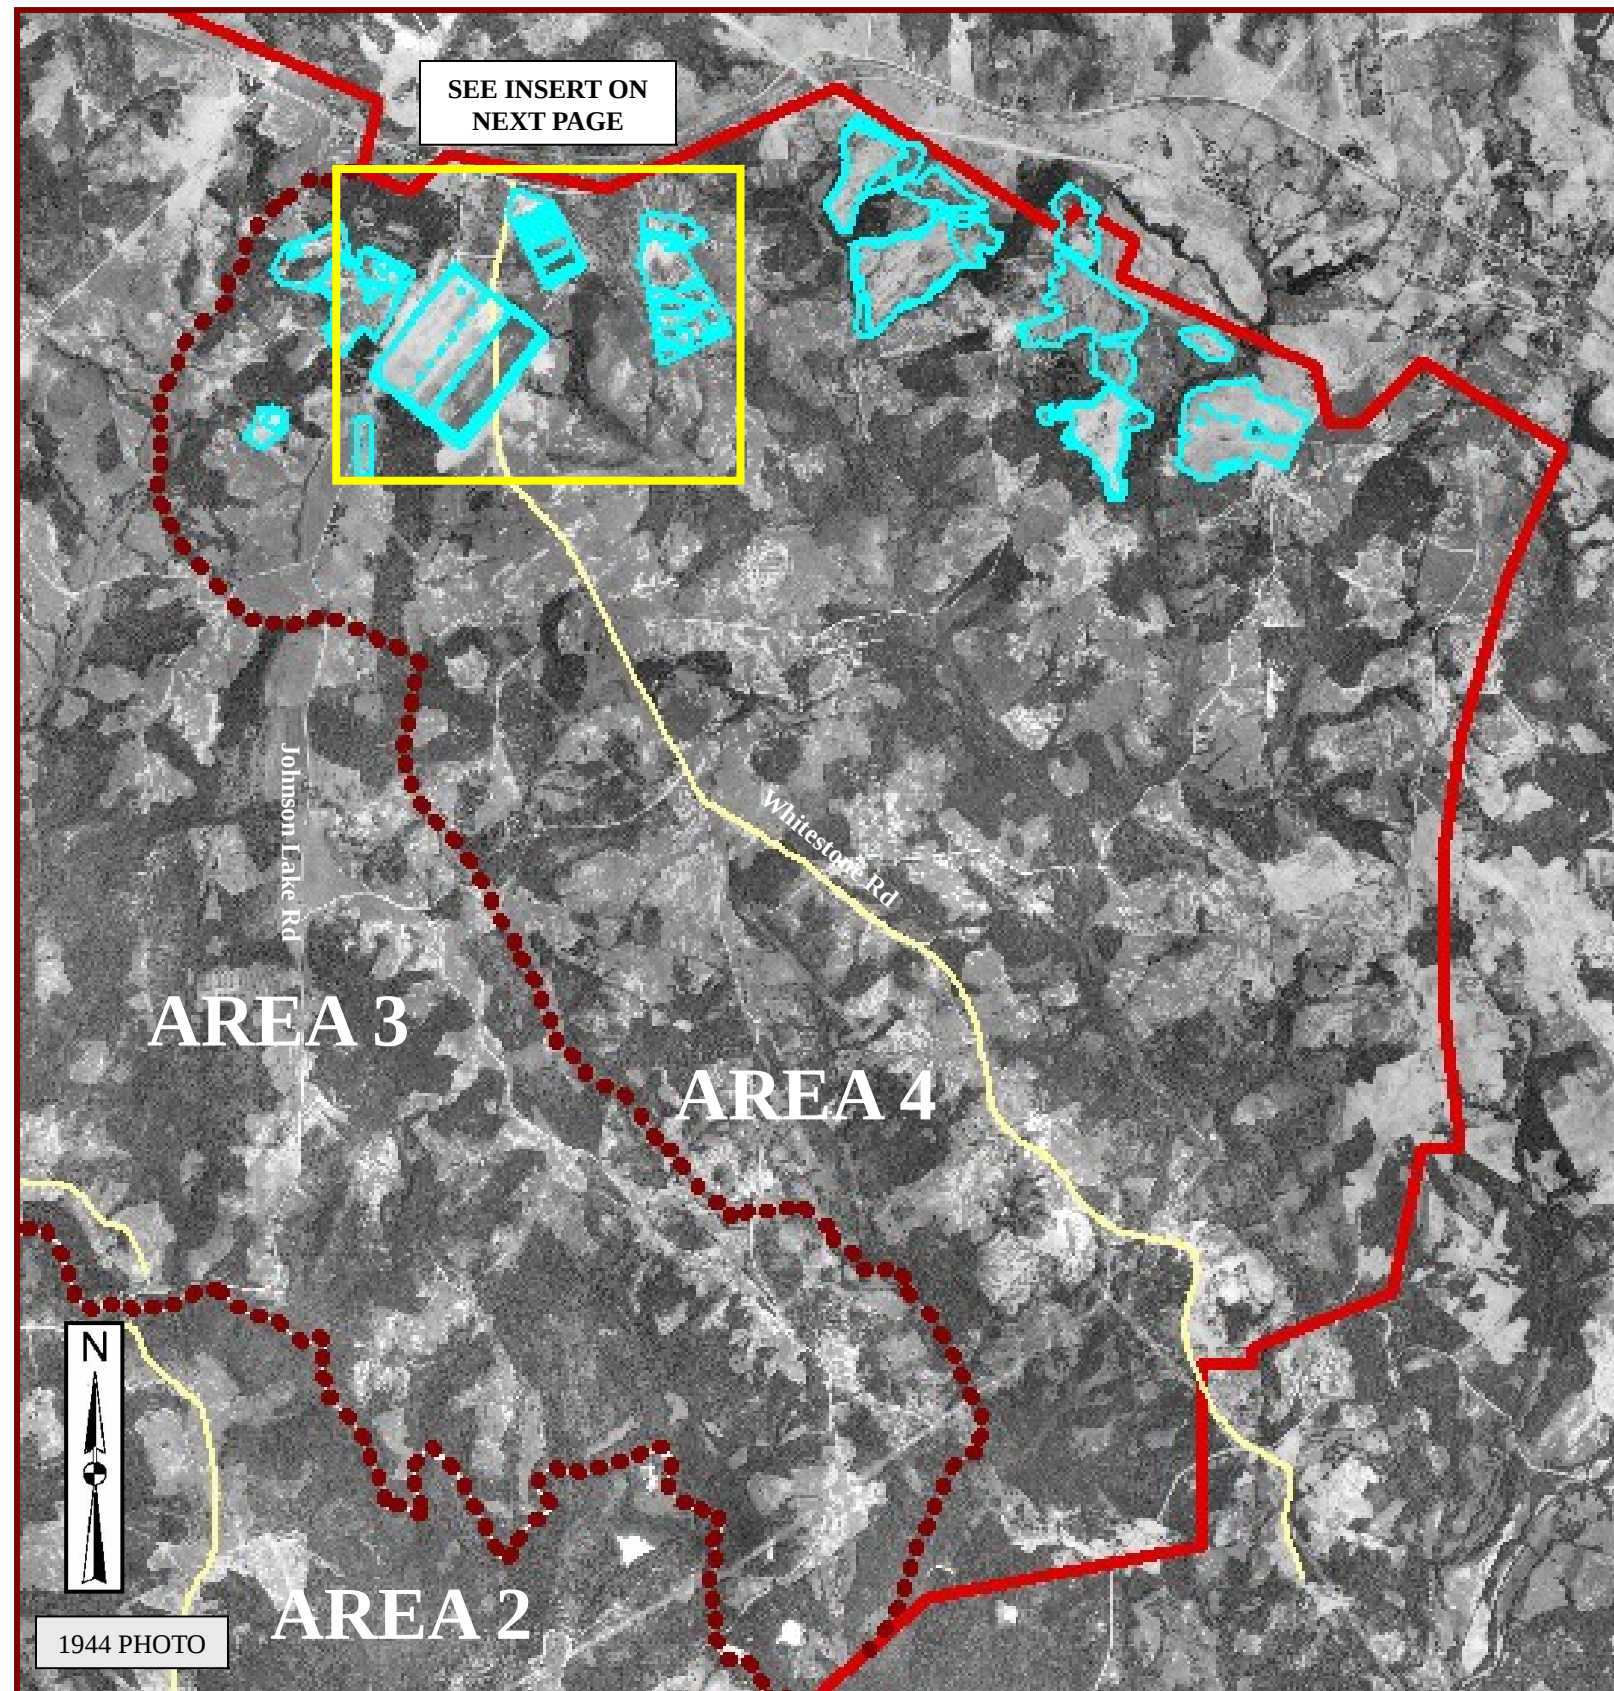
AREA 4 – FIELD TRAINING AREAS

RANGES, TRAINING AREAS, OBSTACLE COURSES, AND TARGETS ARE CONSOLIDATED AND DISPLAYED AS ONE GROUP CALLED "FIELD TRAINING AREAS". THE LOCATION OF MANY OF THESE FEATURES IS SUPPORTED BY ANCILLARY DATA.

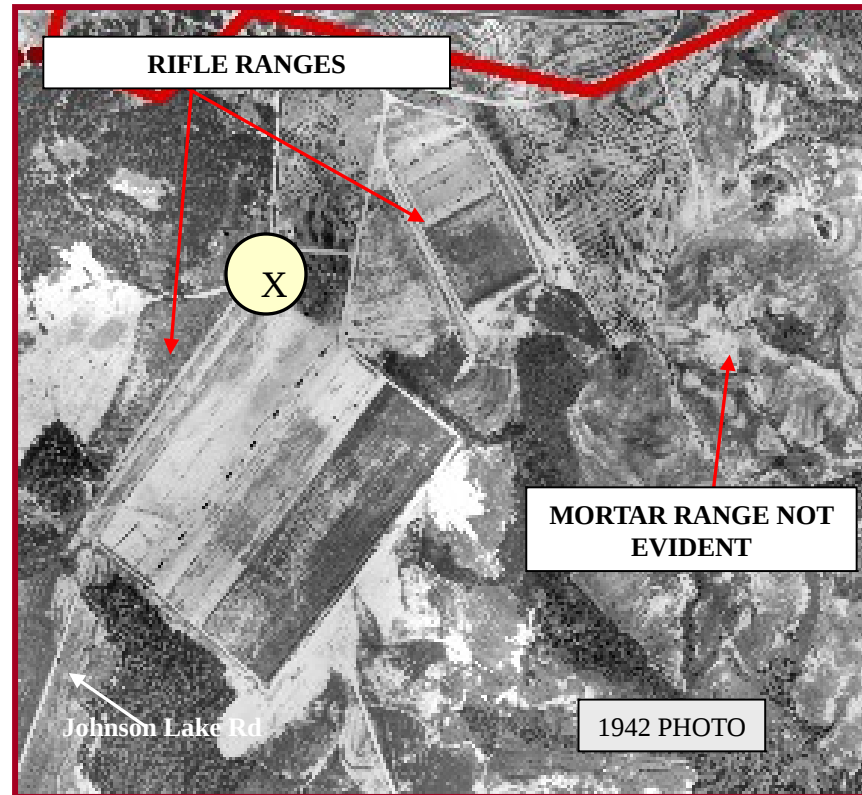
1944 PHOTO

MORTAR RANGE AS PER MAP C-7

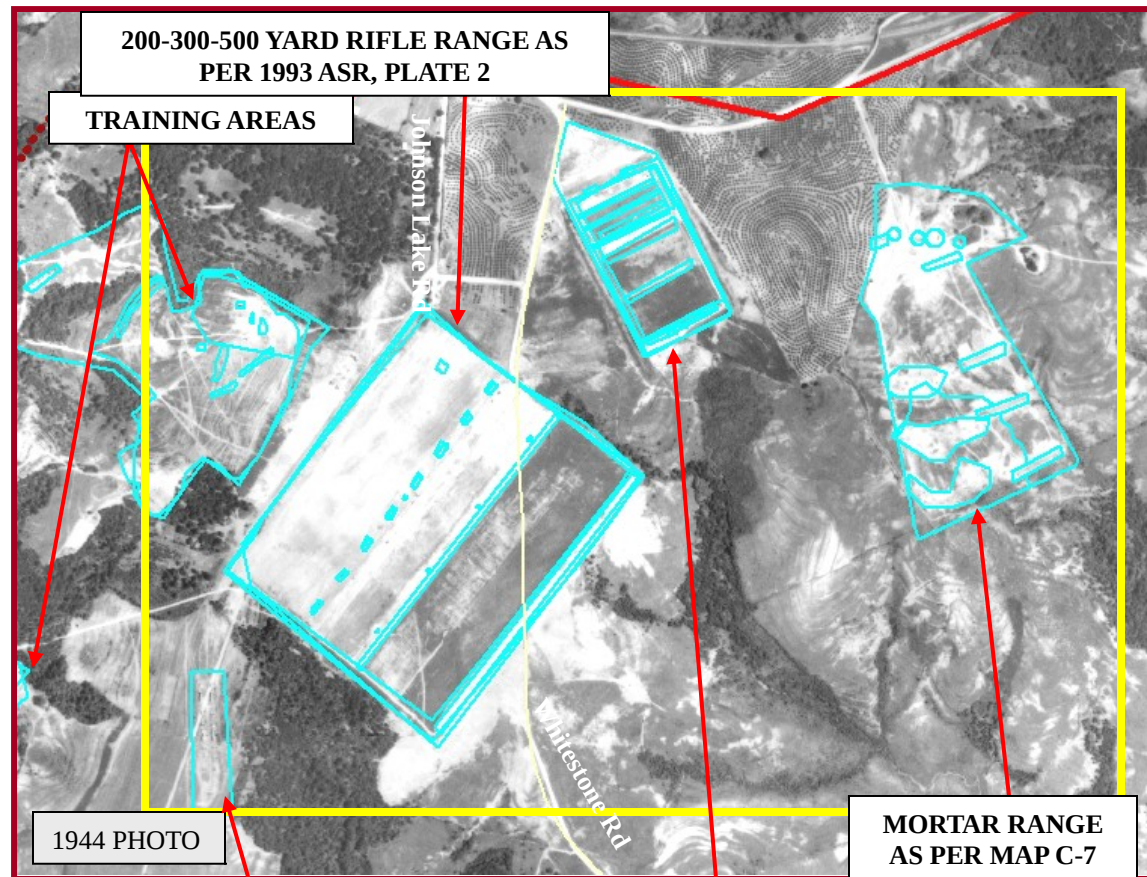
AREA 4 – FIELD TRAINING AREAS – SELECTED FEATURES

MOCK TRAINING VILLAGE

200-300 YARD RIFLE RANGE AS PER 1993 ASR, PLATE 2

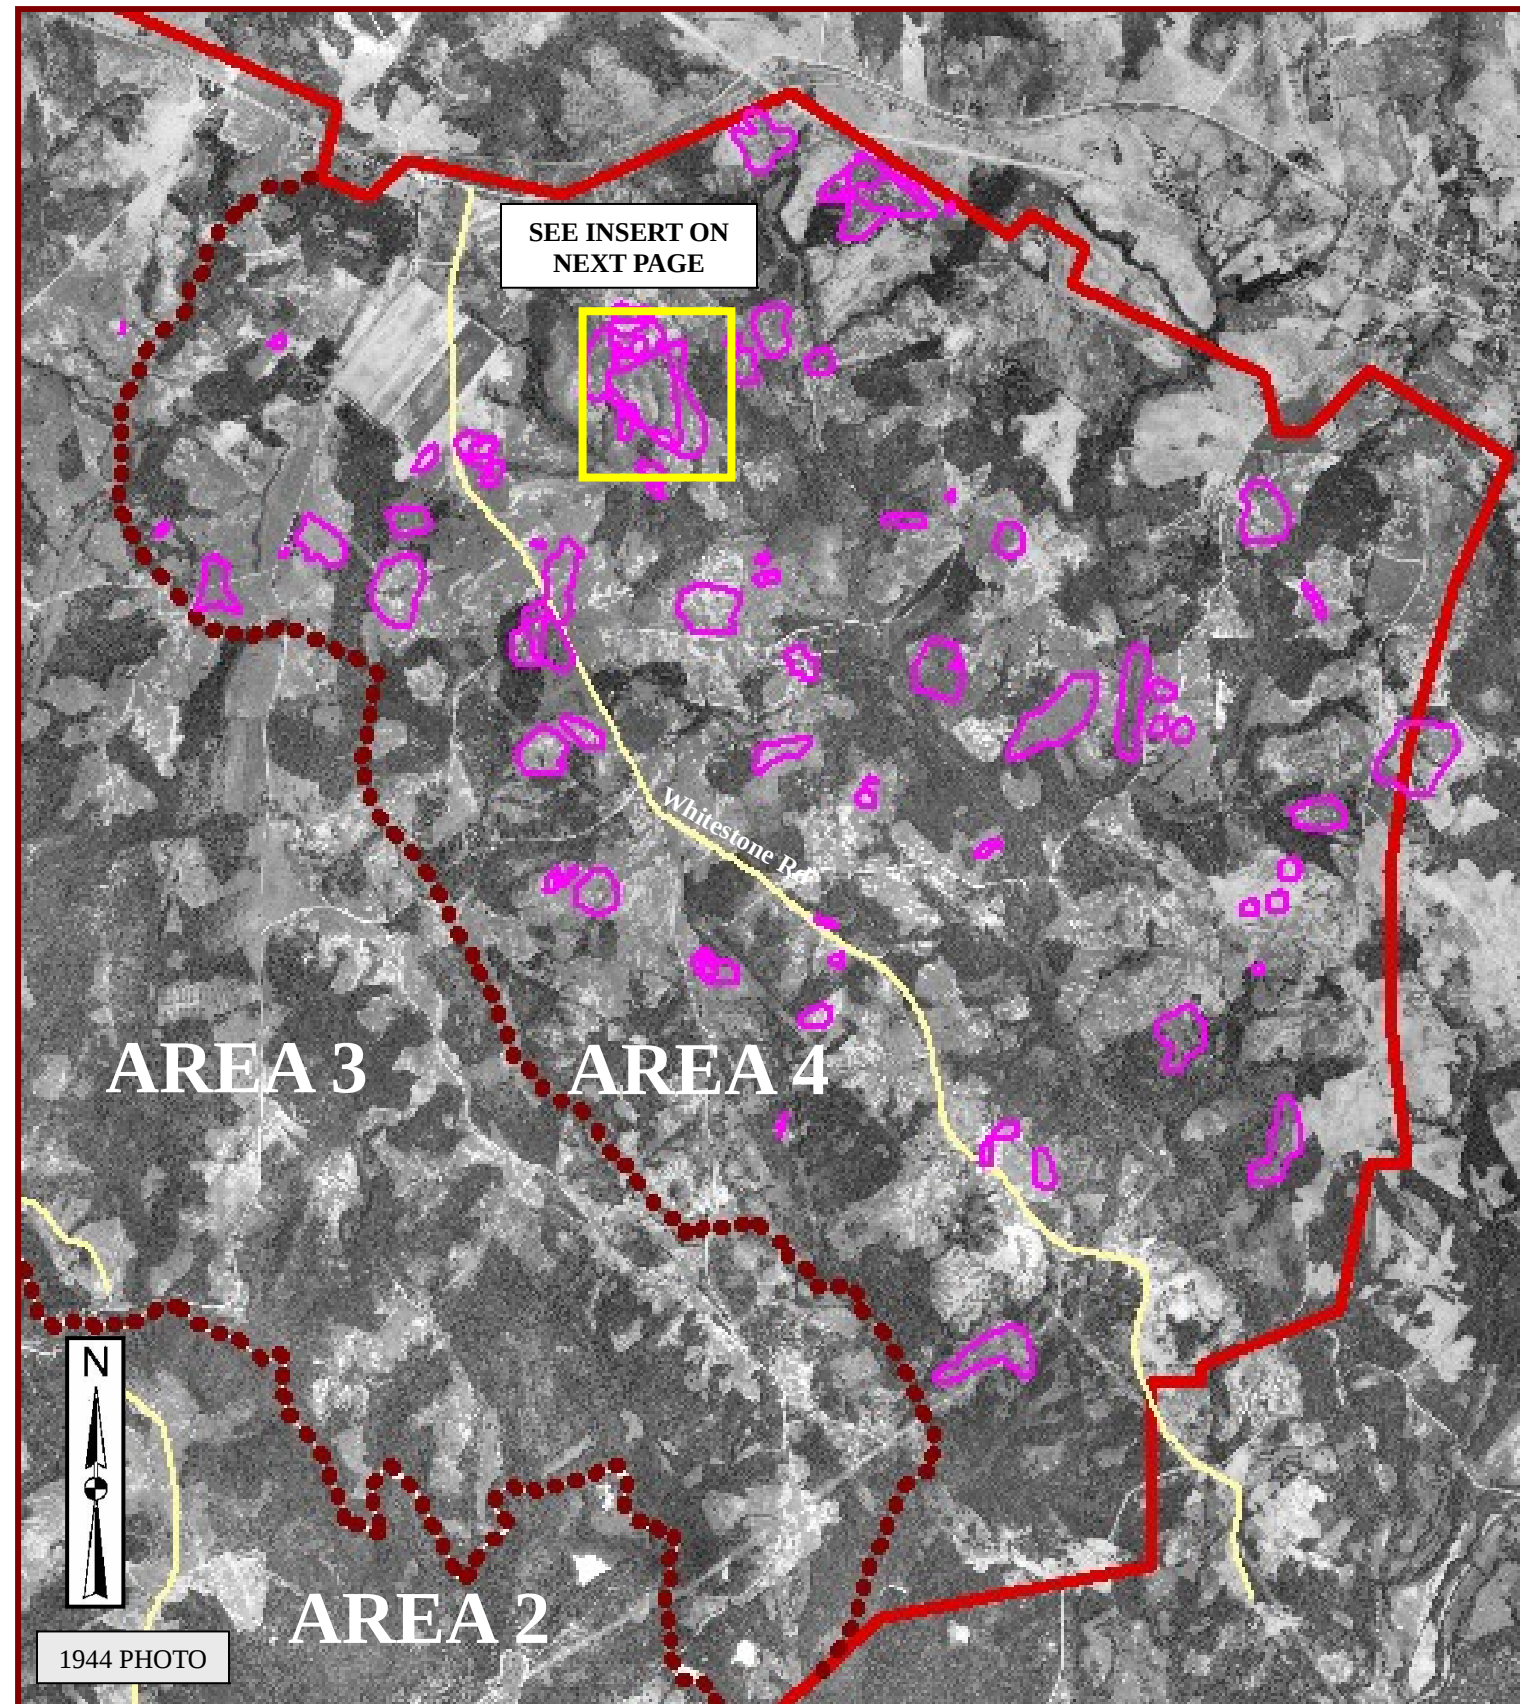
AREA 4 – CIRCULAR SHAPED FEATURES

POSSIBLE IMPACT CRATERS, PITS AND CIRCLE FEATURES HAVE BEEN CONSOLIDATED AND DISPLAYED AS ONE GROUP CALLED “CIRCULAR SHAPED FEATURES”. THESE FEATURES EXHIBIT SIMILAR PHOTO SIGNATURES BUT THE ORIGIN OR CAUSE FOR THE SIGNATURE MAY VARY. IMPACTS OF EXPLOSIVES CAN RESULT IN SIGNATURES THAT ARE ANALYZED AS PITS OR CIRCLE FEATURES.

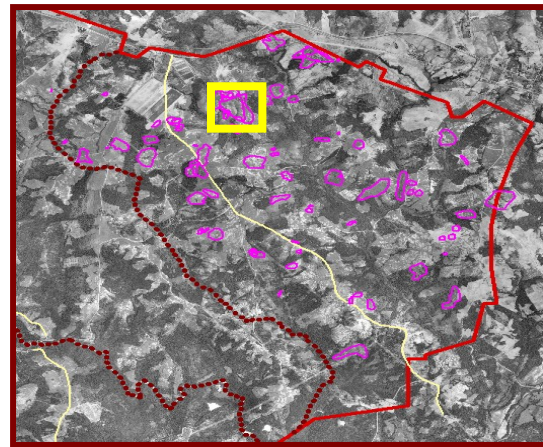
AREA 4 – CIRCULAR SHAPED FEATURES – SELECTED FEATURES

IMPACT CRATERS ARE EVIDENT IN 1942 PHOTOS. THEY ARE LESS EVIDENT IN THE 1943 TO 1951 PHOTOS BECAUSE OF THE SMALLER SCALE OF THE PHOTOS. OTHER ACTIVITY IS EVIDENT IN THE 1943 TO 1951 PHOTOS. FOR INSTANCE A RANGE WAS BUILT AND DESTROYED IN THE NORTHEAST SECTION OF THIS FEATURE.
