Camp Croft Army Training Facility

GIS-Based Historical Photographic Analysis

FORMER CAMP CROFT ARMY TRAINING FACILITY

OCTOBER 2005 REPORT

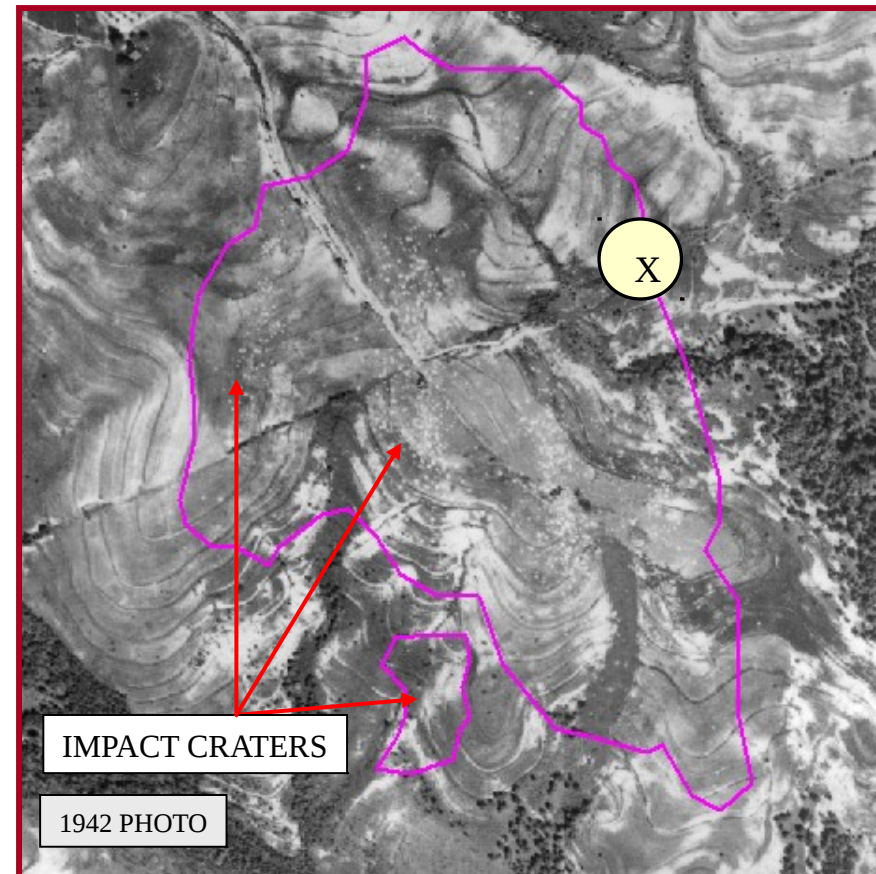
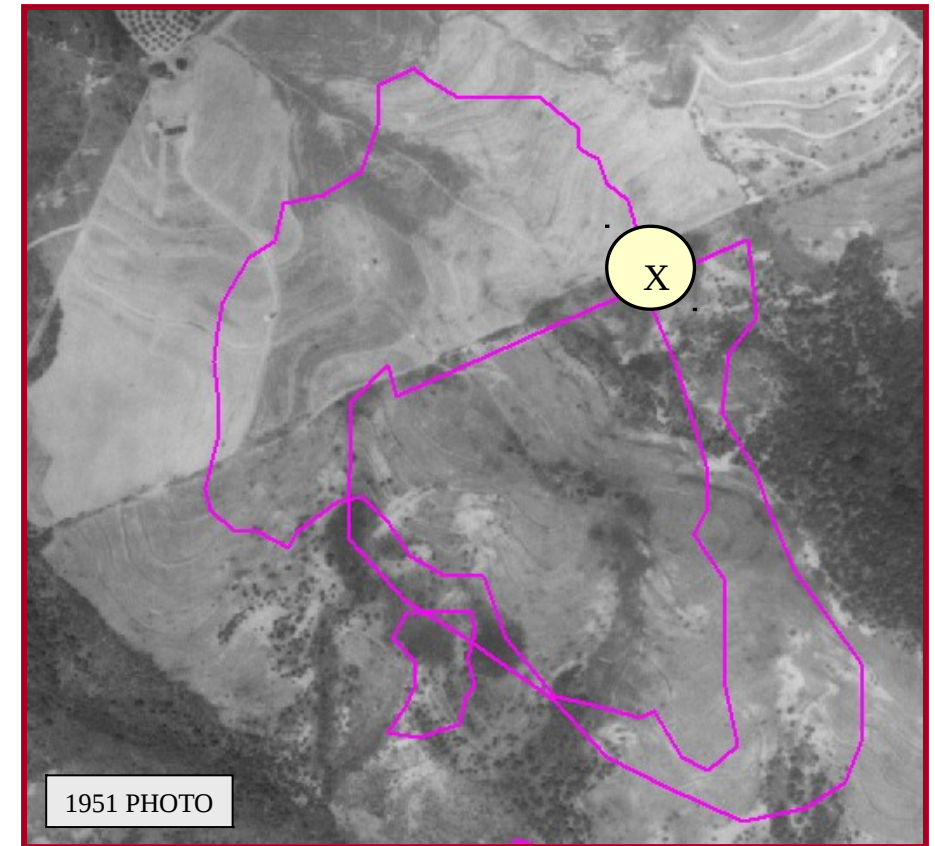
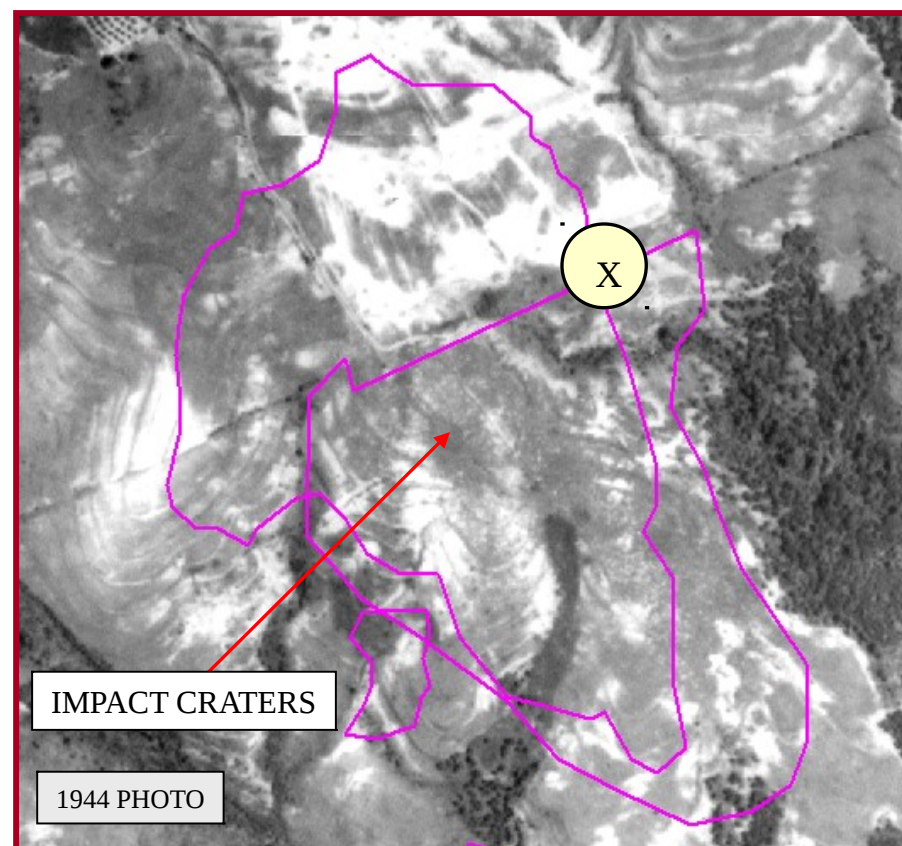
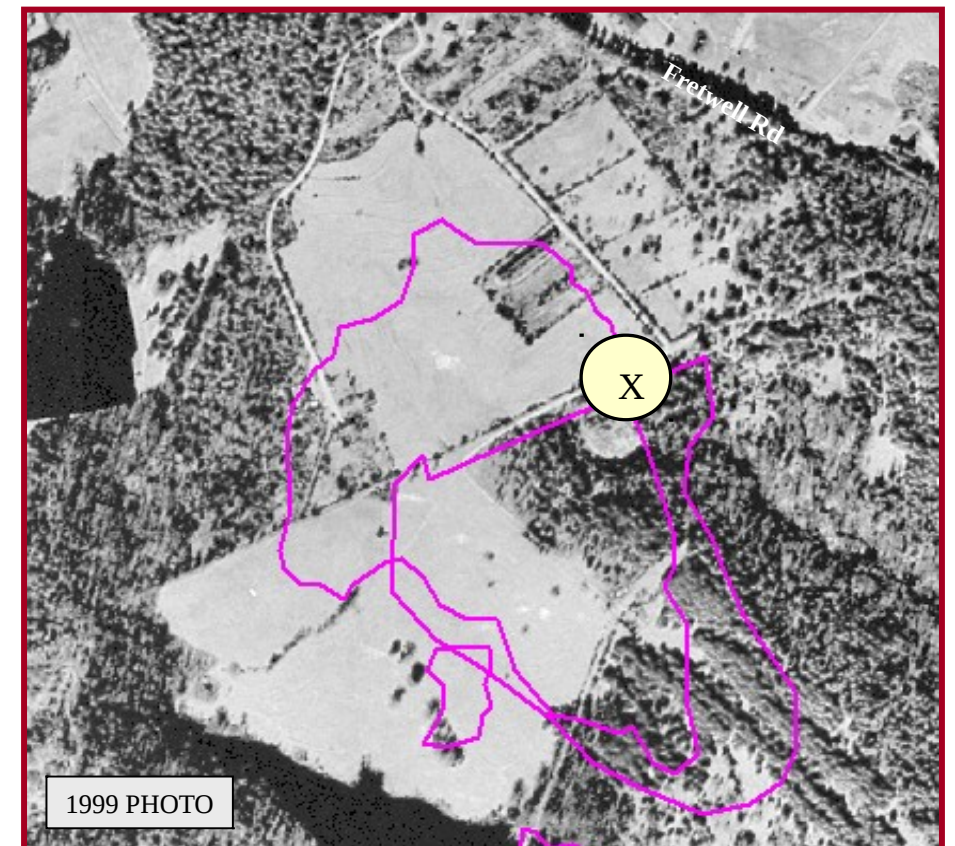
AREA 4 – CIRCULAR SHAPED FEATURES – SELECTED FEATURES

IMPACT CRATERS ARE EVIDENT IN 1942 PHOTOS. THEY ARE LESS EVIDENT IN THE 1943 TO 1951 PHOTOS BECAUSE OF THE SMALLER SCALE OF THE PHOTOS. OTHER ACTIVITY IS EVIDENT IN THE 1943 TO 1951 PHOTOS. FOR INSTANCE A RANGE WAS BUILT AND DESTROYED IN THE NORTHEAST SECTION OF THIS FEATURE.

As such, it is possible that areas of potential ordnance contamination exist in areas that are identified as pits, craters, disturbed ground, circle features and ground scars. Further field investigation will be required to determine if the areas are potentially hazardous sites (some may not be hazardous).

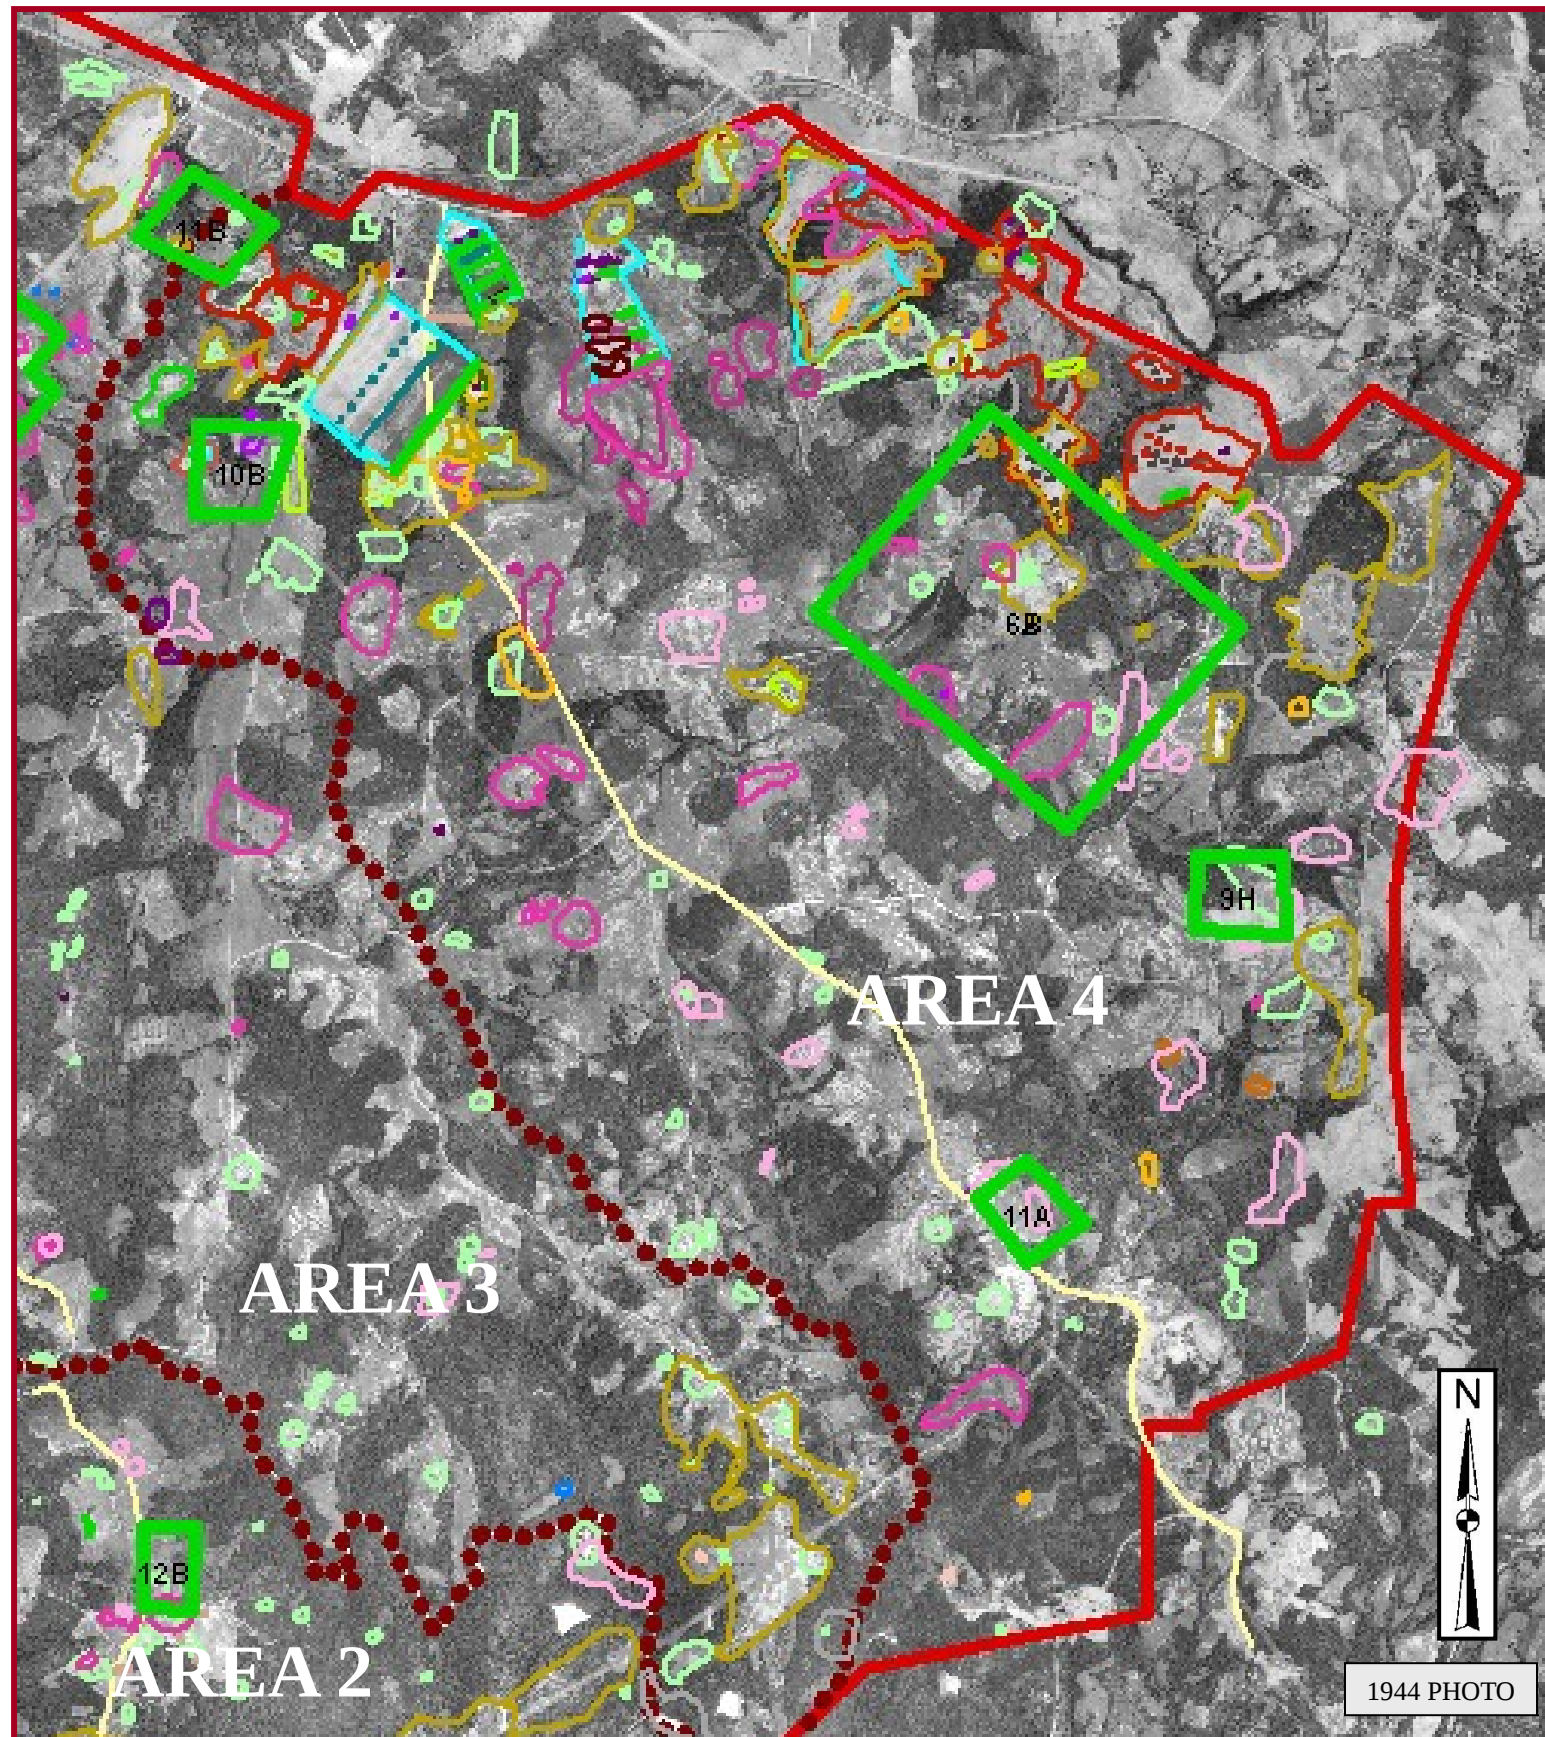
AREA 4 – ALL FEATURES FOUND DISPLAYED WITH OOU's

NOTE: For details on each feature polygon, refer to the data within the GIS data (ESRI Shape File Format) on the accompanying DVD. This will provide information on the feature type, a UTM coordinate and remarks as appropriate. Select features will be presented in this report.
